Ed Gurka, Consulting Arborist

August 1, 2011

ASSIGNMENT:

A request to provide an Arborist Report for Stefan Hastrup, Turnbull Griffen & Haeslopp and Daphane Edwards, MLA, for the Collier Reynolds Residence located at 2-2¹/₂ Bulkley Avenue construction project. Plants scheduled for removal, and replacement are located on public right of way and private property locations. The proposed removals will include replacement of landscape plants with plants suitable to the designated location. This report will provide information on trees within the front yard area and make recommendations for future construction plans.

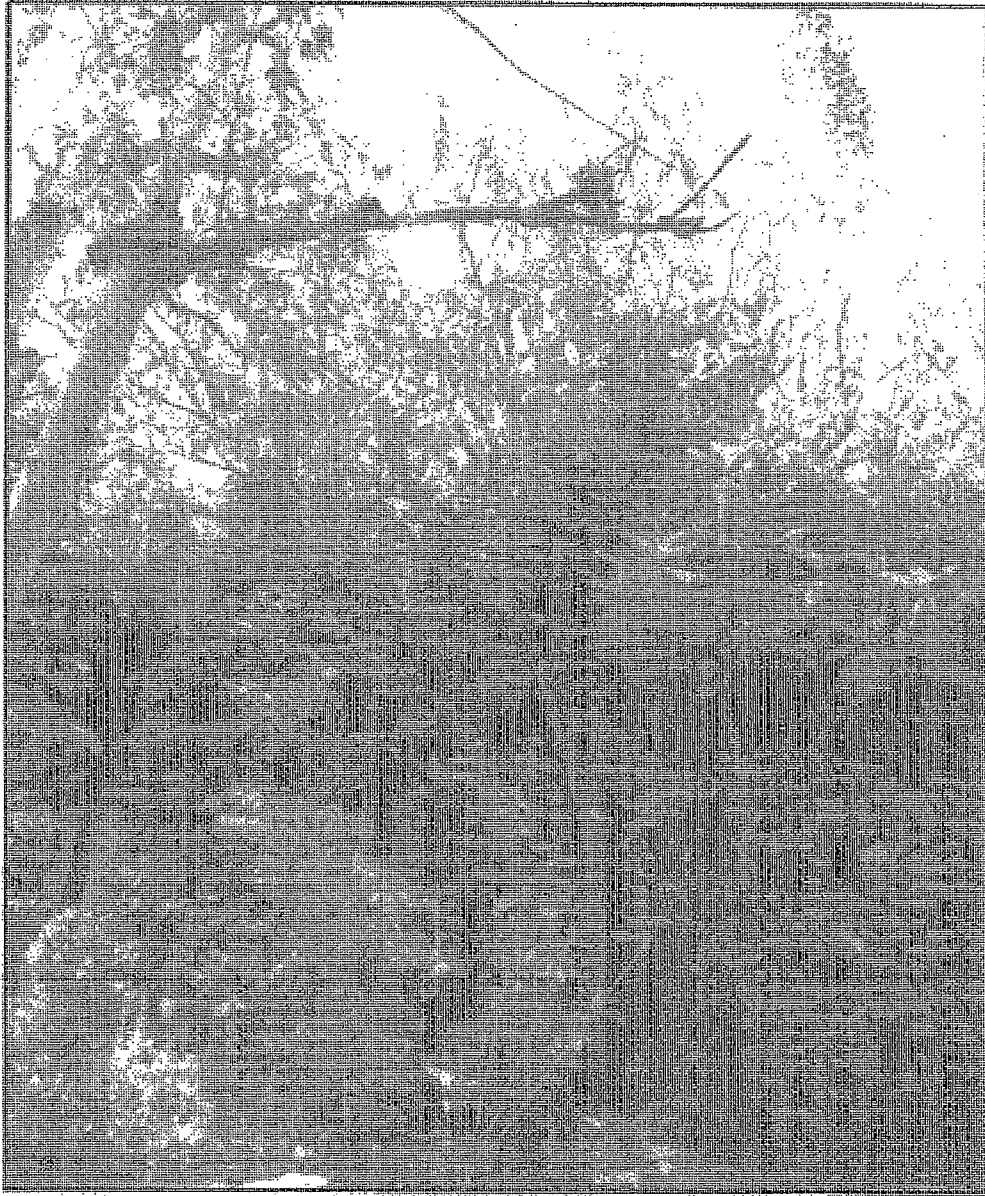
- #3 *Magnolia*, *soulangiana*, CBH 2.4, 1.2, 1.3 feet and 8.2 inches. The tree's height is 18 feet. The tree consists of four stems originating at the base of the tree. The tree placement is directly against the retaining wall and 43 inches from the outer edge. Upper canopy branches are defoliated on alternate branch tips. The bare branch tips indicate a root problem from the restricted space location. Photograph page 4.

Tree #3, a multi stem Magnolia against the retaining wall is recommended for removal.

Trees #3 and #4, *Magnolia* and *Acer palmatum* both located in the public right of way area of the landscape are recommended for removal. The planter bed size cannot contain the root system of these trees. When they mature the root confinement will crack the retaining wall requiring extensive repair work and this wall supports Bulkley Avenue directly 6 feet above the patio. The retaining wall and planter is the only buffer to Bulkley Avenue. The separation is now visible in the lower section of the wall nearest the *Acer* tree along the outer planter wall. Replacing the removed trees is not advised. Planting even a small tree would eventually require removal when roots conflict with the retaining wall. The narrow shallow planter is only suitable for small shrubs or annual perennial flower plants such as *Santolina*, *Erigeron*, or *Nandina*.

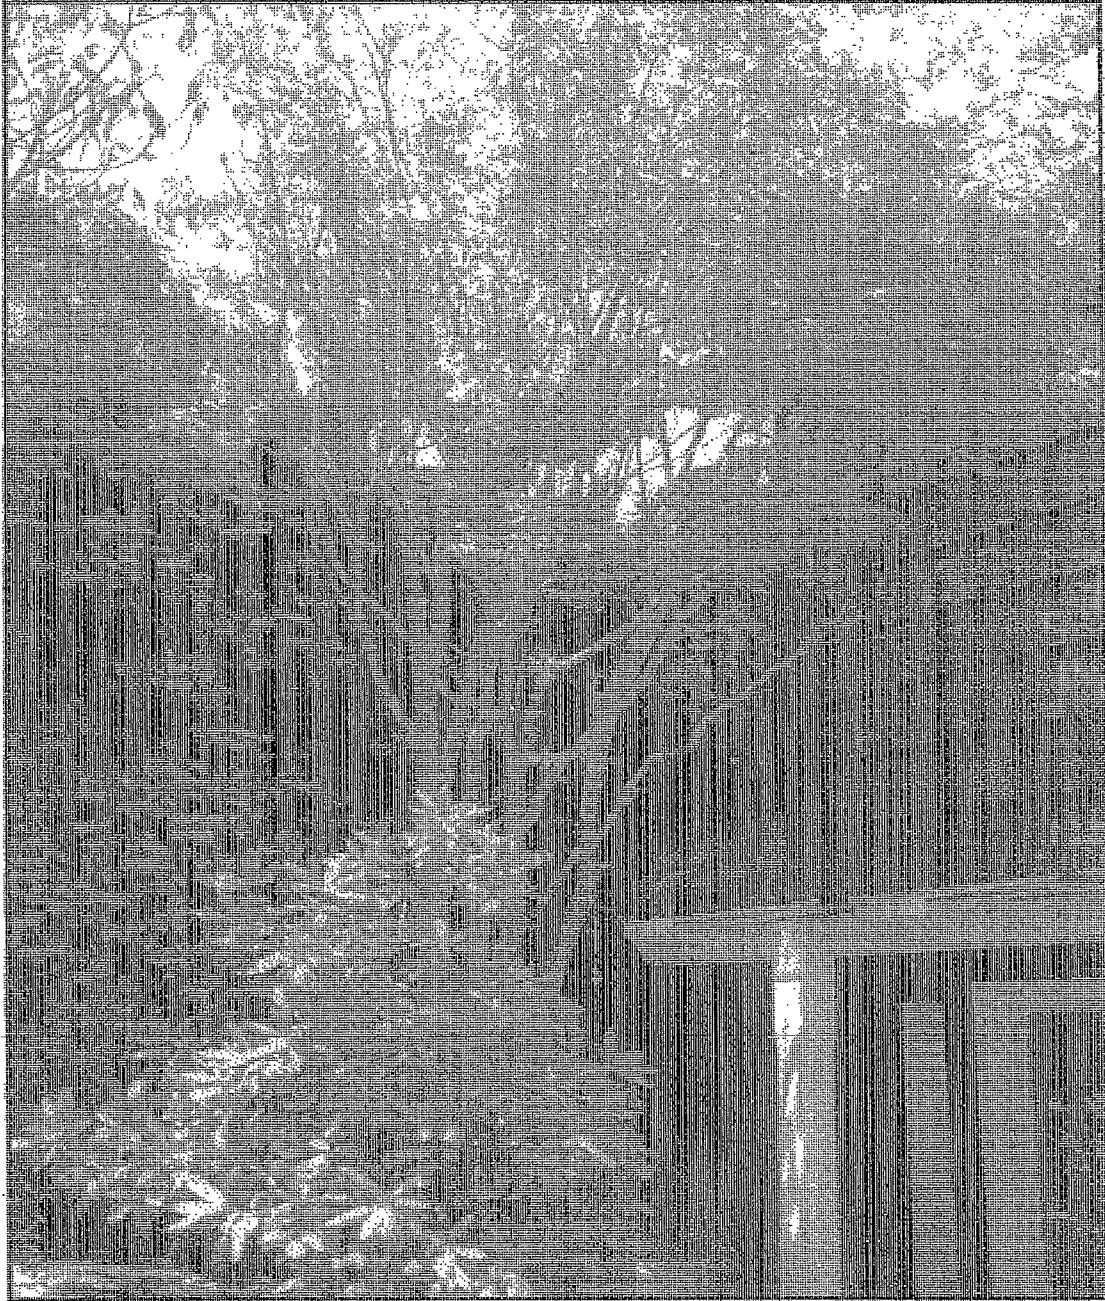
- #4 *Acer palmatum*, Japanese Maple, CBH 4.5, 4, 1.5, and 7 inches. This is a young multi-stem Maple tree with three upright stems originating at the base of the tree. It has a height of 18 feet. Photograph page 5.

Acer palmatum, Japanese Maple tree in a confined space with roots affecting plants below.

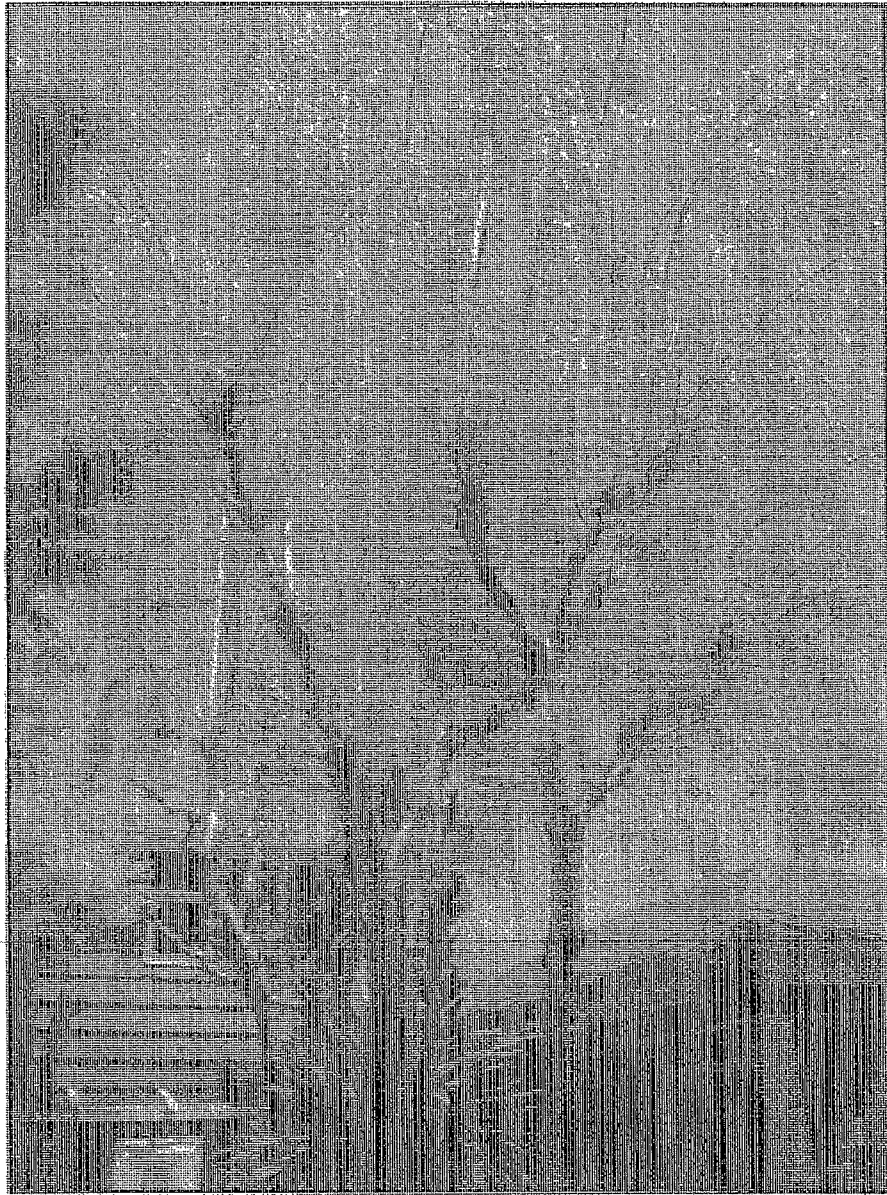
- #5 *Betula pendula*, European White Birch. The tree consists of three upright stems originating at the trunk base. The complete CBH is 1.9, 1.6 feet and 8 inches. This equals 50 inches. The tree is a non-native species and native to summer rainy climates. It does not perform well in California climates due to the lack of summer rainfall. The upper canopy exhibits branch tip dieback associated with root problems. The dieback can be attributed to the climate conditions. Condition is rated as fair to poor. See photograph page 6

- #6 *Betula pendula*, European White Birch. This tree is directly next to Birch number 5 in the courtyard. CBH is two, and 1.7 feet total CBH is 44 inches. Condition is rated as fair to poor. See Photograph page 6.

#5 and #6 two Betula trees in front courtyard of property in fair to poor condition. Recommendation is for replacement with a more suitable species for a Sausalito climate and a lower height when mature to accommodate views from neighboring properties.

Trees #5 and #6, the two Birch trees are recommended for removal and replacement with species more adaptable to a Sausalito climate. They are rated as fair to poor condition and maintaining them to fit the climate and conditions is difficult and would eventually require removal. *Betula* species are best suited in a climate with abundant rainfall throughout the year and best suited for riparian locations. Selection of a more suitable feature tree such as *Magnolia soulangiana* Saucer Magnolia, twelve species listed in Western Gardening, *Magnolia stellata* Star Magnolia, seven varieties, *Cercis occidentalis*, Western Red Bud, *Arbutus unedo*, Strawberry tree, or *Prunus yedoensis*, Flowering Cherry are species that provide features such as red color trunk, spring flowers, or fall color. All are deciduous with the exception of *Arbutus* species that are evergreen. These choices require less maintenance and are most adaptable to the climate and location. If removal is granted, the selections are an opportunity for a replacement tree that will not block neighboring views or require topping to reduce height.

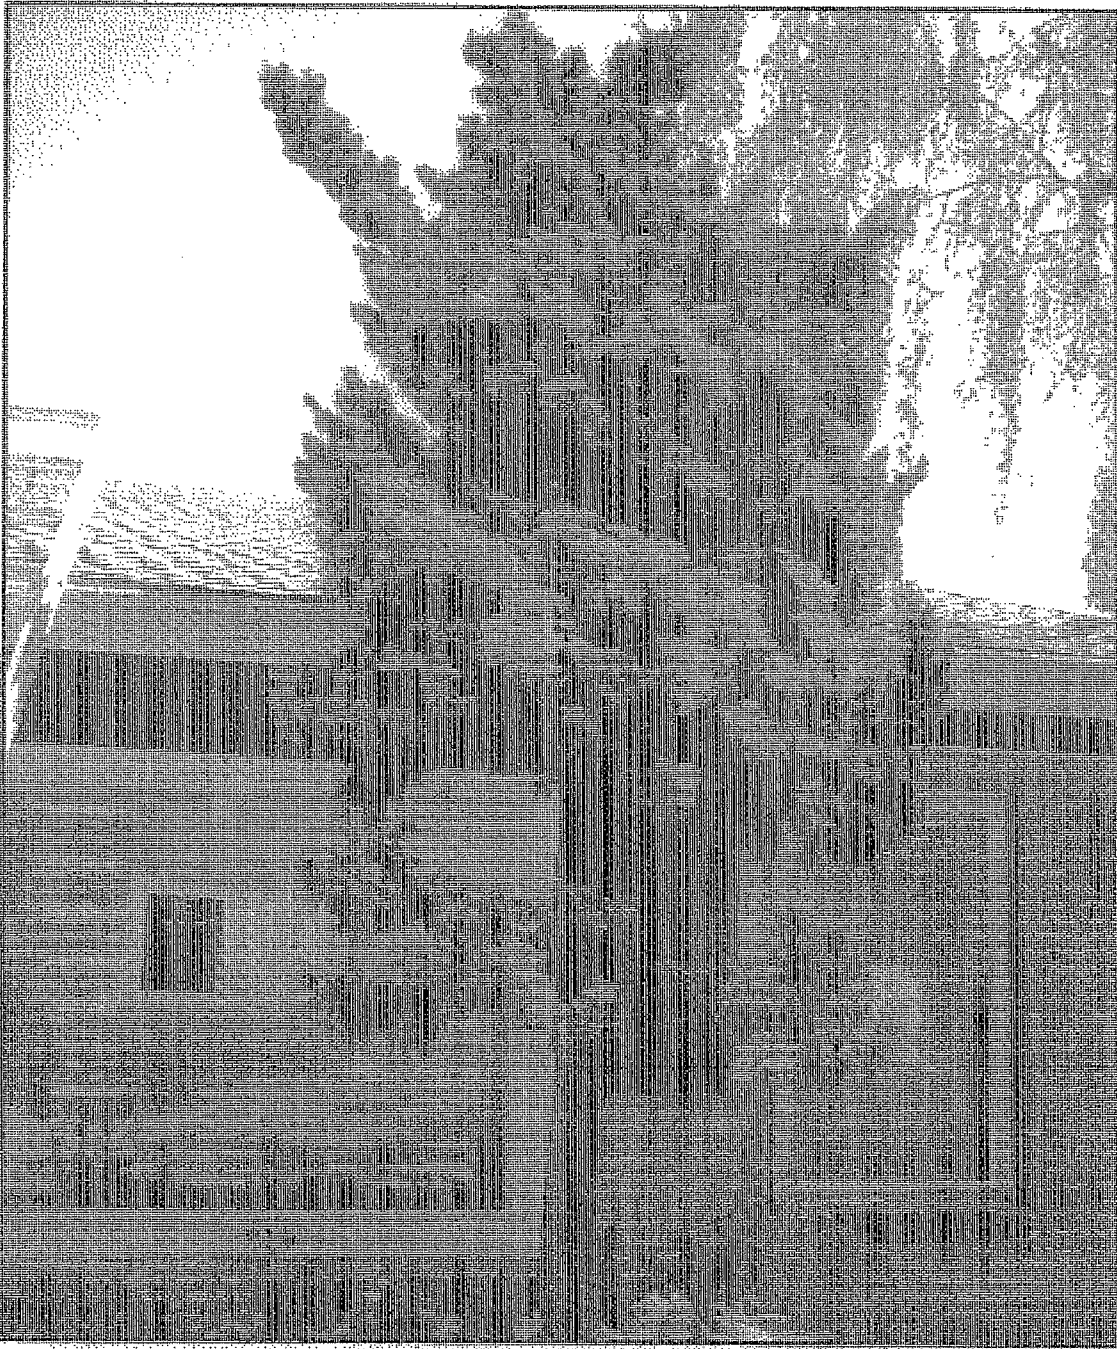
- #7 *Chamaecyparis, obtusea*, Arborvitae. Cypress. This tree is located 30 inches from the front wall of the home. CBH is 1.5 feet. This tree species and its varieties are native and non-native to California. The tree is in good condition and pruned to be displayed as a feature tree. See photograph on page 7.

Architect plans indicate front wall extension that is within the area of existing Cypress tree # 7

Tree # 7 *Chamaecyparis obtuse* is recommended for removal. The tree is within the area if the front wall expansion a direct conflict with the building construction plans. The replacement of courtyard patio trees is suggested as the alternative to replacing this tree.

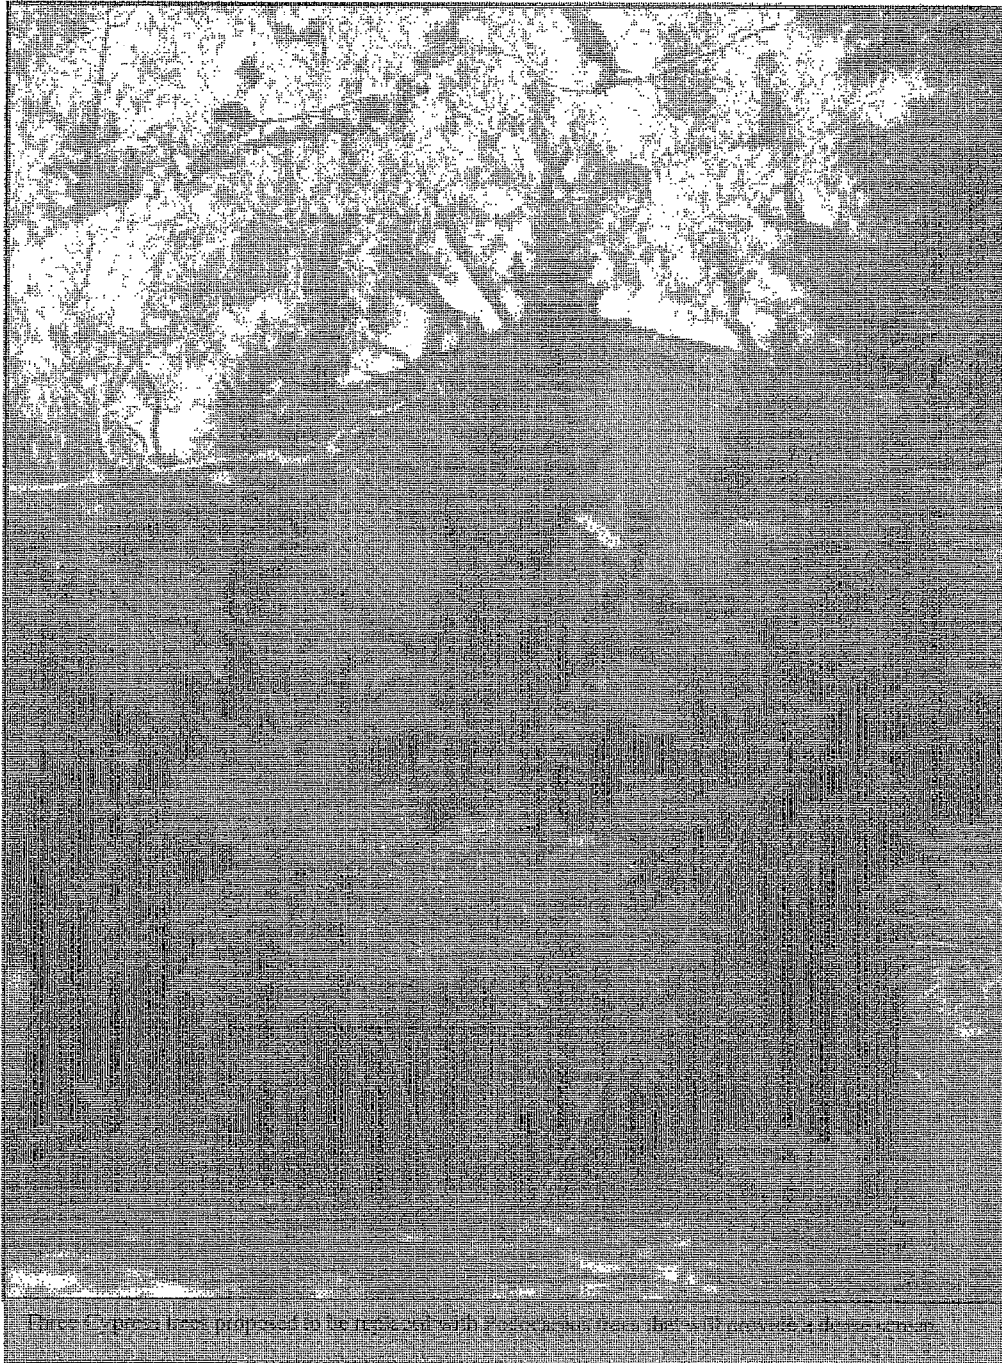
- #8, 9, 10, Three *Chamaecyparis*, False Cypress, Arborvitae. These trees form a screen between 2 Bulkley Avenue front yard and the neighboring property to the south. These three trees are in good condition. See photograph on page 8 of this report.

Three Cypress trees proposed to be retained with 20' clearance from abutment presents a dense screen.

Trees 8, 9, and 10, *Chamaecyparis, obtusa*, are planned as removals and replacement with *Podocarpus* species that form a denser screening at maturity. The recommendation is that the existing three *Chamaecyparis* trees planned for removal are replaced with four replacements to form the screen between 2 Bulkley Avenue and the neighboring property just to the south.

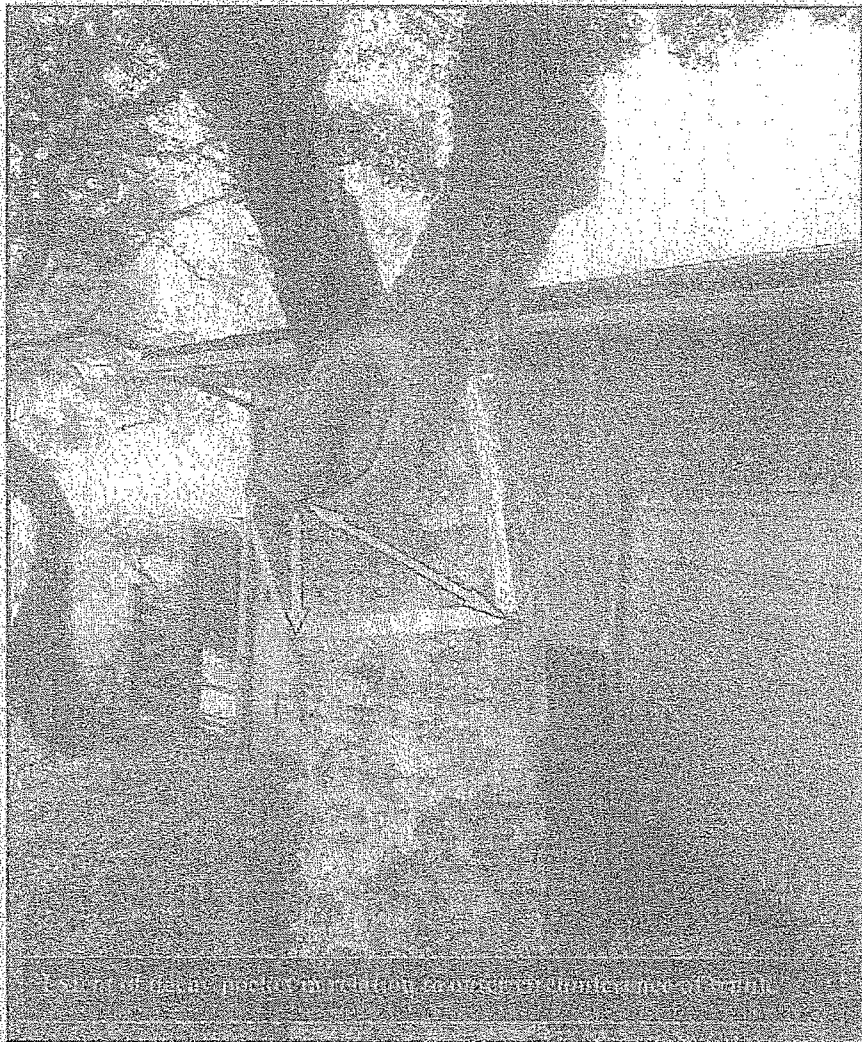
This tree is identified as a *Quercus agrifolia*, Coast Live Oak. The Circumference at Breast Height (CBH) is 3.8 feet. This Oak tree is located on the North property boundary 12 inches from the curb of Lower Crescent Avenue opposite the neighboring property of 54 Lower Crescent Avenue. The tree is 5 feet left of the driveway at 49 Lower Crescent Avenue, and the canopy extends over the home. A large trunk cavity was noticed at 6 feet above grade. The cavity opening measured 11x6 inches. The interior of the cavity, (cavity pocket) measured 5 inches in depth from the lowest part of the cavity opening. The extent of the decay was masked with tape to indicate the extent of the decay in proportion to the overall circumference of the tree, see photograph at right.

This tree has an extensive decay pocket at a critical section with scaffold limb that supports the entire canopy. The dense wood tissue that provides support for a tree's canopy is compromised by at least 75 percent and there is only 25 percent of the support wood structure remaining. The most critical factor is that the heartwood which is the

densest wood that provides support for the canopy is compromised by the decay. The canopy is positioned over the home and will fall on the home when it fails. The recommendation is that the tree is removed as soon as possible to eliminate structure damage.

The recommendation is to remove the two Coast Live Oak trees identified in this report. Coast Live Oak Tree #1 has *Phytophthora ramorum*, Sudden Oak Disease and this disease once established cannot be controlled or eliminated. Coast Live Oak Tree #2 has an extensive decay pocket that equals 80 percent of the total wood volume in the area of the trunk decay. The amount of decay cannot support the canopy over the home, and the decay will slowly increase until it cannot support the canopy. At 80 percent of total volume, this is very close to failure point.

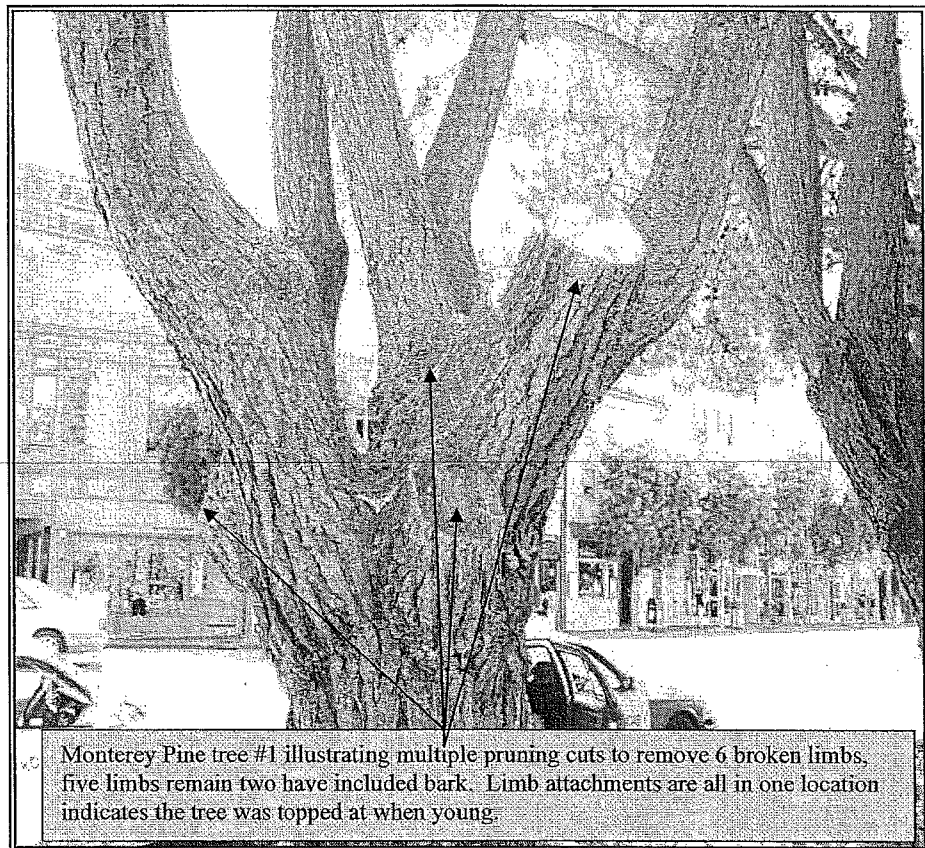
Circumference measurement at just below the lowest attachment point is 12.9 feet. Measuring at this location gives a more accurate measurement of the trunk size than if taken where limb attachments are because the attachments bulge there. The status of Monterey Pine trees is described as **undesirable** in the Sausalito Trees and Views Preservation Ordinance, 11.12.030, DEFINITIONS, Undesirable Tree. The tree has several larger diameter pruning cuts including one recent event when a large-diameter limb (16 inches in diameter) fell and damaged a street tree located on Anchor Street approximately 30 feet away from the trunk of the Monterey Pine. A count of remaining and removed limbs was made during the last site visit July 27, 2011. On this tree, there are five of eleven limbs remaining. A total of six large-diameter limbs were removed because of limb breakage. Two of the remaining limbs have very acute angles at their point of attachment to the trunk.

At the point of attachment, the two limbs have a condition referred to in arboricultural terms as bark inclusion, (bark that becomes embedded in a crotch (union) between branch and trunk or between codominant stems; causing a weak structure, ISA Glossary of Arboricultural Terms.)

This condition presents a very high-risk failure of one of the two limbs because of the extreme pressure of the two limbs against each other. The brick plaza where these trees are located is a very high density of pedestrian traffic. The bank entrance is located here, and the plaza is the location of a self-service bicycle rental location.

Monterey Pine tree #1 illustrating multiple pruning cuts to remove 6 broken limbs, five limbs remain two have included bark. Limb attachments are all in one location indicates the tree was topped at when young.

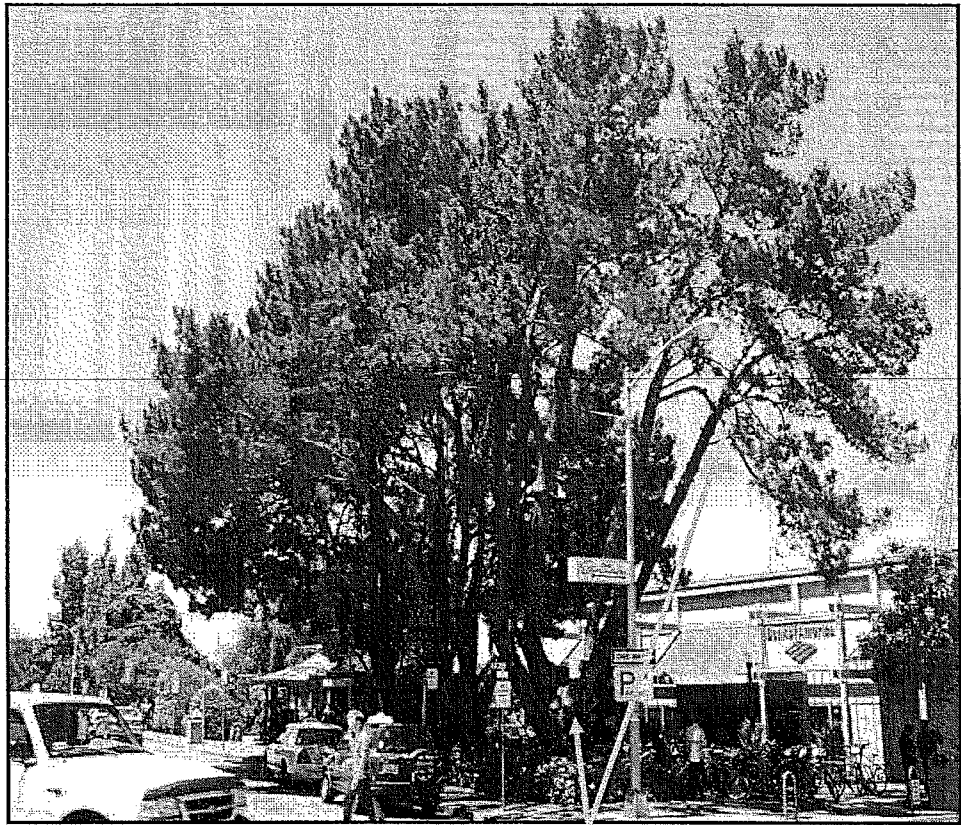
Monterey Pine #1 has large extended scaffold limb leaning over a brick Plaza. This tree has several large diameter pruning cuts due to limb failures caused by poor structure the result of topping when the tree was in its early growth stage.

These multiple leaders all compete for space and eventually fail because of their structure. In a location with infrequent traffic, risk would be reduced because potential for injury would be limited. The location of these Pine trees on Bridgeway in the down town business district has constant activity, the frequency of activity, the bicycle rental station, bank, bus shelter, public restrooms, and tourist traffic increase the risk of personal injury exponentially when limb failures occur. There are a poor canopy structure and history of limb failure, especially on Monterey Pine tree #1. There is very little that can be done to correct the trees' structure at this stage of the trees' growth. All three pines have either Pine pitch canker or Western Pine Rust fungal diseases most likely introduced by Pine Beetles. These compound conditions will very likely cause more limb failure that may cause personal injury if the heavy weight limbs strike a pedestrian. Monterey Pine tree #1 should be removed immediately. The Bridgeway corridor is a windy location and wind influence on heavy end-weighted limbs with poor attachments increases limb failure. The two limbs with bark inclusion are high failure potentials. These multiple factors are the basis of the recommendation for removal.
