DEPARTMENT OF PUBLIC WORKS
 TREE MAINTENANCE ACTIVITIES PERFORMED AND PENDING
 OCTOBER-NOVEMBER 2011

Arborist Report, Monterey Pine Tree, Spencer & Miller Avenue, Sausalito, CA.
Prepared by Ed Gurka Independent Services, San Rafael, California

**View Obstruction Arborist Report
81 Cazneau Avenue, Sausalito, CA**

Arborist Report 2 Bulkley Avenue, Sausalito, CA
Prepared by Ed Gurka, Independent Services, San Rafael, California

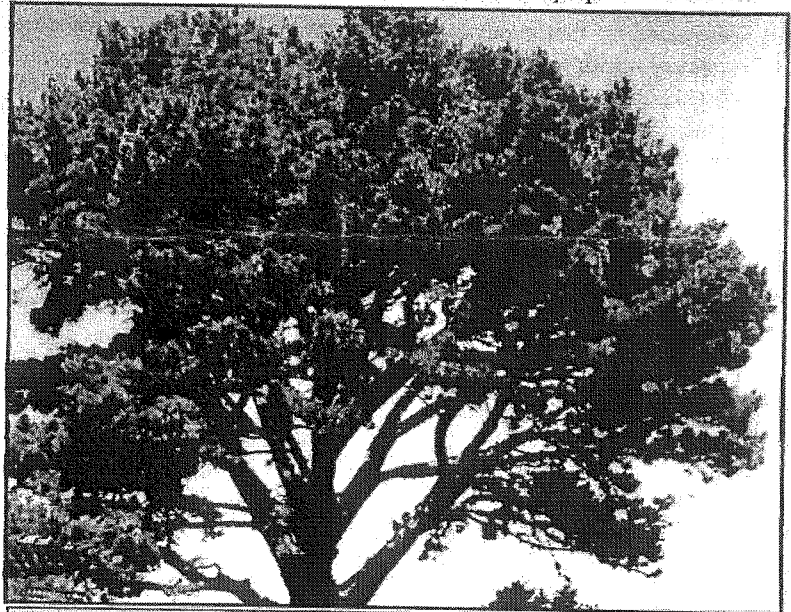
The Monterey Pine canopy inspection noted that there is tip dieback of terminal growth points throughout the upper canopy. In other limb tips, where smaller branches terminate, there appeared brown foliage, described as brown needle coloration. It is very possible that the two conditions are related. First, the limb tips produce brown needles that result in bare limb tip branches indicating a condition described as "dieback." This condition appears randomly throughout the canopy.

This dieback of branch tips and needle browning is a sign of Pine Pitch Canker, a fungal disease that most commonly occurs through wounding from pruning cuts or insect attacks.

Brown needles on Pine branch tips. 11.19.2010

This Monterey Pine tree is in a stressed condition that has compromised its defense mechanisms. This is exhibited by the symptoms identified and discussed in this report. The tree will continue to decline and will be determined by factors such as continued beetle attacks, advancement of the fungal disease and climate conditions. There are multiple high value risk targets present in the failure path from falling branches and debris from the tree. A heavy pinecone production will also add to the debris produced by the tree. These events will increase with frequency as the tree declines and risk associated within the fall path must be evaluated by the City if the tree is on public right of way. The recommendation, based on these discovered findings from the site inspection, is that the tree should be removed to eliminate the risk.

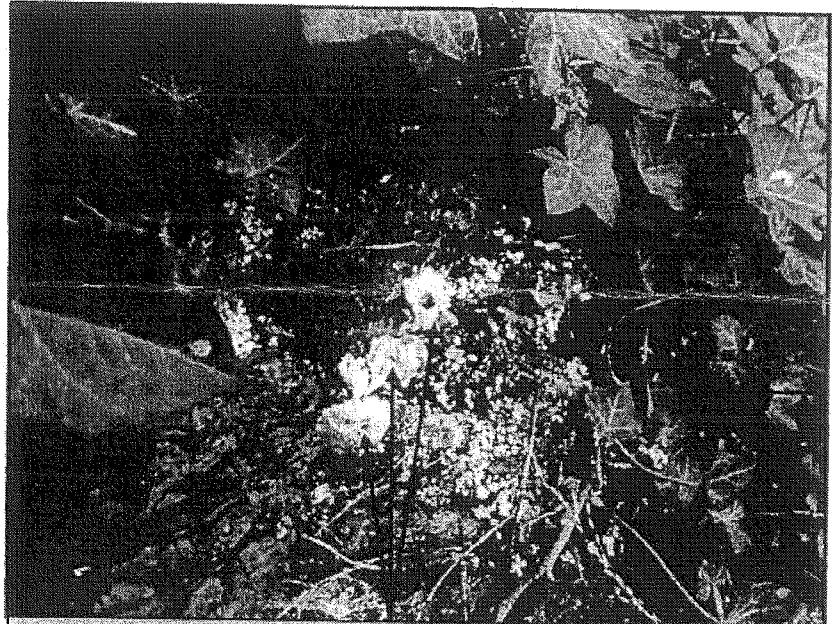
Pruning cuts performed during the growing season produce a sap pitch attracting pine beetles that are also active during the late spring, summer, and early fall months of the year. Since Pine Pitch Canker was noted during the time of visual inspection, the lower trunk area was examined for the presence of *Dendroctonus valens*, Red Turpentine Beetle. This beetle attacks the lower base of Pine trunks and exposed roots just below the soil surface. The Red Turpentine Beetle was detected in multiple locations on every side of the lower tree trunk. The beetle produces pitch tubes visible on the outer bark illustrated in the photograph from just one location on the lower trunk of this pine tree.

Beetle Pitch tubes on lower M. Pine trunk. 11.13.2010

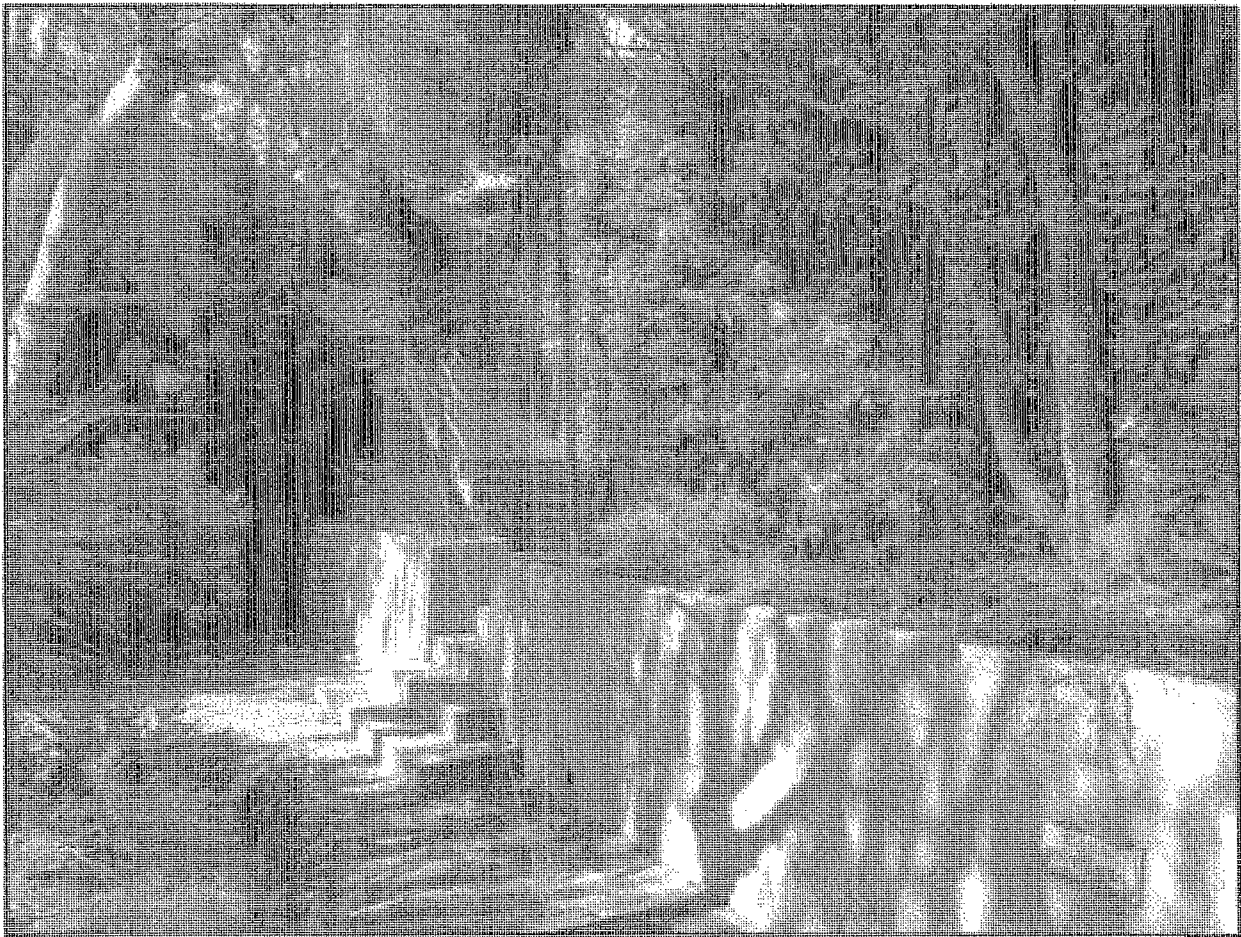
Chamaecyparis trees 1 and 2, removal is recommended. The location in a very constricted space for a tree of this size roots will soon damage the planter and retaining wall if not removed. This planter is 5 feet wide and appropriate plants for this location are small shrubs, small perennial plants.

Trees #1 & 2, *Chamaecyparis, cyperinus* on either side of stairway, recommended for removal.

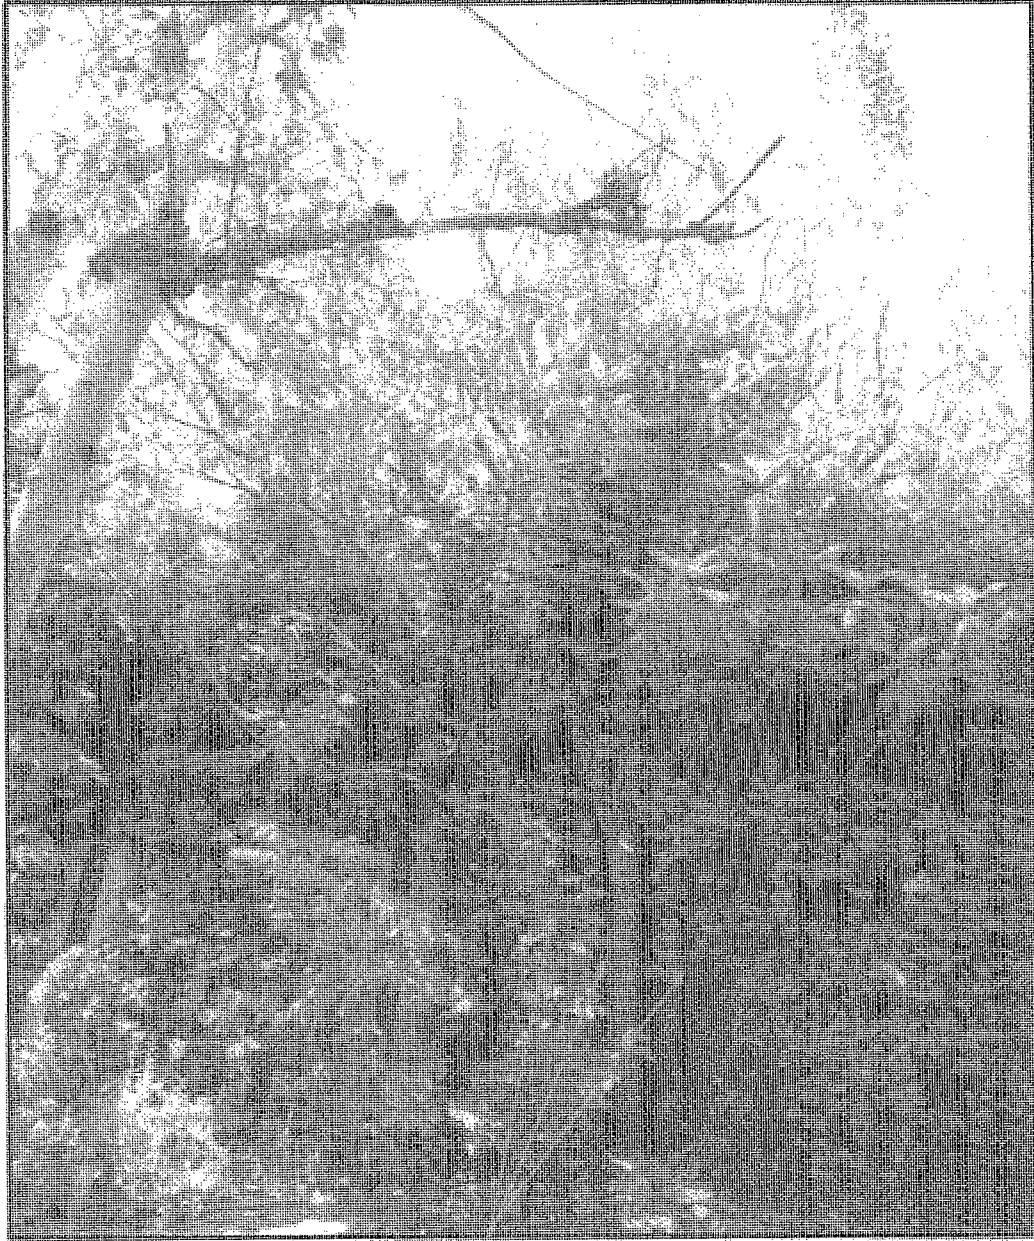
Trees #3 and #4, *Magnolia* and *Acer palmatum* both located in the public right of way area of the landscape are recommended for removal. The planter bed size cannot contain the root system of these trees. When they mature the root confinement will crack the retaining wall requiring extensive repair work and this wall supports Bulkley Avenue directly 6 feet above the patio. The retaining wall and planter is the only buffer to Bulkley Avenue. The separation is now visible in the lower section of the wall nearest the *Acer* tree along the outer planter wall. Replacing the removed trees is not advised. Planting even a small tree would eventually require removal when roots conflict with the retaining wall. The narrow shallow planter is only suitable for small shrubs or annual perennial flower plants such as *Santolina*, *Erigeron*, or *Nandina*.

Tree #3, a multi stem Magnolia against the retaining wall is recommended for removal.

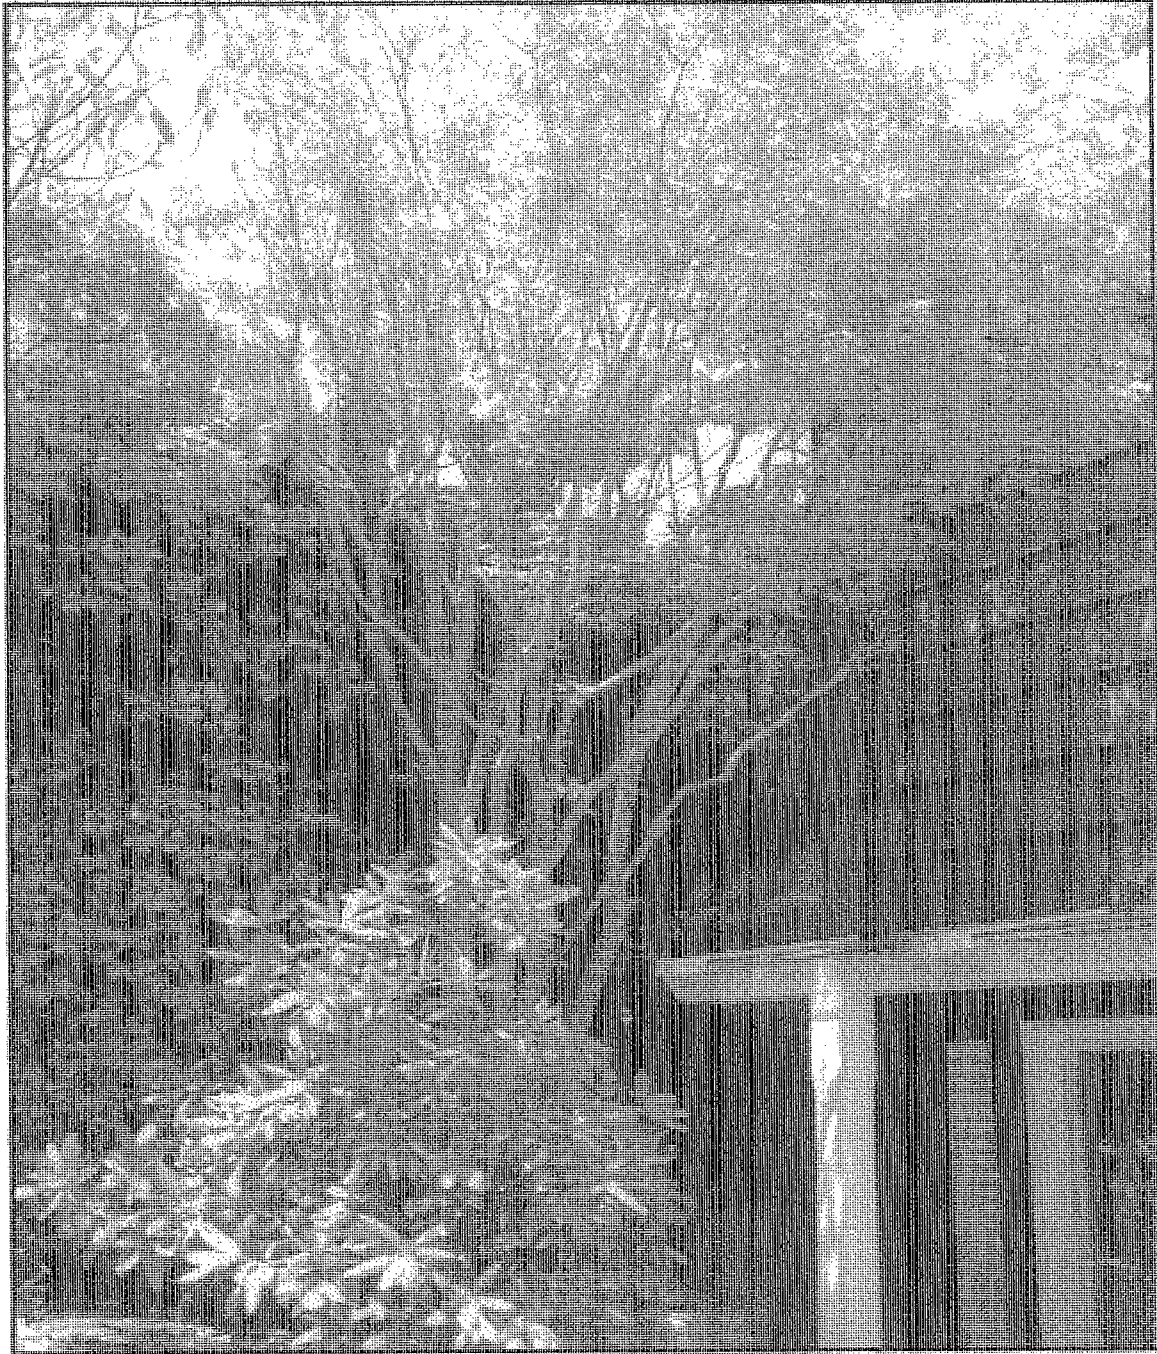
Acer palmatum, Japanese Maple tree in a contained planter with roots affecting planter bed wall.

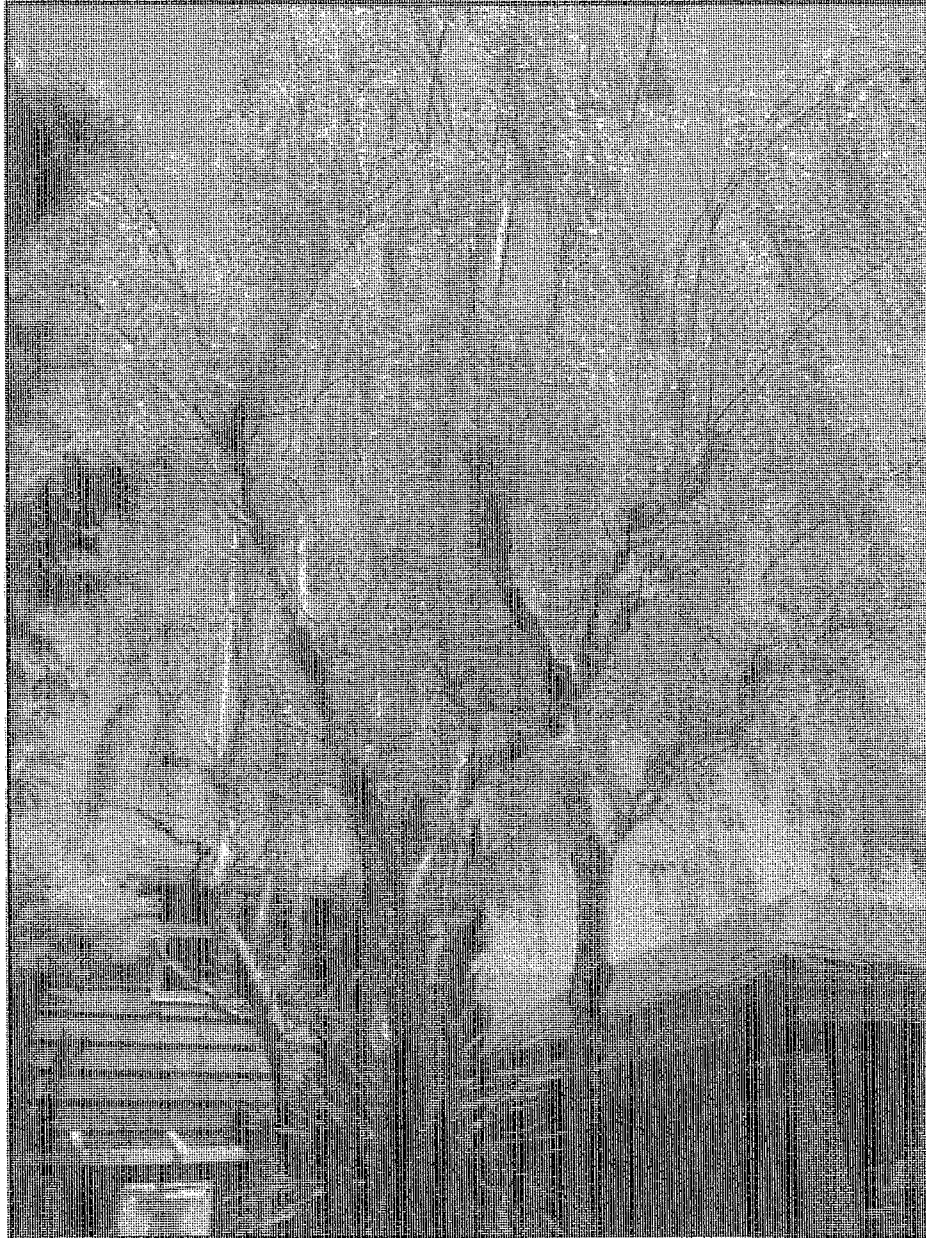
- **#5 *Betula pendula*, European White Birch.** The tree consists of three upright stems originating at the trunk base. The complete CBH is 1.9, 1.6 feet and 8 inches. This equals 50 inches. The tree is a non-native species and native to summer rainy climates. It does not perform well in California climates due to the lack of summer rainfall. The upper canopy exhibits branch tip dieback associated with root problems. The dieback can be attributed to the climate conditions. Condition is rated as fair to poor. See photograph page 6

- **#6 *Betula pendula*, European White Birch.** This tree is directly next to Birch number 5 in the courtyard. CBH is two, and 1.7 feet total CBH is 44 inches. Condition is rated as fair to poor. See Photograph page 6.

#5 and #6 two Betula trees in front courtyard of property in fair to poor condition. Recommendation is for replacement with a more suitable species for a Sausalito climate and a lower height when mature to accommodate views from neighboring properties.

Trees #5 and #6, the two Birch trees are recommended for removal and replacement with species more adaptable to a Sausalito climate. They are rated as fair to poor condition and maintaining them to fit the climate and conditions is difficult and would eventually require removal. *Betula* species are best suited in a climate with abundant rainfall throughout the year and best suited for riparian locations. Selection of a more suitable feature tree such as *Magnolia soulangiana* Saucer Magnolia, twelve species listed in Western Gardening, *Magnolia stellata* Star Magnolia, seven varieties, *Cercis occidentalis*, Western Red Bud, *Arbutus unedo*, Strawberry tree, or *Prunus yedoensis*, Flowering Cherry are species that provide features such as red color trunk, spring flowers, or fall color. All are deciduous with the exception of *Arbutus* species that are evergreen. These choices require less maintenance and are most adaptable to the climate and location. If removal is granted, the selections are an opportunity for a replacement tree that will not block neighboring views or require topping to reduce height.

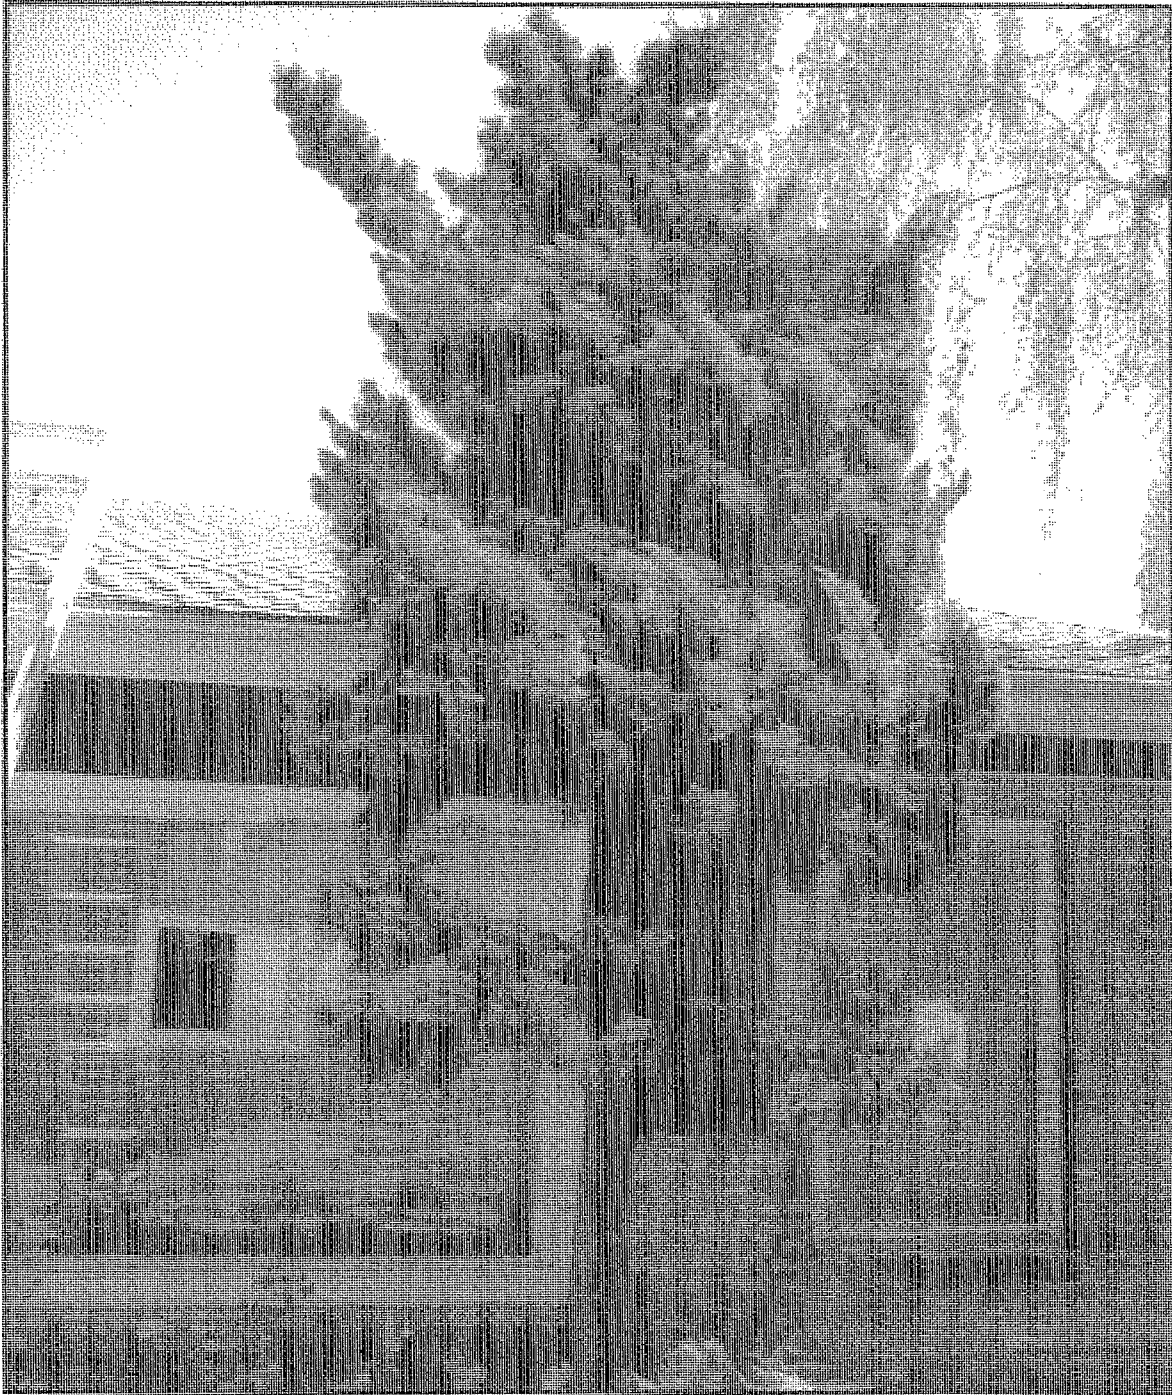
Architect plans indicate front wall extension that is within the area of existing Cypress tree # 7.

Tree # 7 *Chamaecyparis obtuse* is recommended for removal. The tree is within the area if the front wall expansion a direct conflict with the building construction plans. The replacement of courtyard patio trees is suggested as the alternative to replacing this tree.

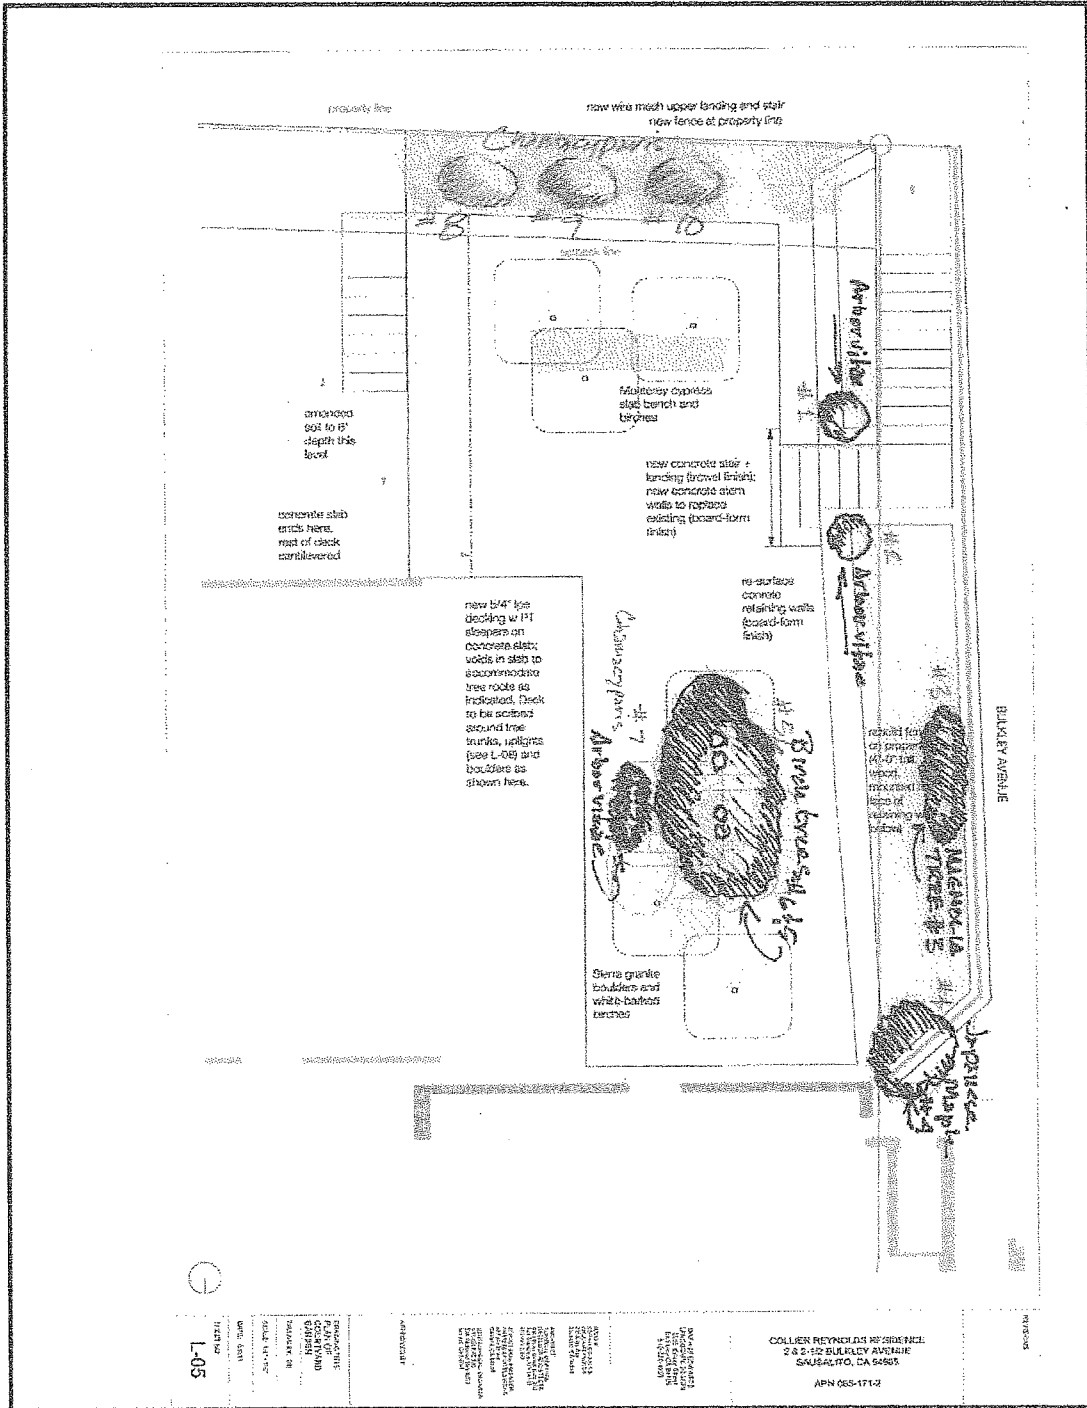
Site map with tree locations trees numbered 1, 2, 3, 4, 5, 6, 7, 8, 9, and 10 are to be removed and replaced with other trees, small shrubs, and perennials.

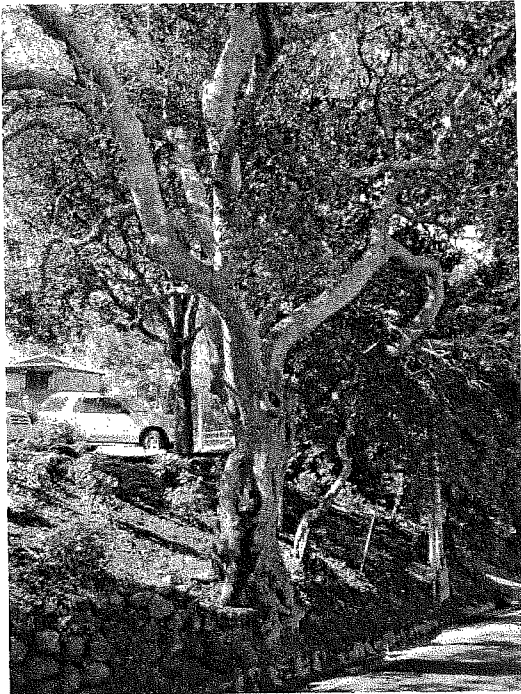
Picture 1. Live Oak located at 184 Harrison Ave.

On Friday, October 7, 2011, I inspected the Live Oak (*Quercus agrifolia*) located in front of 184 Harrison Ave, adjacent to the road (See Picture 1).

Due to the structural and health condition of the tree and considering its location on the landscape, this tree represents an imminent hazard and should be removed as soon as possible.

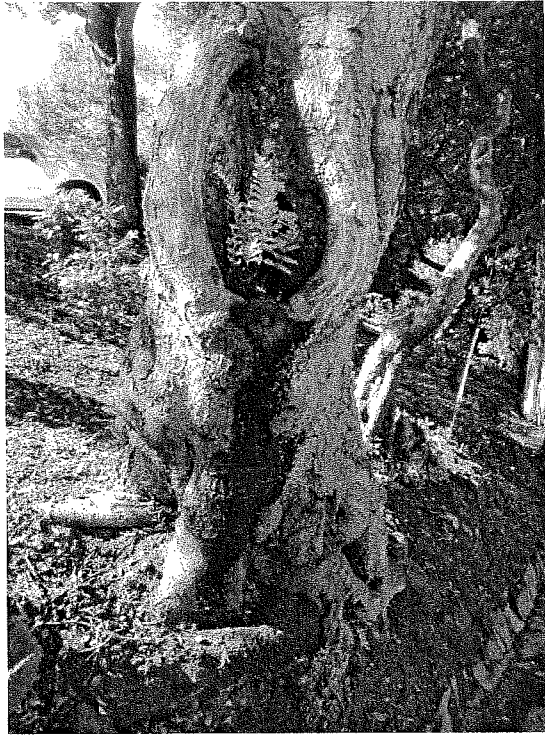
The tree has a full canopy of green leaves. The lower trunk has a large pocket of decay (See Picture 2) and, on its base the tree has cracks and is severely infected with the fungus *Hypoxylon thouarsianum* (See Picture 3). This fungus causes a white rot of the sapwood of living trees and dead wood. Sapwood decay caused by *H. thouarsianum* in trees may be quite extensive and may lead to trunk failure.

Picture 2. Large pocket of decay on the lower trunk of Live Oak.

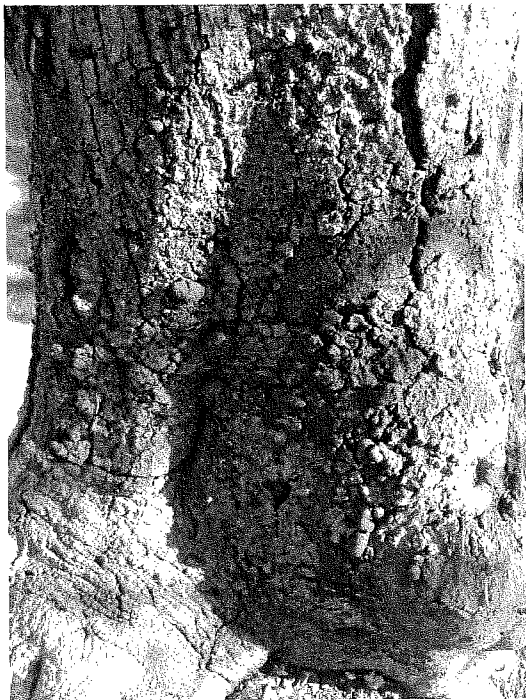
Picture 3. Cracks and fruiting bodies of the fungus *Hypoxylon touarsianum*.
