Ed Gurka, Consulting Arborist  
 Member, American Society of Consulting Arborists

I received a request to prepare an Arborist Report that will describe trees located within a proposed public works construction project on the public right of way in front of 750 Bridgeway, Sausalito, California. A report is necessary because the trees are located in the construction area and will affect the planning and outcome of the project. This report will provide information on the trees' condition, their compatibility for the location, and make a recommendation based on the information and knowledge of the species.

**RE:** Black Acacia (*Acacia melanoxylon*) located at the intersection between Sausalito Blvd and Spencer Ave, on the left side of the stairway on Cooper Lane

Re: Tree report proposing pine tree removals

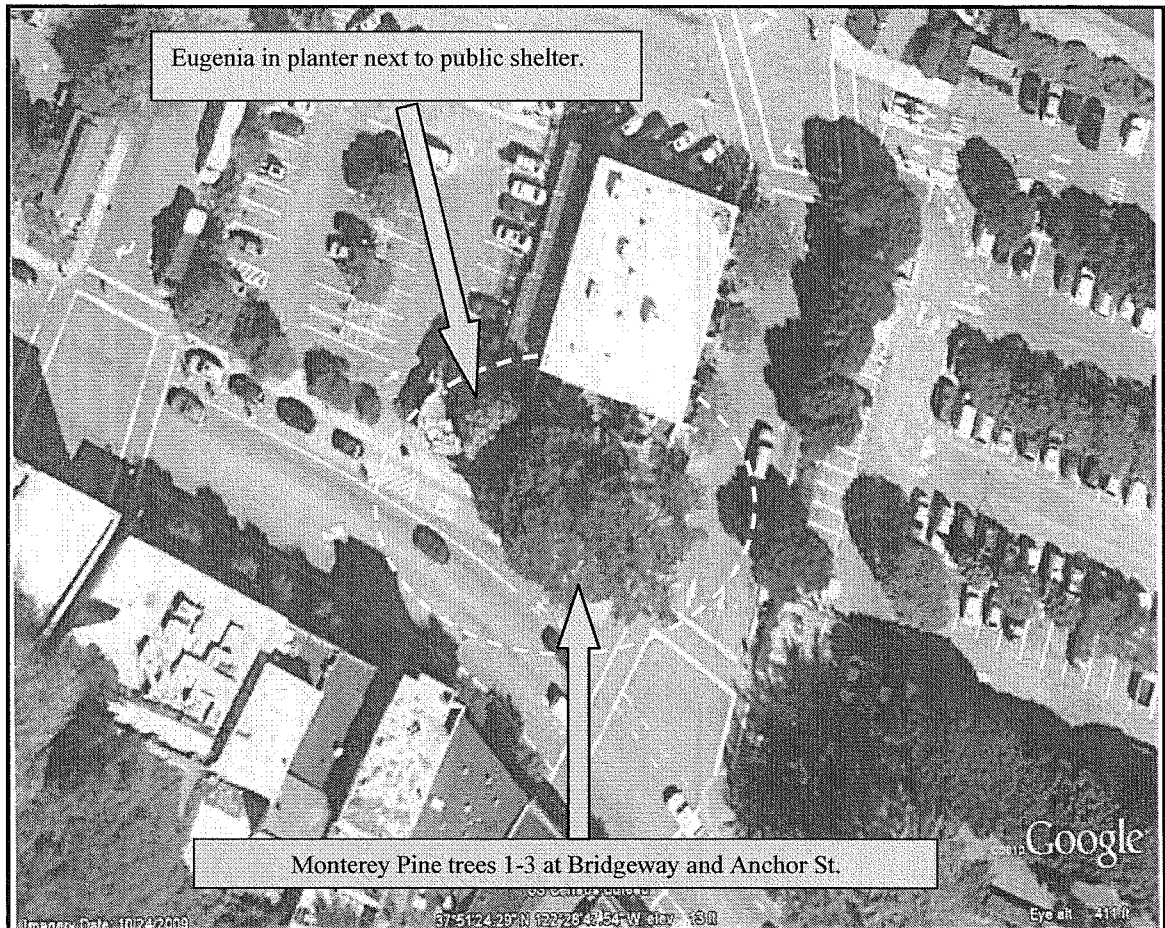
The trees are identified as three mature *Pinus radiata*, Monterey Pine and a *Syzygium paniculatum*, Eugenia paniculata, Australian Brush Cherry. The three Monterey Pine trees are located in a planter area bordered by a brick plaza and Bridgeway sidewalk. The Eugenia tree is located just to the left in a small planter that is next to and below the ramp leading from the bus shelter portion of the structure to the public restrooms. See aerial photograph page 1. The circle indicates the three pine trees in the planter and the Eugenia tree by the bus stop and restrooms.

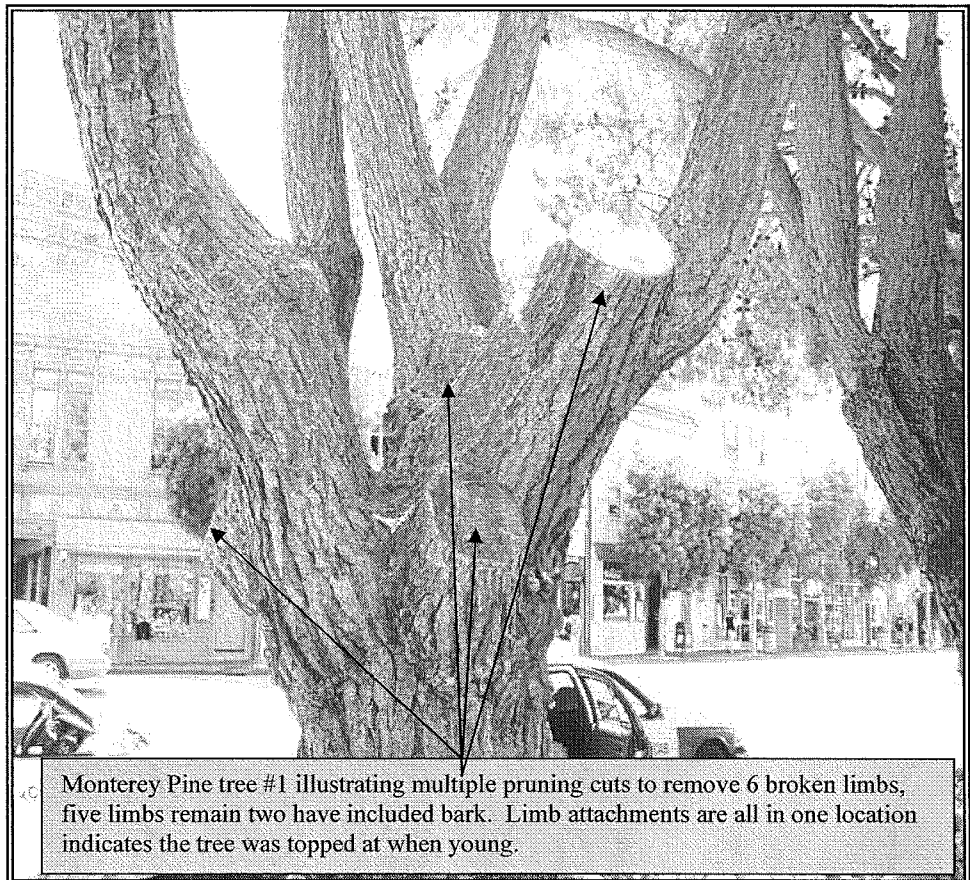
Circumference measurement at just below the lowest attachment point is 12.9 feet. Measuring at this location gives a more accurate measurement of the trunk size than if taken where limb attachments are because the attachments bulge there. The status of Monterey Pine trees is described as **undesirable** in the Sausalito Trees and Views Preservation Ordinance, 11.12.030, DEFINITIONS, Undesirable Tree. The tree has several larger diameter pruning cuts including one recent event when a large-diameter limb (16 inches in diameter) fell and damaged a street tree located on Anchor Street approximately 30 feet away from the trunk of the Monterey Pine. A count of remaining and removed limbs was made during the last site visit July 27, 2011. On this tree, there are five of eleven limbs remaining. A total of six large-diameter limbs were removed because of limb breakage. Two of the remaining limbs have very acute angles at their point of attachment to the trunk.

At the point of attachment, the two limbs have a condition referred to in arboricultural terms as bark inclusion, (bark that becomes embedded in a crotch (union) between branch and trunk or between codominant stems; causing a weak structure, ISA Glossary of Arboricultural Terms.)

This condition presents a very high-risk failure of one of the two limbs because of the extreme pressure of the two limbs against each other. The brick plaza where these trees are located is a very high density of pedestrian traffic. The bank entrance is located here, and the plaza is the location of a self-service bicycle rental location.

These multiple leaders all compete for space and eventually fail because of their structure. In a location with infrequent traffic, risk would be reduced because potential for injury would be limited. The location of these Pine trees on Bridgeway in the down town business district has constant activity, the frequency of activity, the bicycle rental station, bank, bus shelter, public restrooms, and tourist traffic increase the risk of personal injury exponentially when limb failures occur. There are a poor canopy structure and history of limb failure, especially on Monterey Pine tree #1. There is very little that can be done to correct the trees' structure at this stage of the trees' growth. All three pines have either Pine pitch canker or Western Pine Rust fungal diseases most likely introduced by Pine Beetles. These compound conditions will very likely cause more limb failure that may cause personal injury if the heavy weight limbs strike a pedestrian. Monterey Pine tree #1 should be removed immediately. The Bridgeway corridor is a windy location and wind influence on heavy end-weighted limbs with poor attachments increases limb failure. The two limbs with bark inclusion are high failure potentials. These multiple factors are the basis of the recommendation for removal.

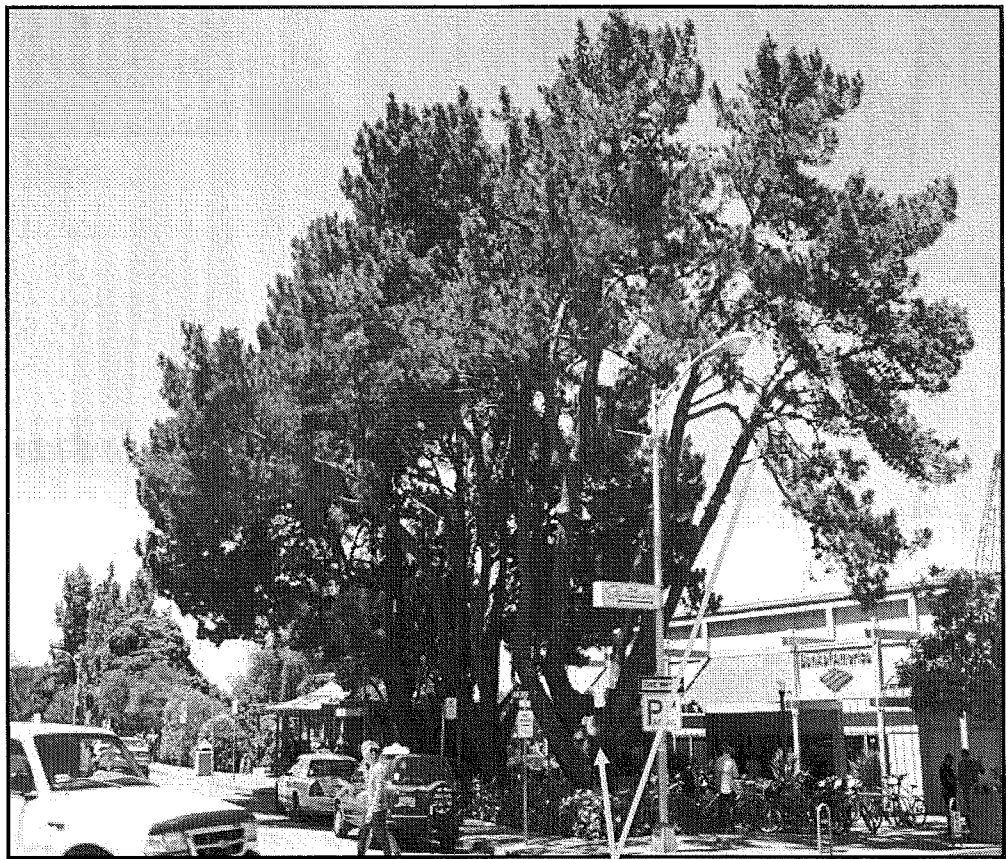
Monterey Pine #1 has large extended scaffold limb leaning over a brick Plaza. This tree has several large diameter pruning cuts due to limb failures caused by poor structure the result of topping when the tree was in its early growth stage.

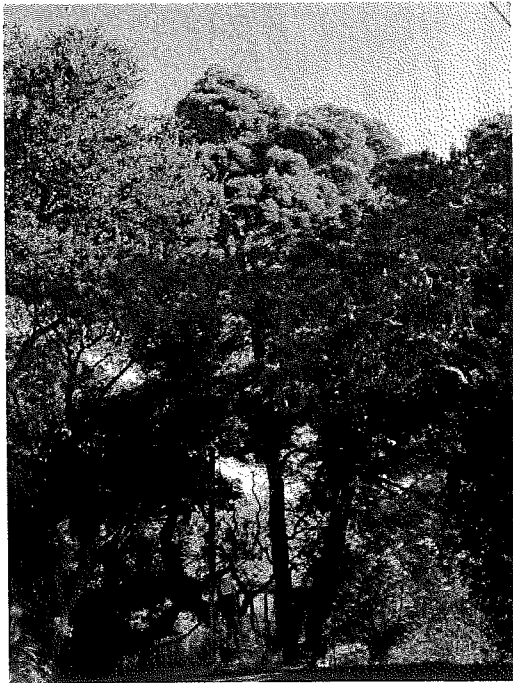
The current health condition of the tree is good, based on a visual inspection of the trunk, limbs and foliage. The canopy of the tree is full indicating good vigor (Picture 1).

Picture 1. Black Acacia on the left side of Cooper Ln with a full canopy of green leaves.

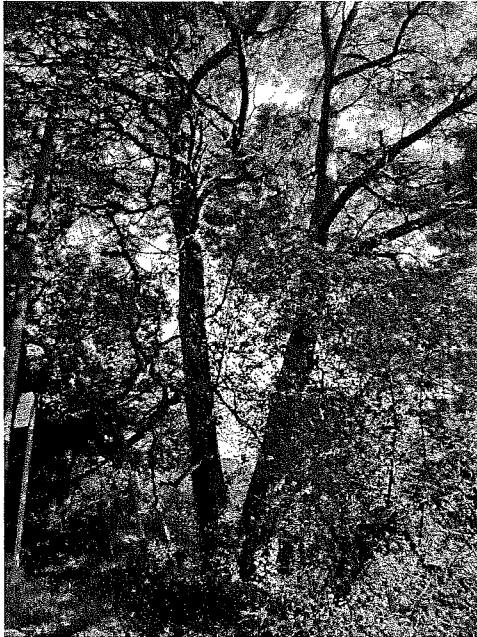
There are dead and broken branches that have accumulated in the crown of the tree that should be removed to reduce the risk of branch failure. The tree has two trunks (codominants) that seem to be solid and structurally sound. No structural problems were evident during my inspection. (Picture 2).

Picture 2. The two-trunk Acacia appears to be structurally sound regardless of its codominant condition.

- Clean to remove all dead, diseased and broken branches that are ½" in diameter and larger throughout crown to improve health and appearance and reduce risk of branch failure.
- Thin crown to remove approximately 15%-20% of live branches to reduce weight on branch ends and to allow more light penetration and air circulation throughout the crown.
- Install EHS cables to provide branch/stem support to limit branch/stem movement to reduce the risk of branch failure. Cables require periodic inspection for evidence of fatigue and to verify functionality.

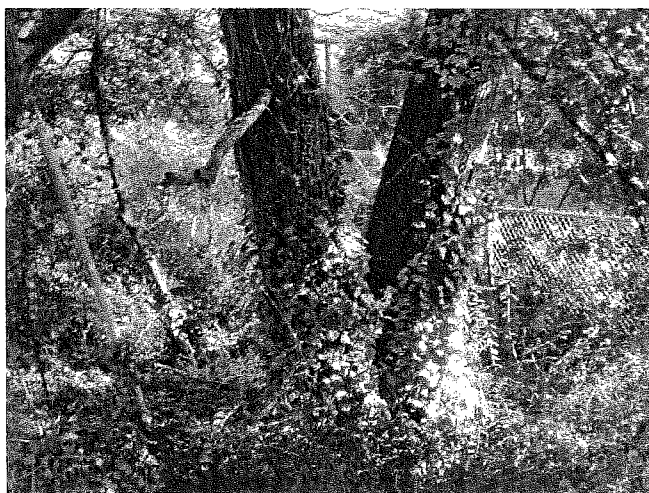
The root collar area will need to be exposed to allow for inspection to determine how safely attached these stems are at the base (Picture 3).

Picture 3. Soil and ivy from the base of the tree need to be cleared to expose the root collar and to allow for a better inspection.

The current condition of the tree does not allow for a proper safety inspection. Therefore, before a decision is made as to whether or not the tree be removed, I recommend that the root collar be exposed and that the tree be pruned according to the following specifications:

- Remove ivy and soil from the bottom of the tree.
- Thoroughly inspect crotches to determine the presence of included bark or other defects.

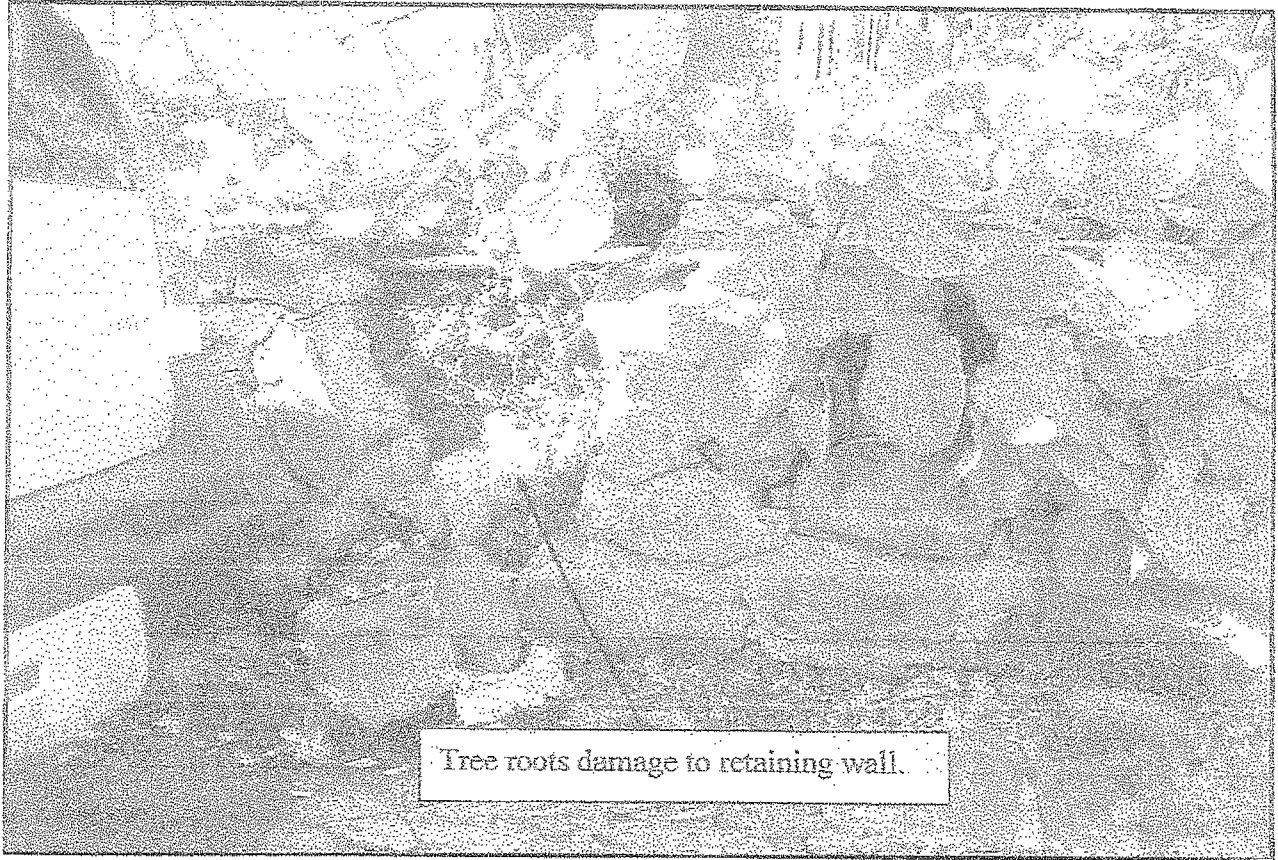
The tree is a *Cinnamomum camphor*. DBH is 7.0, 7.2, and 9.5 inches. This is the measurement of the three main upright branches. Tree height is 25 feet. The tree is located at the beginning of a planter strip at the entrance to 90-103 Bulkley Avenue. There is a rock wall on one side and the stairway that is the entrance to the condominium complex. The Camphor tree is growing in a small confined space that is 4 feet wide. Soil is compacted and very shallow. The tree canopy cover is estimated at 50 percent of normal. This is attributed to shallow compacted soil and height reduction for electric utility lines that supply the complex. A section of the retaining wall had separated and was lying in the street at the time of the site visit. A cluster of roots from the tree was visible where the wall had fallen into the road. The root growth has increased and separated this section of the wall where it now lay in the street. On the opposite side of the tree, tiles from the stairway were separated from the stairway. This was directly in line with the tree trunk and root system.

Tree roots damage to retaining wall.

Camphor trees grow to considerable size and have competitive root systems. The space for this Camphor's development is severely limited. The conflict with the rock retaining wall and stairway entrance to the complex will come into greater conflict if the tree remains. There is no alternative to preserving the tree. It must be removed before root damage to the wall and stairway requires complete replacement. When the Camphor tree is removed, the tree roots must be removed to prevent re growth and eliminate further conflicts.

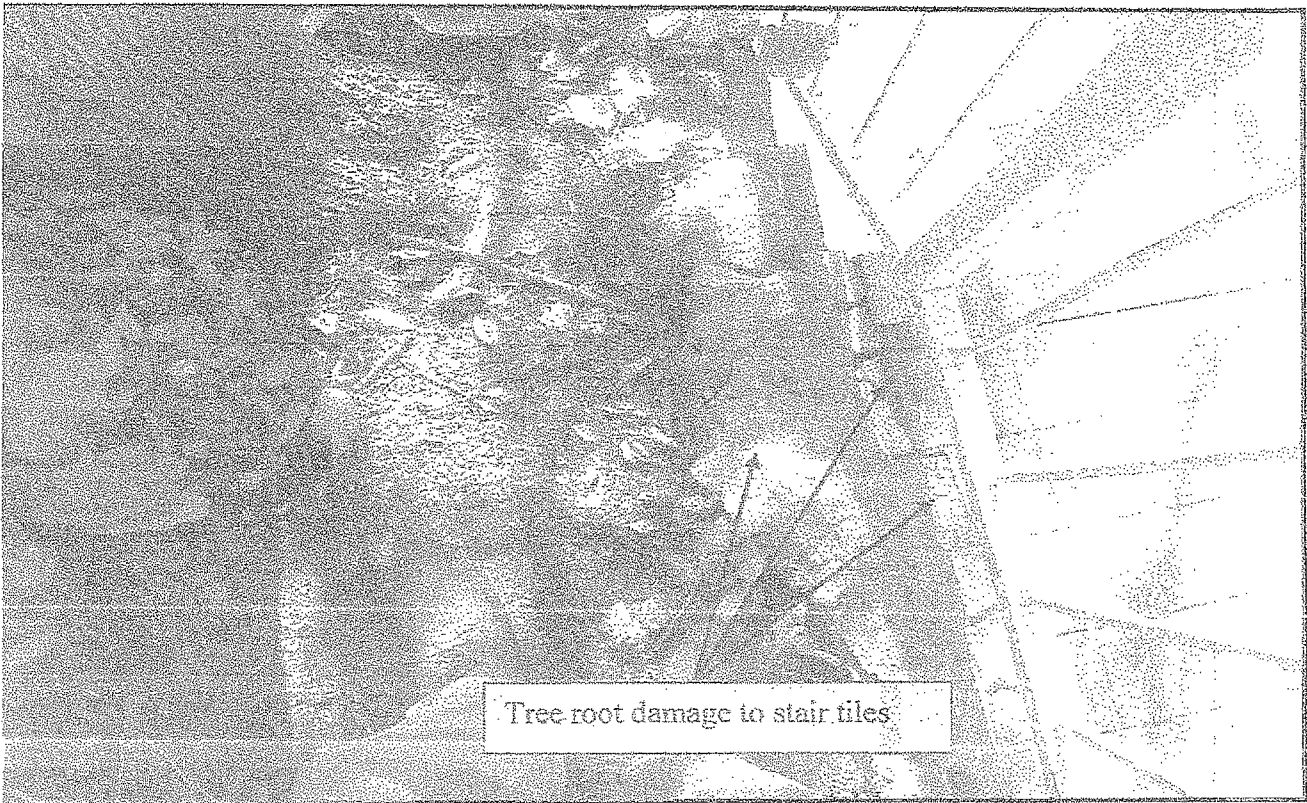
Tree root damage to stair tiles

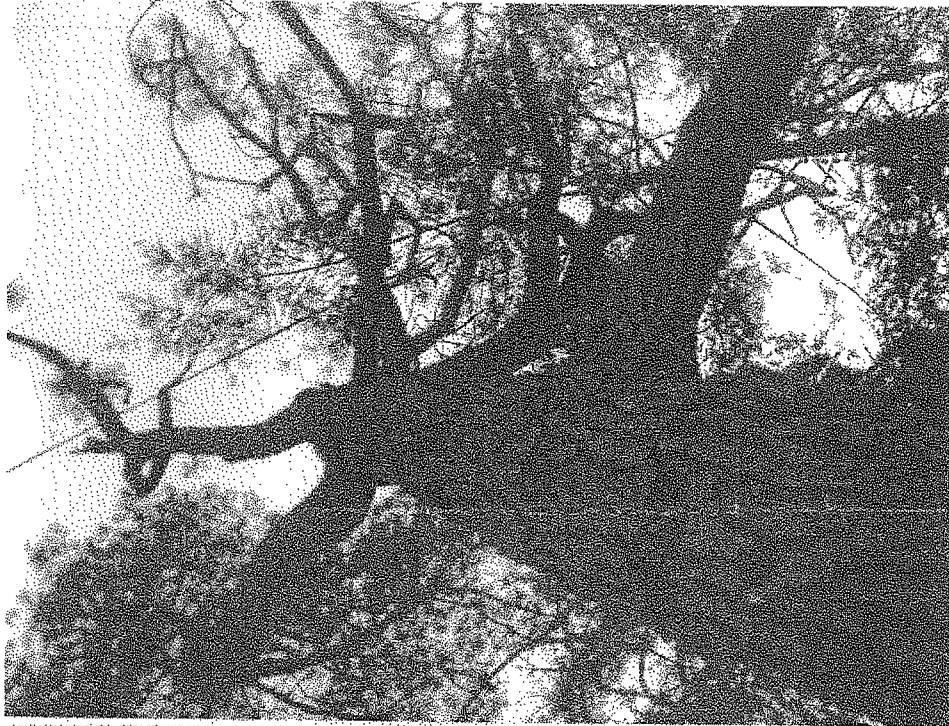
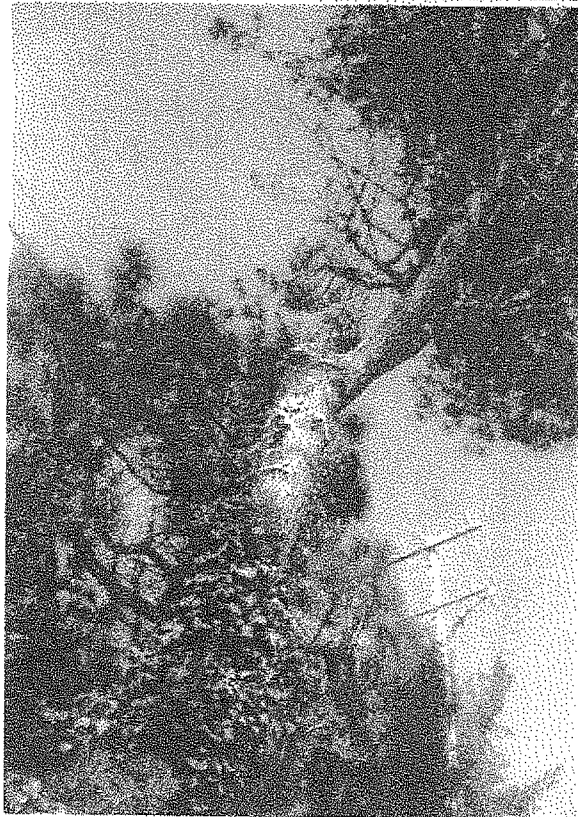
crotch pruning leaving long heavy limbs with poor branch attachment.

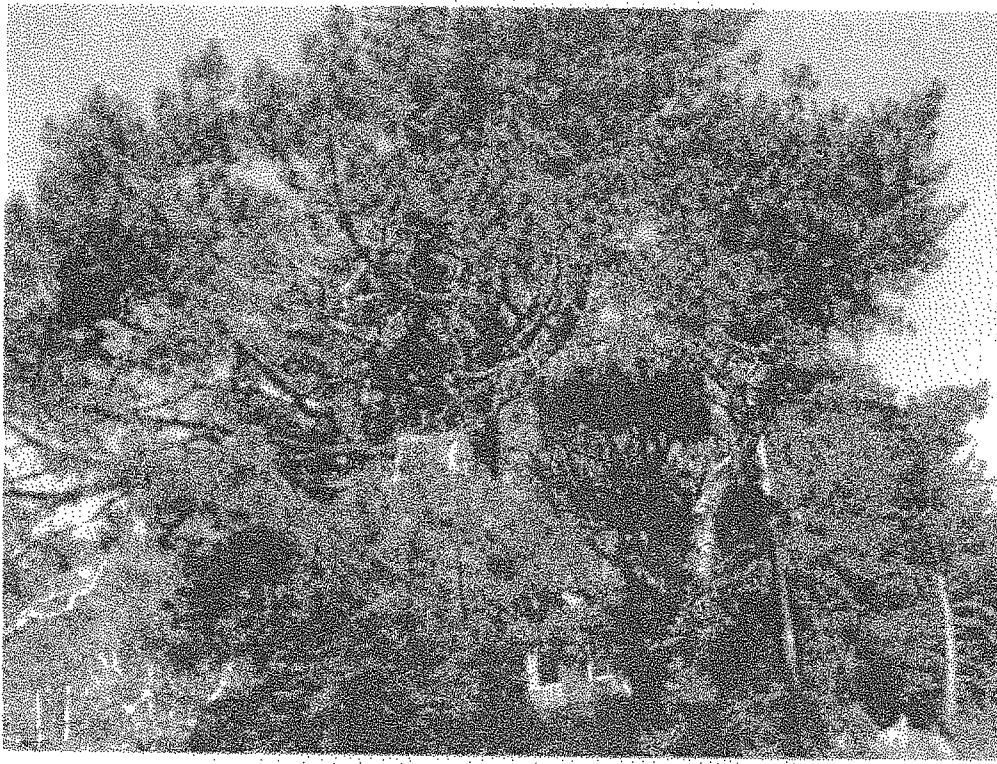
Photo 1. A General view of the pine trees as viewed from downhill on Olima St.

Pine pitch canker is found evident by dead or dying back twig tops. There is evidence of bark beetle activity inside of the trees indicated by the presence of beetle frass or a mix of beetle excrement and sawdust. These beetles will eventually girdle and kill the tree. It's only a matter of time. The present structure of the trees are producing long heavy ended lever arms growing out towards parked cars on the street and children playing in the yard around the trees. These trees are too old and far gone for restructuring, they also pose a risk to the power lines, it would be better to remove them and plant something more suitable for overhead high voltage lines, something much shorter in stature at maturity and unlikely to interfere with the utilities.
