DEPARTMENT OF PUBLIC WORKS
 TREE MAINTENANCE ACTIVITIES PERFORMED AND PENDING
 DECEMBER 2011

ASSIGNMENT:

A request by the City of Sausalito Public Works Department to inspect a Pine tree at Spencer and Miller Avenue in Sausalito. The inspection results will be presented in an arborist report that will provide a recommendation based on the findings.

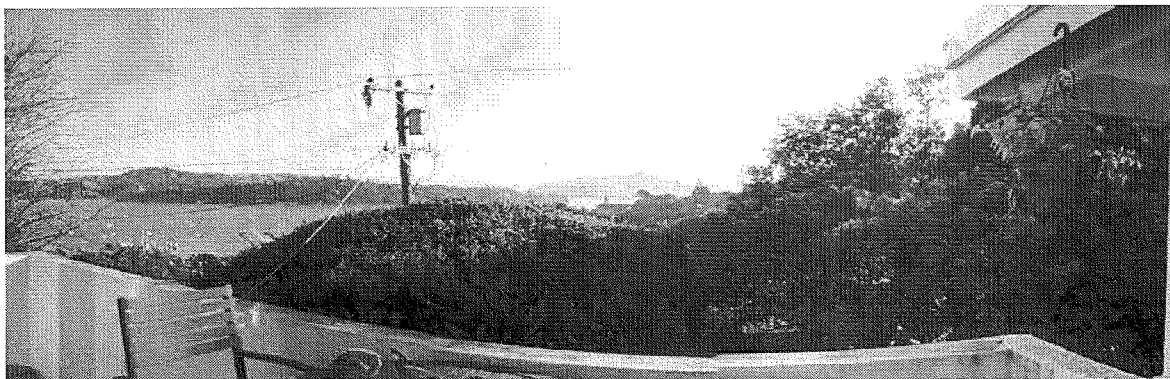
transmission wires. Over the past 5 years, living room views of Richardson Bay and a Sausalito ridgeline to the east have been significantly reduced by the subject trees (Figure 2).

Figure 2. November 2011 view panorama from the 2nd floor of the Micheltorena home. Views of Richardson Bay, the Belvedere shoreline, and a Sausalito ridgeline to the east have been significantly diminished by the subject trees over the past 5 years.

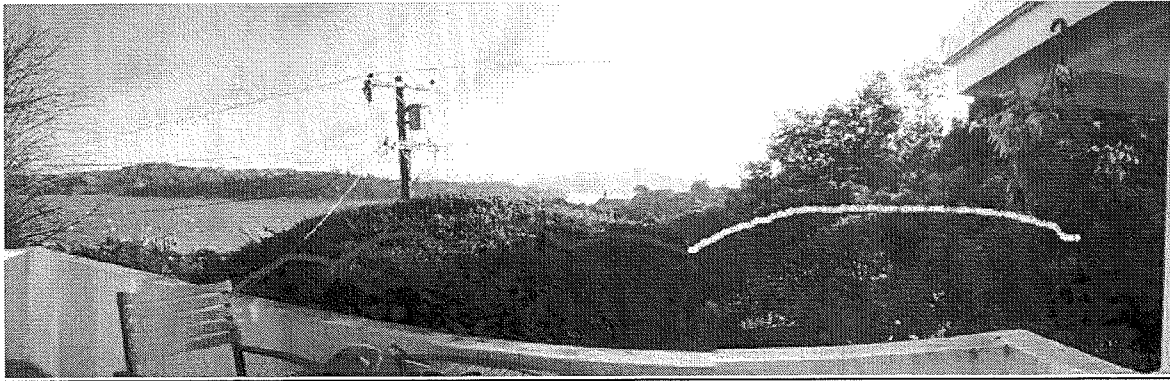
Figure 3. Final pruning height recommendations for the coast live oak (red) and the sweet pittosporums (yellow).

All five subject trees are healthy and will tolerate moderate to heavy view-restoration pruning without compromising their systemic health. The sweet pittosporums have demonstrated their capacity to vigorously respond after pruning by producing lateral branches. The Hodapps desire a dense tree canopy over their front patio; this outcome will be realized several years after the proposed pruning. Pruning will also bring all the subject trees into better balance and reduce the likelihood of trunk- or root failure. I recommend specific measures described below and illustrated in Figure 3.

1. Pittosporums. Initially reduce the height of the pittosporums using drop-crotch pruning in an arc that is about 3 feet below the secondary (lower) electrical transmission wires (Figure 3). Every 2 years—before the growing season begins—perform maintenance pruning to a height of 2 feet below the secondary wires to maintain view of the ridgeline to the east.
2. Coast Live Oak. Reduce the overall height of the oak by 2 feet and window crown by 2-4 feet using drop-crotch pruning. This may need to be done in stages over a two-year period to achieve the recommended final crown height. Balance the tree canopy by pruning more heavily over Glen Drive. Every 2 years, before the growing season begins, perform maintenance pruning to maintain view of the Sausalito waterfront. Both neighbors expressed support (independently) for pruning the oak as proposed.
