DEPARTMENT OF PUBLIC WORKS
 TREE MAINTENANCE ACTIVITIES PERFORMED AND PENDING
 DECEMBER 2011

A request by the City of Sausalito Public Works Department to inspect a Pine tree at Spencer and Miller Avenue in Sausalito. The inspection results will be presented in an arborist report that will provide a recommendation based on the findings.

**View Obstruction Arborist Report
81 Cazneau Avenue, Sausalito, CA****ASSIGNMENT**

**Independent Arborist Review
View Restoration Request
255 Glen Drive, Sausalito**

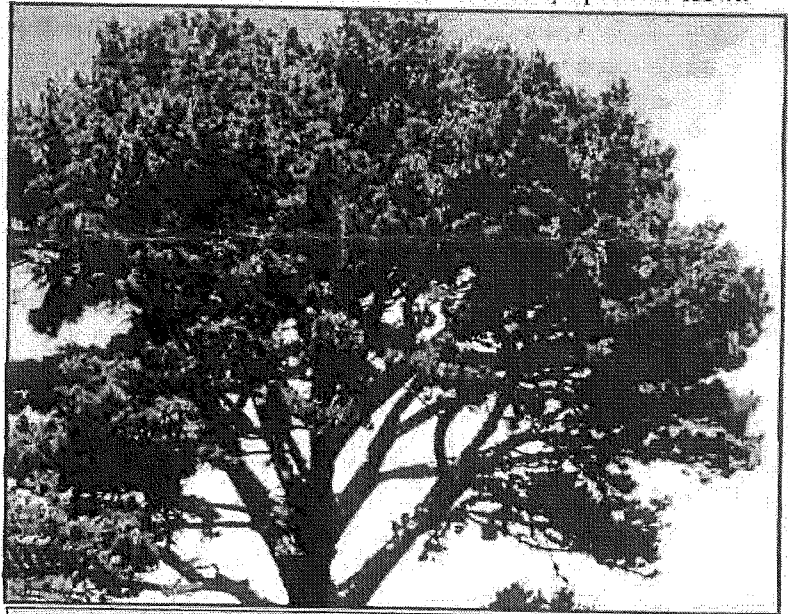
The Monterey Pine canopy inspection noted that there is tip dieback of terminal growth points throughout the upper canopy. In other limb tips, where smaller branches terminate, there appeared brown foliage, described as brown needle coloration. It is very possible that the two conditions are related. First, the limb tips produce brown needles that result in bare limb tip branches indicating a condition described as "dieback." This condition appears randomly throughout the canopy.

This dieback of branch tips and needle browning is a sign of Pine Pitch Canker, a fungal disease that most commonly occurs through wounding from pruning cuts or insect attacks.

Brown needles on Pine branch tips. 11.19.2010

This Monterey Pine tree is in a stressed condition that has compromised its defense mechanisms. This is exhibited by the symptoms identified and discussed in this report. The tree will continue to decline and will be determined by factors such as continued beetle attacks, advancement of the fungal disease and climate conditions. There are multiple high value risk targets present in the failure path from falling branches and debris from the tree. A heavy pinecone production will also add to the debris produced by the tree. These events will increase with frequency as the tree declines and risk associated within the fall path must be evaluated by the City if the tree is on public right of way. The recommendation, based on these discovered findings from the site inspection, is that the tree should be removed to eliminate the risk.

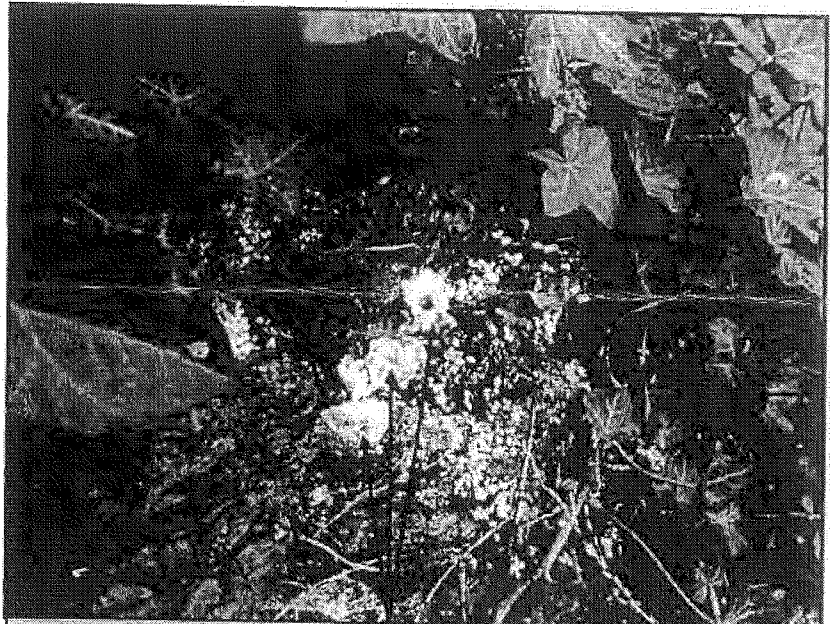
Pruning cuts performed during the growing season produce a sap pitch attracting pine beetles that are also active during the late spring, summer, and early fall months of the year. Since Pine Pitch Canker was noted during the time of visual inspection, the lower trunk area was examined for the presence of *Dendroctonus valens*, Red Turpentine Beetle. This beetle attacks the lower base of Pine trunks and exposed roots just below the soil surface. The Red Turpentine Beetle was detected in multiple locations on every side of the lower tree trunk. The beetle produces pitch tubes visible on the outer bark illustrated in the photograph from just one location on the lower trunk of this pine tree.

Beetle Pitch tubes on lower M. Pine trunk. 11.13.2010

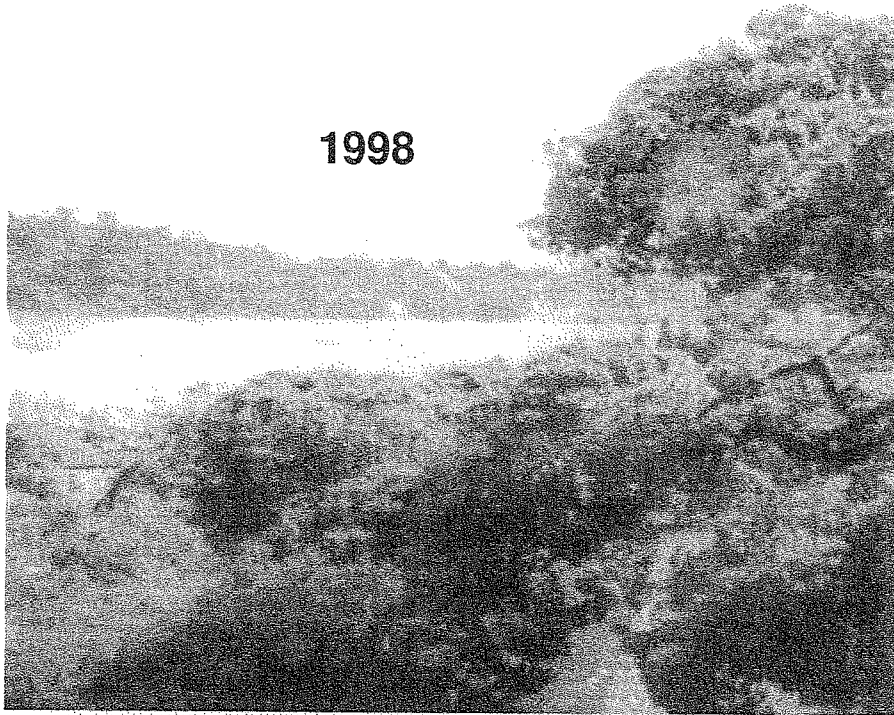
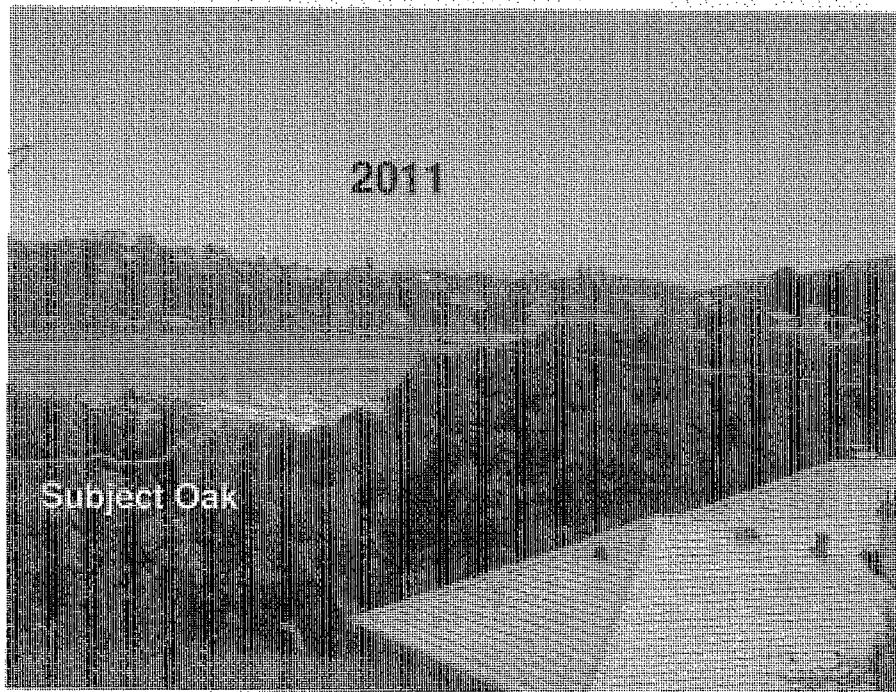
On the next page are two photographs showing the views from the Wells living room that were present in 1998 and in 2011. The approximate line of proposed pruning is shown on the 2011 photo in red.

Description and reasons for alteration. Ms. Wells proposes to prune one coast live oak downslope of her property to restore a documented, pre-existing view of Richardson Bay and Sausalito Yacht Harbor from her living room. Approximately 2-4 feet of the upper canopy would be pruned per American National Standards Institute (ANSI A300) pruning standards. See pruning profile in photo at right.

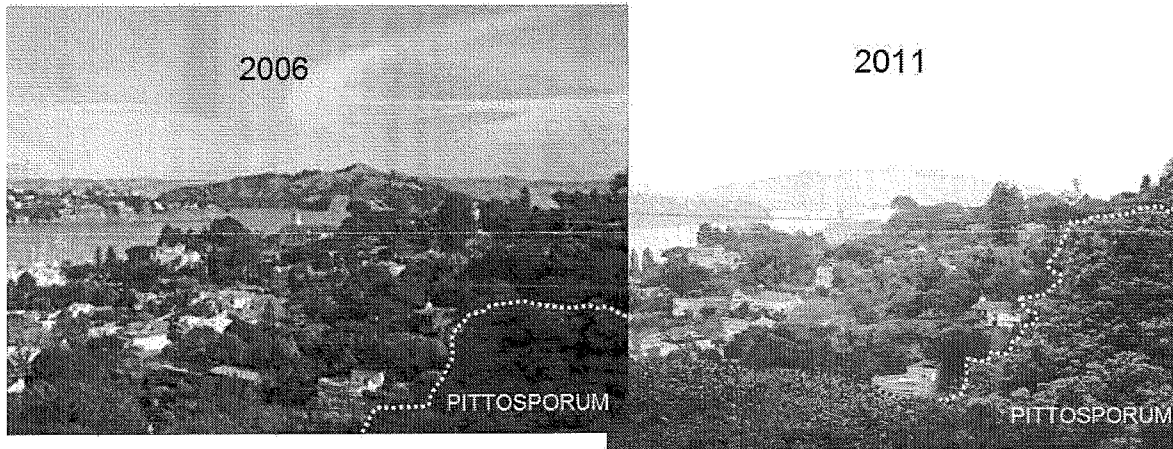
The Micheltorenas purchased their home on March 3, 2006. Their realtor, Jane Richmond (Pacific Union International & Christie's Great Estates, Mill Valley, 380-6123), captured the eastward view from the 3rd floor of the Micheltorena home in a photograph at the time of the sale. On November 21, 2011 Gina Micheltorena took a photograph from approximately the same location (3rd floor). This photo pair clearly shows that the pittosporums and the oak have both grown significantly in the last five years. In 2006, the upper canopy of the pittosporum was below the lower, secondary electrical

transmission wires. Over the past 5 years, living room views of Richardson Bay and a Sausalito ridgeline to the east have been significantly reduced by the subject trees (Figure 2).

Figure 1. View photographs taken in 2006 and in 2011 from the 3rd floor of the Micheltorena home. Shown are the upper canopy extents of the sweet pittosporums and the coast live oak. A blue-dotted reference line was added along the lower roofline of St. Mary Star of the Sea Church on Harrison Avenue.

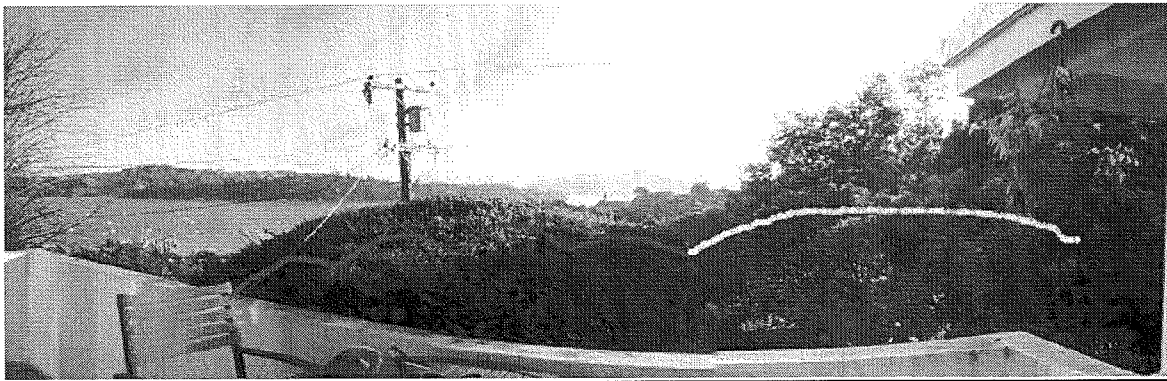
Figure 3. Final pruning height recommendations for the coast live oak (red) and the sweet pittosporums (yellow).

1. Pittosporums. Initially reduce the height of the pittosporums using drop-crotch pruning in an arc that is about 3 feet below the secondary (lower) electrical transmission wires (Figure 3). Every 2 years—before the growing season begins—perform maintenance pruning to a height of 2 feet below the secondary wires to maintain view of the ridgeline to the east.
2. Coast Live Oak. Reduce the overall height of the oak by 2 feet and window crown by 2-4 feet using drop-crotch pruning. This may need to be done in stages over a two-year period to achieve the recommended final crown height. Balance the tree canopy by pruning more heavily over Glen Drive. Every 2 years, before the growing season begins, perform maintenance pruning to maintain view of the Sausalito waterfront. Both neighbors expressed support (independently) for pruning the oak as proposed.

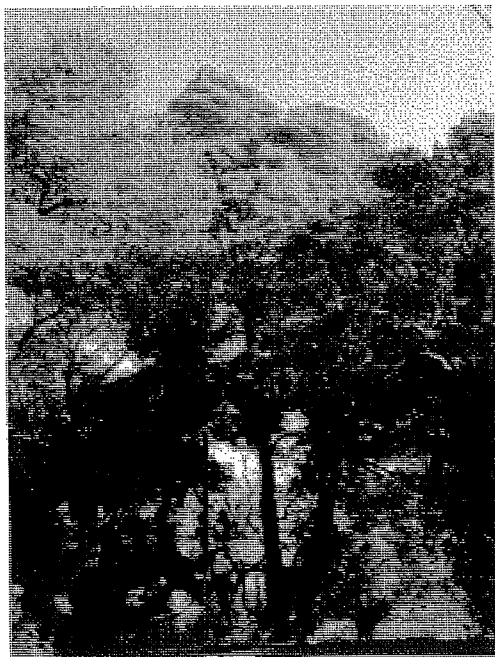
The current health condition of the tree is good, based on a visual inspection of the trunk, limbs and foliage. The canopy of the tree is full indicating good vigor (Picture 1).

Picture 1. Black Acacia on the left side of Cooper Ln with a full canopy of green leaves.

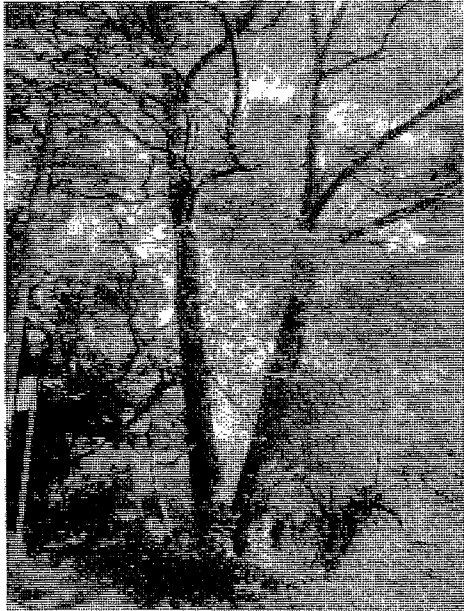
There are dead and broken branches that have accumulated in the crown of the tree that should be removed to reduce the risk of branch failure. The tree has two trunks (codominants) that seem to be solid and structurally sound. No structural problems were evident during my inspection. (Picture 2).

Picture 2. The two-trunk Acacia appears to be structurally sound regardless of its codominant condition.

- Clean to remove all dead, diseased and broken branches that are ½" in diameter and larger throughout crown to improve health and appearance and reduce risk of branch failure.
- Thin crown to remove approximately 15%-20% of live branches to reduce weight on branch ends and to allow more light penetration and air circulation throughout the crown.
- Install EHS cables to provide branch/stem support to limit branch/stem movement to reduce the risk of branch failure. Cables require periodic inspection for evidence of fatigue and to verify functionality.

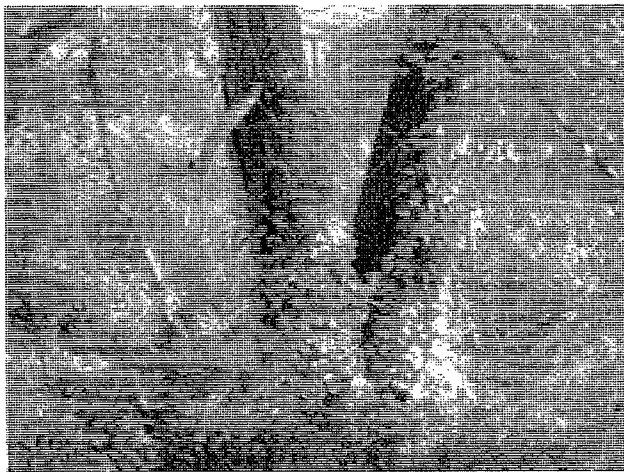
The root collar area will need to be exposed to allow for inspection to determine how safely attached these stems are at the base (Picture 3).

Picture 3. Soil and ivy from the base of the tree need to be cleared to expose the root collar and to allow for a better inspection.

The current condition of the tree does not allow for a proper safety inspection. Therefore, before a decision is made as to whether or not the tree be removed, I recommend that the root collar be exposed and that the tree be pruned according to the following specifications:

- Remove ivy and soil from the bottom of the tree.
- Thoroughly inspect crotches to determine the presence of included bark or other defects.

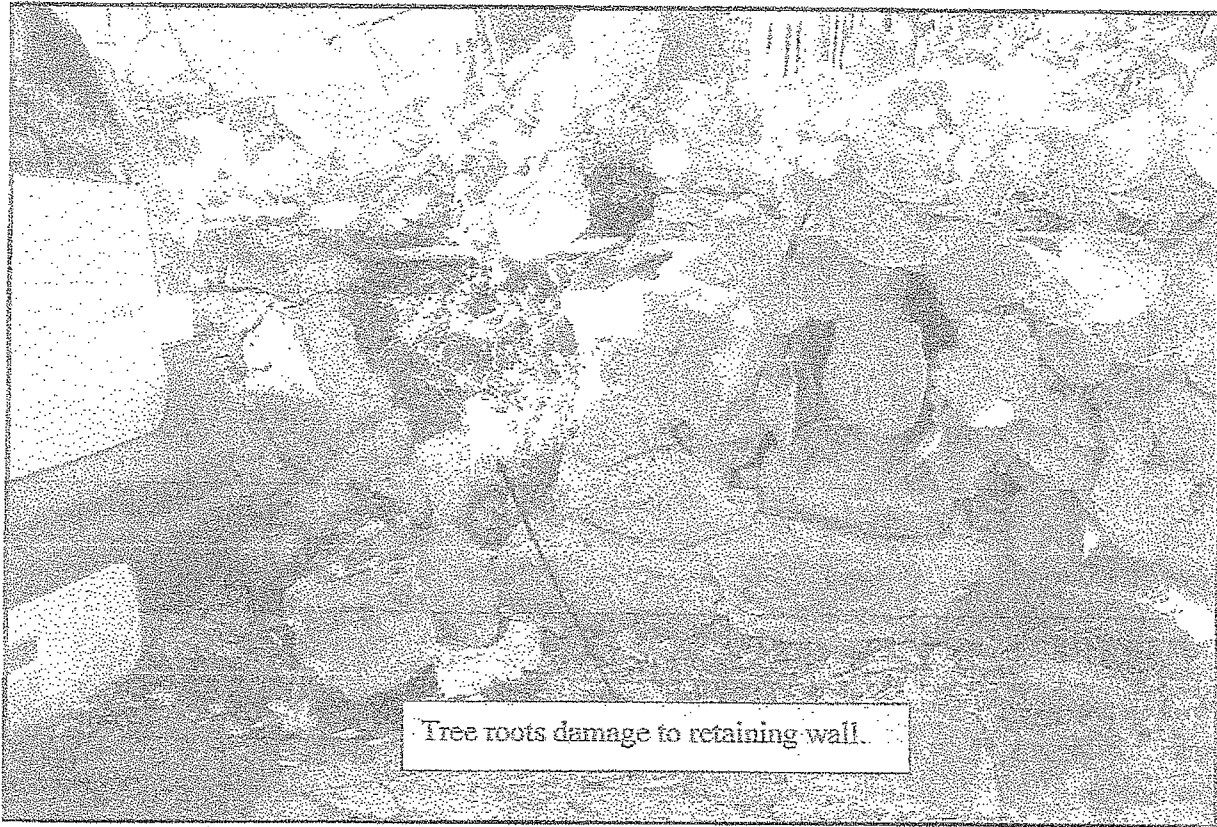
The tree is a Cinnamomum camphor. DBH is 7.0, 7.2, and 9.5 inches. This is the measurement of the three main upright branches. Tree height is 25 feet. The tree is located at the beginning of a planter strip at the entrance to 90-103 Bulkley Avenue. There is a rock wall on one side and the stairway that is the entrance to the condominium complex. The Camphor tree is growing in a small confined space that is 4 feet wide. Soil is compacted and very shallow. The tree canopy cover is estimated at 50 percent of normal. This is attributed to shallow compacted soil and height reduction for electric utility lines that supply the complex. A section of the retaining wall had separated and was lying in the street at the time of the site visit. A cluster of roots from the tree was visible where the wall had fallen into the road. The root growth has increased and separated this section of the wall where it now lay in the street. On the opposite side of the tree, tiles from the stairway were separated from the stairway. This was directly in line with the tree trunk and root system.

Tree roots damage to retaining wall.

Camphor trees grow to considerable size and have competitive root systems. The space for this Camphor's development is severely limited. The conflict with the rock retaining wall and stairway entrance to the complex will come into greater conflict if the tree remains. There is no alternative to preserving the tree. It must be removed before root damage to the wall and stairway requires complete replacement. When the Camphor tree is removed, the tree roots must be removed to prevent re growth and eliminate further conflicts.

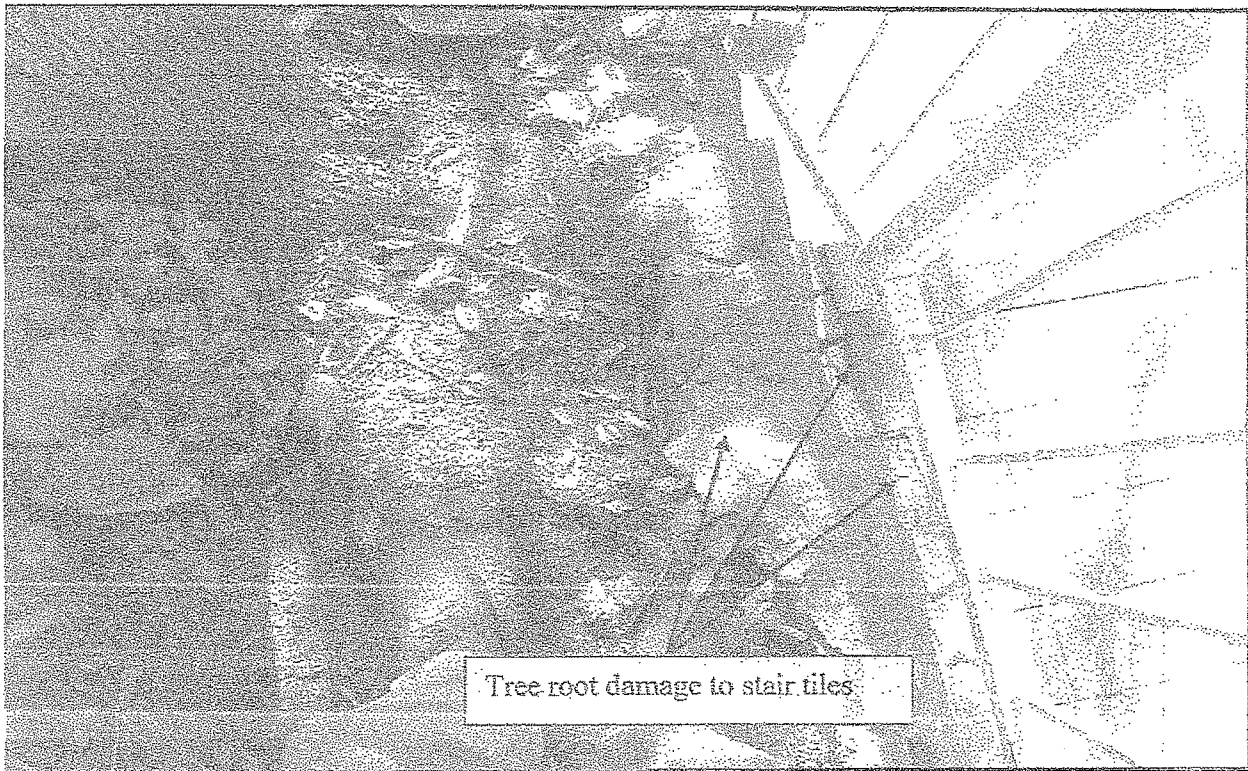
Tree root damage to stair tiles.
