DEPARTMENT OF PUBLIC WORKS  
 TREE MAINTENANCE ACTIVITIES PERFORMED AND PENDING  
 JANUARY 2012

**RE:** Removal of Dedicated Monterey Pine  
Public Right of Way fronting 506 Olive Avenue  
**DATE:** 26JAN12  
**ACTION:** For Information  
**cc:** Sausalito Women's Club

**RE:** Monterey Pine (*Pinus radiata*) located in front of 506 Olive St in Sausalito.

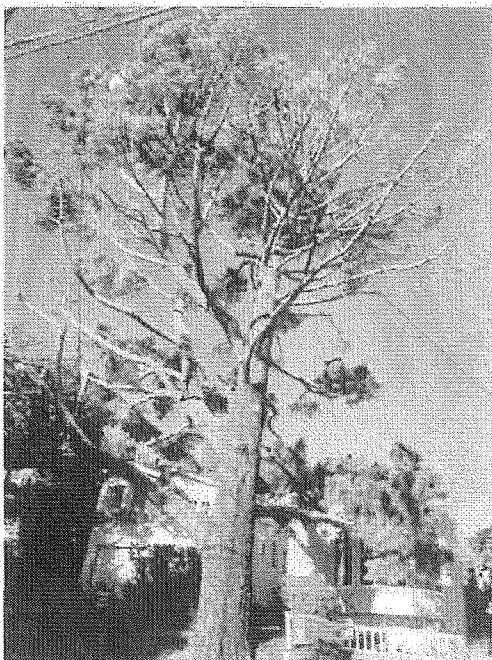
The Monterey Pine appears to be in poor health condition with a very thin crown and several dead branches larger than 1 inch in diameter (Figure 1).

**Figure 1.** Dedicated Monterey Pine (*Pinus radiata*) located in front of 506 Olive St in Sausalito.

This Monterey Pine hangs over the road, electrical wires, driveways and buildings (Figure 3). In order to eliminate the risk of the trunk, roots and/or branch failure, and considering the poor health condition, I recommend that the tree be removed.

1. Clean to remove all dead, diseased and broken branches that are 1/2" in diameter and larger throughout crown to improve health and appearance and reduce risk of branch failure.
2. Treat the lower stem twice per year, in March and in August, to help suppress Turpentine beetle attacks.
3. Deep water the tree three times per week for 15-20 minutes each time.
4. Perform prescription fertilization based on a soil analysis to help correct nutrient deficiencies and improve plant health.
5. Monitor tree once per month to evaluate response to treatments and pruning.

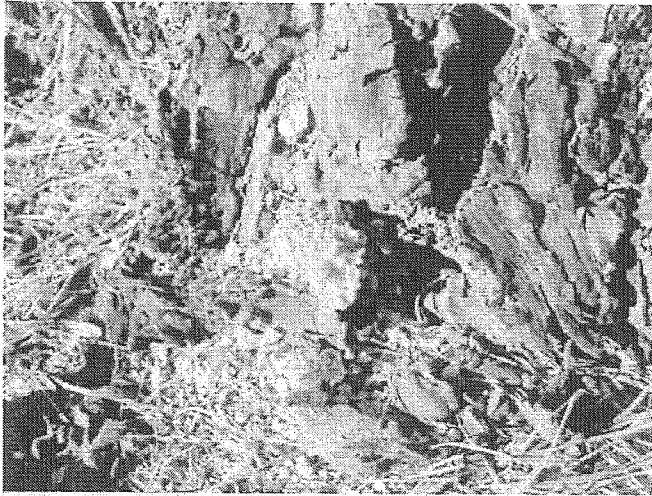
There is evidence of Red Turpentine beetle attacks at the base of the tree. These bark beetles frequently attack trees weakened by drought, disease, injuries, or other factors that stress the tree. Turpentine beetles can contribute to the decline and eventual death of the tree (Figure 2).

**Figure 2.** Red Turpentine beetle pitch tube at the base of the Monterey Pine located at 506 Olive St

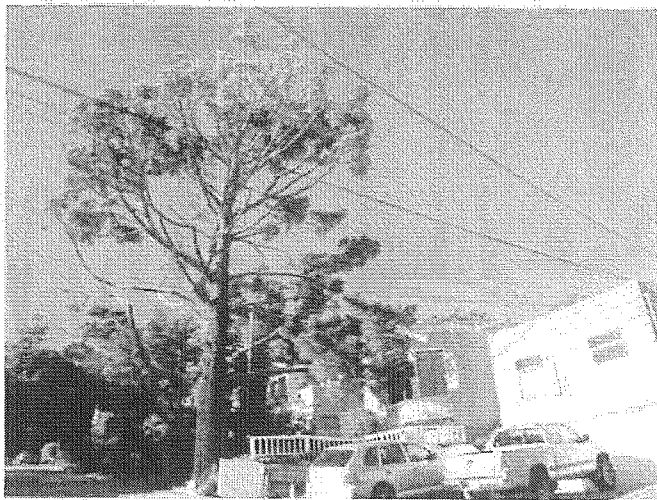
It seems as if construction of adjacent driveways, several years ago, might have impacted a portion of the root system of the tree through root damage and/or soil compaction. The side of the tree hanging over the driveways at 506 and 510 Olive St is in advance stage of decline and is where most of the deadwood has accumulated (Figure 3).

**Figure 3.** East side of the tree, hanging over the driveways at 506 and 510 Olive St is in advance stage of decline.
