DEPARTMENT OF PUBLIC WORKS  
 TREE MAINTENANCE ACTIVITIES PERFORMED AND PENDING  
 MAY 2012

# BARTLETT TREE EXPERTS

**RE:** Victorian Box (*Pittosporum undulatum*) located in front of 417 Richardson St in Sausalito.

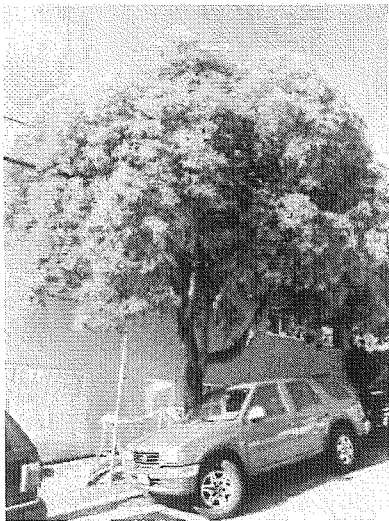
The Victorian Box tree appears to be in good health with a full, healthy canopy along with well-spaced scaffold branches. The root collar of the tree is properly exposed. There is a pocket of decayed at about 5 feet up from the base of the tree that was formed where a branch was removed several years ago. No other signs of decay or other defects were evident at the time of the inspection (Picture 1).

**Picture 1.** Victorian Box (*Pittosporum undulatum*) located in front of 417 Richardson St.

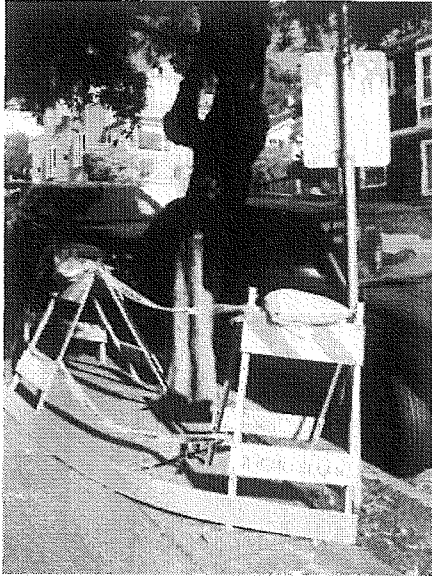
The roots of the Victorian Box overgrew the space where it was planted and some roots have cracked and lifted the walkway that runs along Richardson St, making a trip hazard for pedestrians (Picture 2).

**Picture 2.** The side walk in front of 417 Richardson St is cracked and uplifted by the roots of the Victorian Box tree planted next to it.

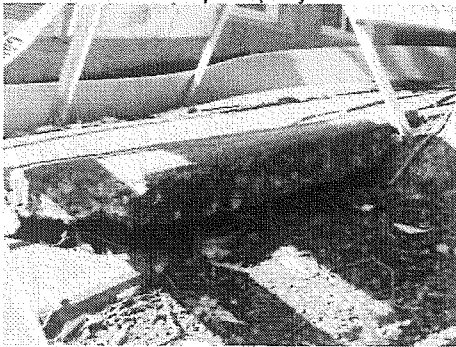
Since the walkway in front 417 Richardson St will have to be rebuilt, major roots will have to be cut close to the trunk, compromising the trees' health and stability. Therefore, the removal of the trees is recommended to eliminate any potential risks of the tree failing as a result of this repair project.

**Picture 3.** In order to repair the walkway, roots will have to be cut back at the base of the tree, compromising the tree's stability and safety.

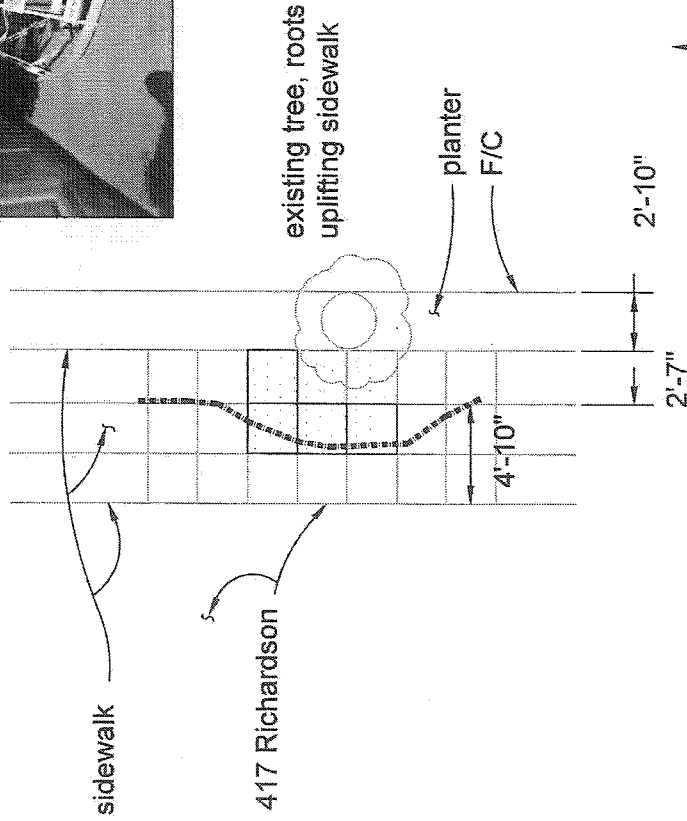
existing sidewalk to be removed

sidewalk to be removed and replaced

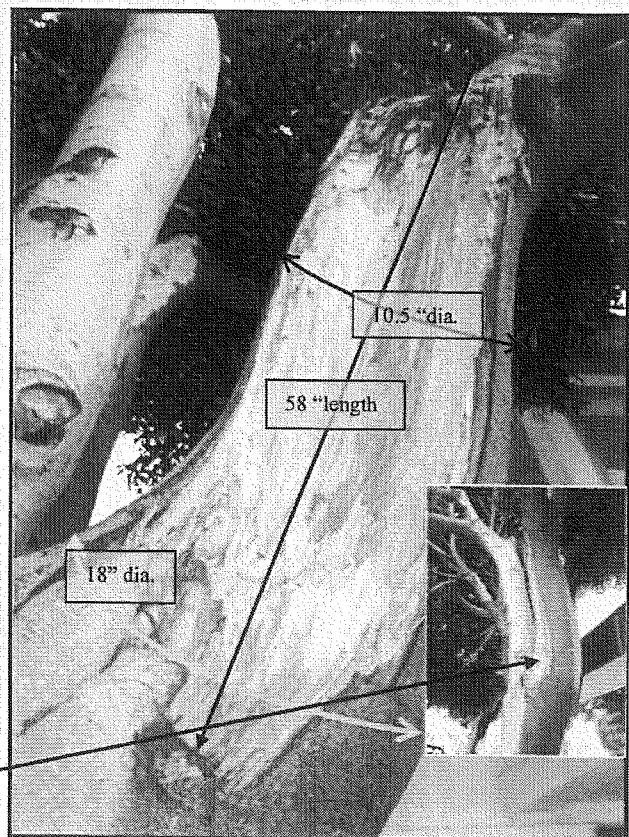
The Ficus tree has a large tear in a remaining scaffold limb on the street side of the canopy. This is where the limb failure occurred in February 2012. A measurement was made to determine the remaining circumference of the scaffold limb. Diameter just below the tear measured 18 inches, and at the center of the tear, 10.5 inches. The holding wood supporting the weight of the foliage and remaining limbs is now at 42 percent.

Arrows in the photograph depict the extent of the tear wound. Inset photograph is a side view of the wound with 42% remaining holding wood.

End weight on remaining limbs is critical; the probability of a second limb failure is high. The occupancy rate in the tree location is moderate to high dependent on time of day. It is very likely that street parking is constant. Thus, property damage is most likely, however, personal injury is considered high because of the commercial businesses in the immediate area. It is not practical to propose pruning alterations to mitigate these conditions and eliminate the risk. The tree would require severe pruning that would produce additional long-term problems that would eventually result in a similar limb failure.

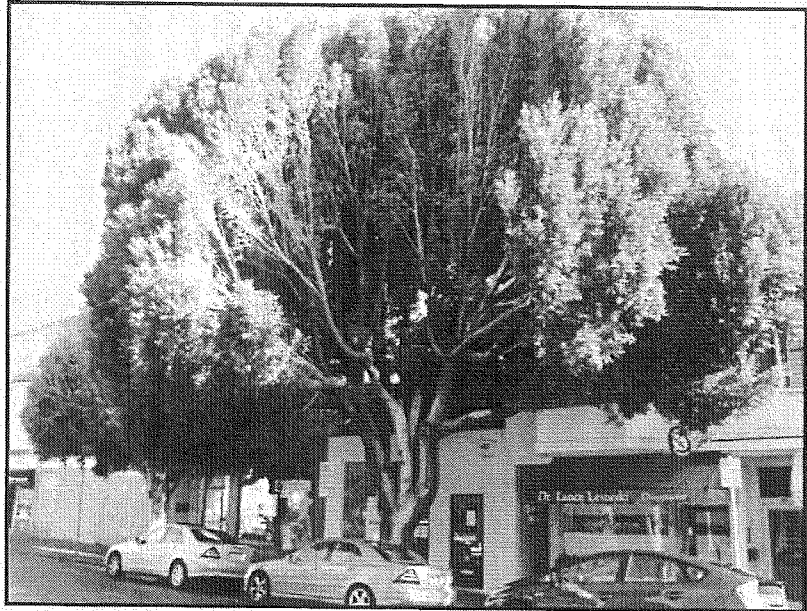
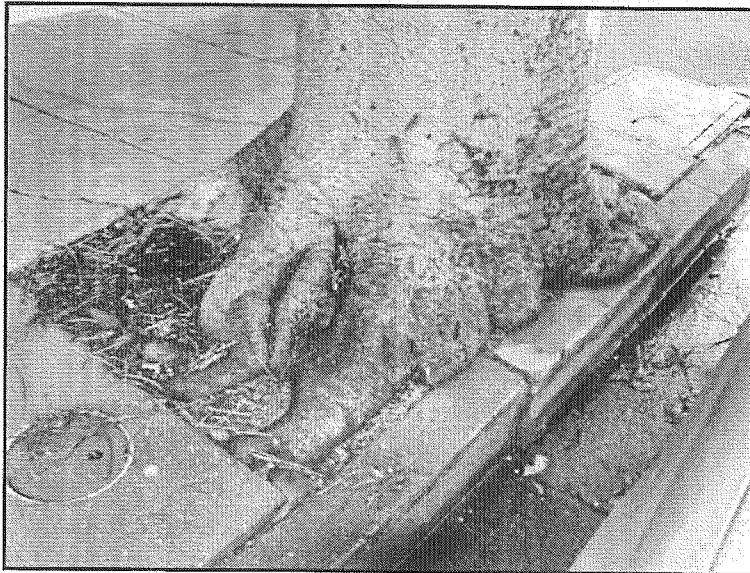
The broken scaffold limb resulted in a large hole in the canopy shape over Caledonia Street. In the photograph and when visiting the site, the extended length of remaining limbs and end weight exerted on the attachment points explains why the failure occurred and that the occurrence will be repeated. The heavy end weight is not sustainable by the scaffold limb attachments.

An additional concern is the restricted space this tree is required to produce growth. The canopy is off balance by the limitations of the row of two-story buildings. All growth is positioned over the Caledonia sidewalk and street.

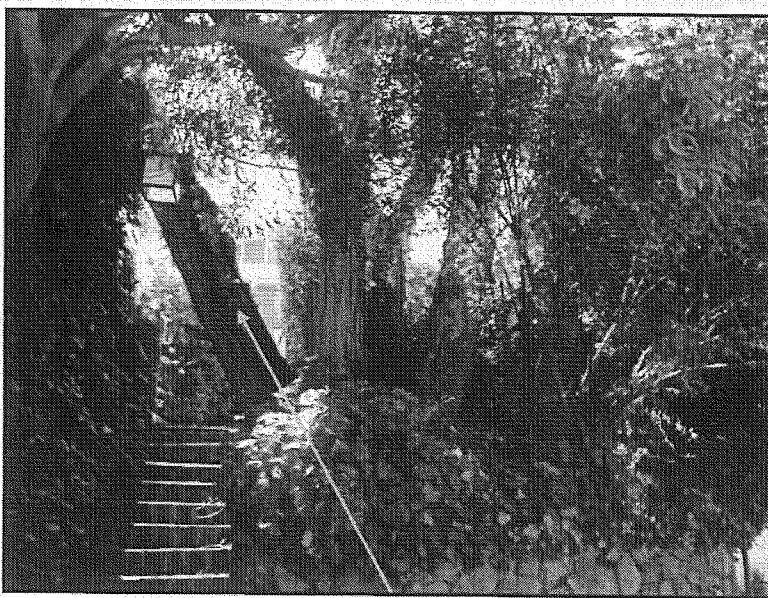
The limb with a 5.5-foot CBH that extends over the stairway to 53 Glen Drive is leaning at a 28 degree angle. In comparison, the other limbs are leaning at a 10 degree angle. *Gleditsia* trees have a spreading canopy structure, and therefore, a slight lean is expected.

The limb with the 28 degree lean is partially obstructing passage along the stairway leading to and from the residence. A visual inspection of the stem did not reveal open decay cavities. A basic sounding test was performed to a section of the limb to determine if internal decay could contribute to the lean. Hollow tones were noted at breast height levels, and internal wood decay is suspected on the stem area approximately 4.5 feet above the stem's base. Based on the sounding tests the decay area does not appear to be extensive or consume a great deal of trunk area. Sounding tests were performed only to the lower portion of the leaning stem.

Locust tree with leaning stem over stairway 53 Glen Drive.
