# STAFF REPORT

## SAUSALITO TREES AND VIEWS COMMITTEE

**Project** Casa Madrona Tree / 801 Bridgeway  
Tree Removal Permit  
TRP 12-151

**Meeting Date** July 5, 2012

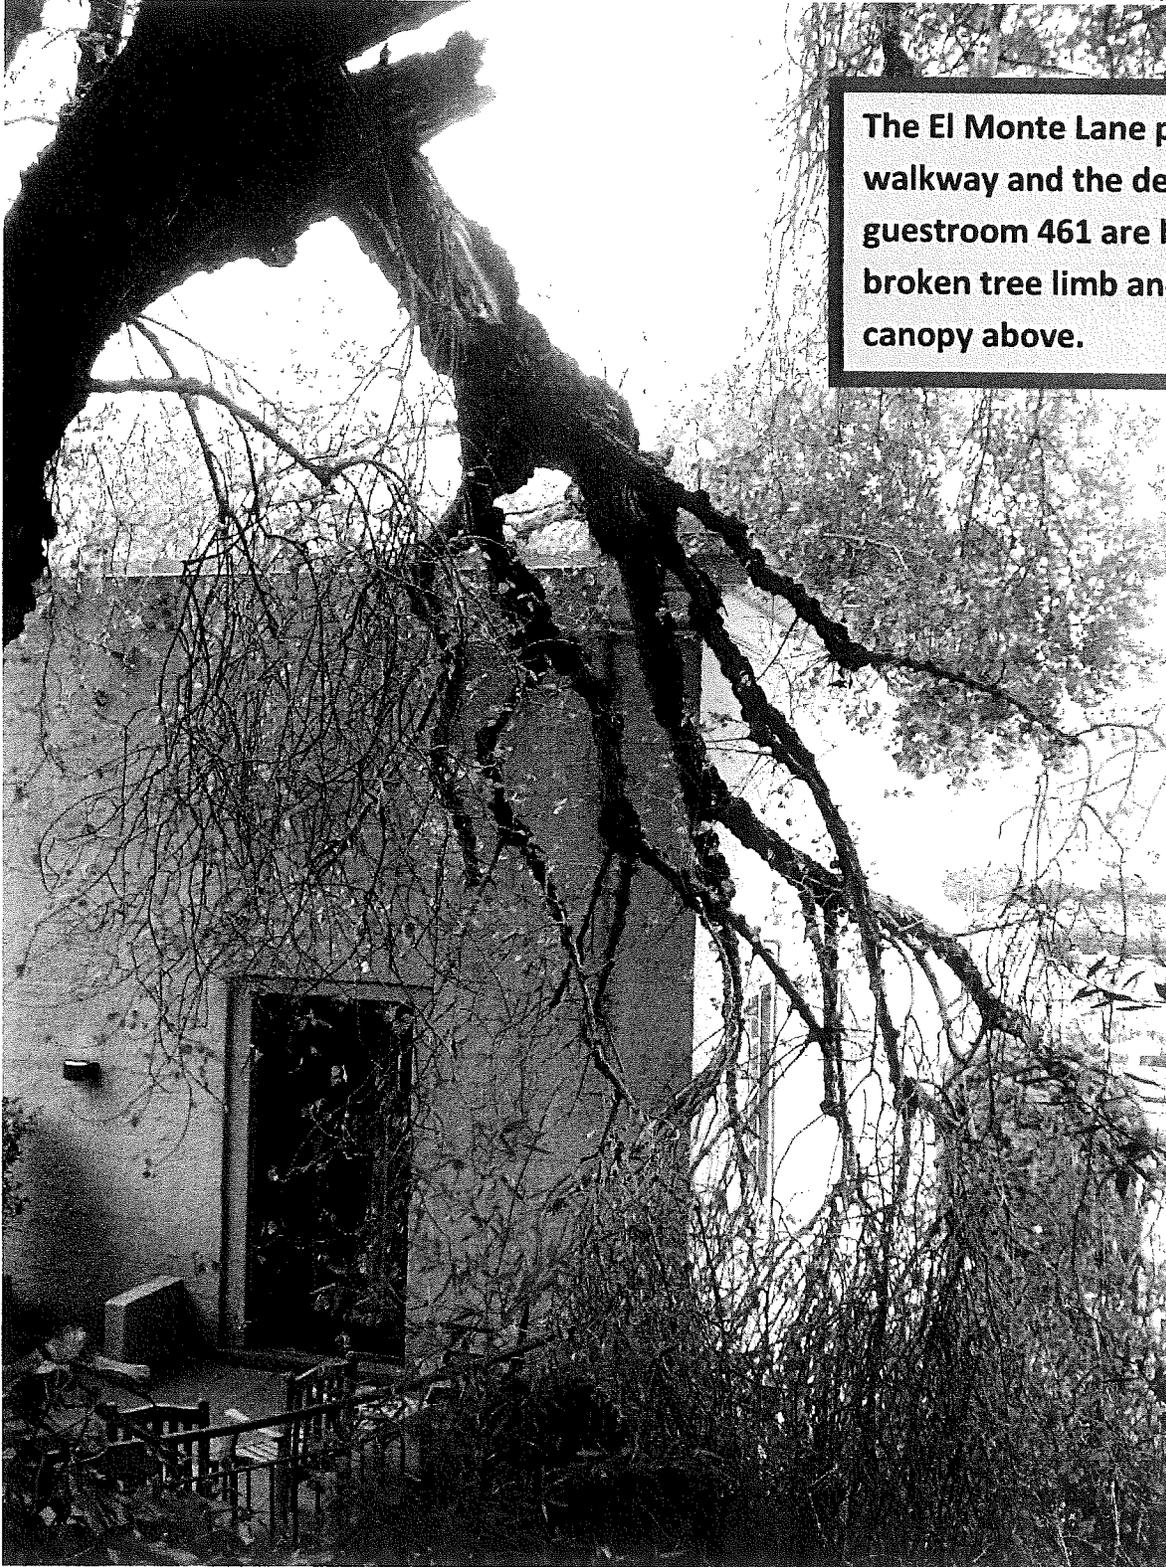
**PHOTO 1 OF 4**

**BROKEN LIMB 5/12/12**

**(Photo taken from parking lot above the tree)**

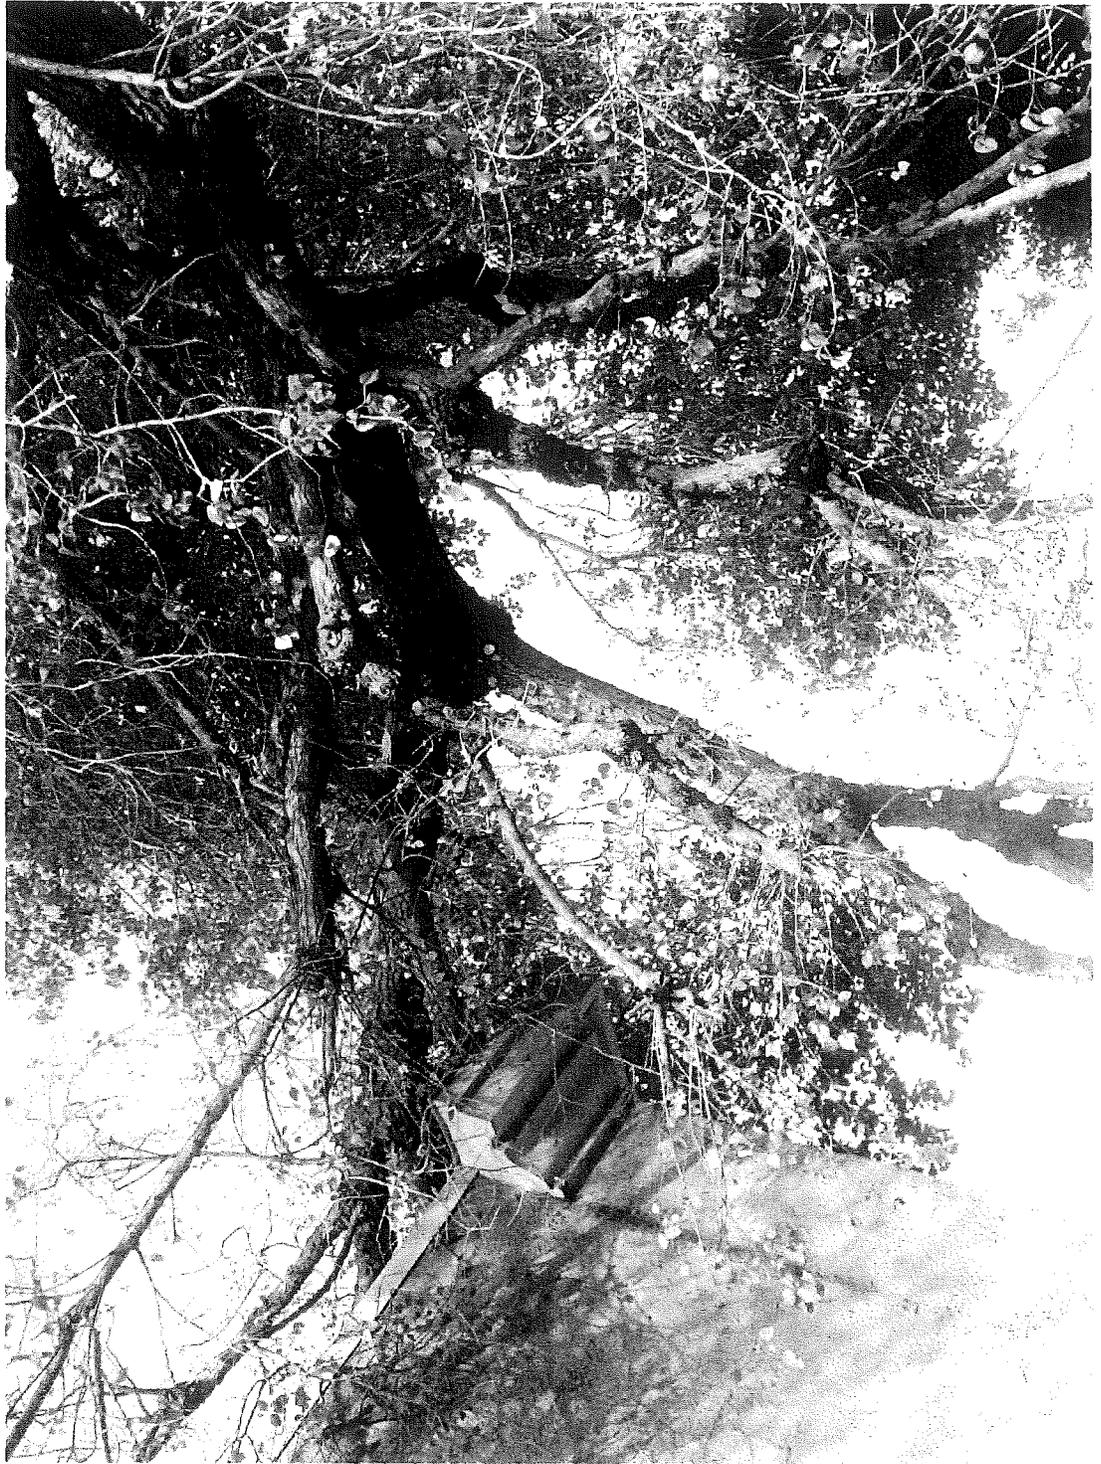
**PHOTO 2 OF 4**  
**(Photo taken from the deck of guestroom 461)**

**The El Monte Lane public walkway and the deck of guestroom 461 are below the broken tree limb and tree canopy above.**

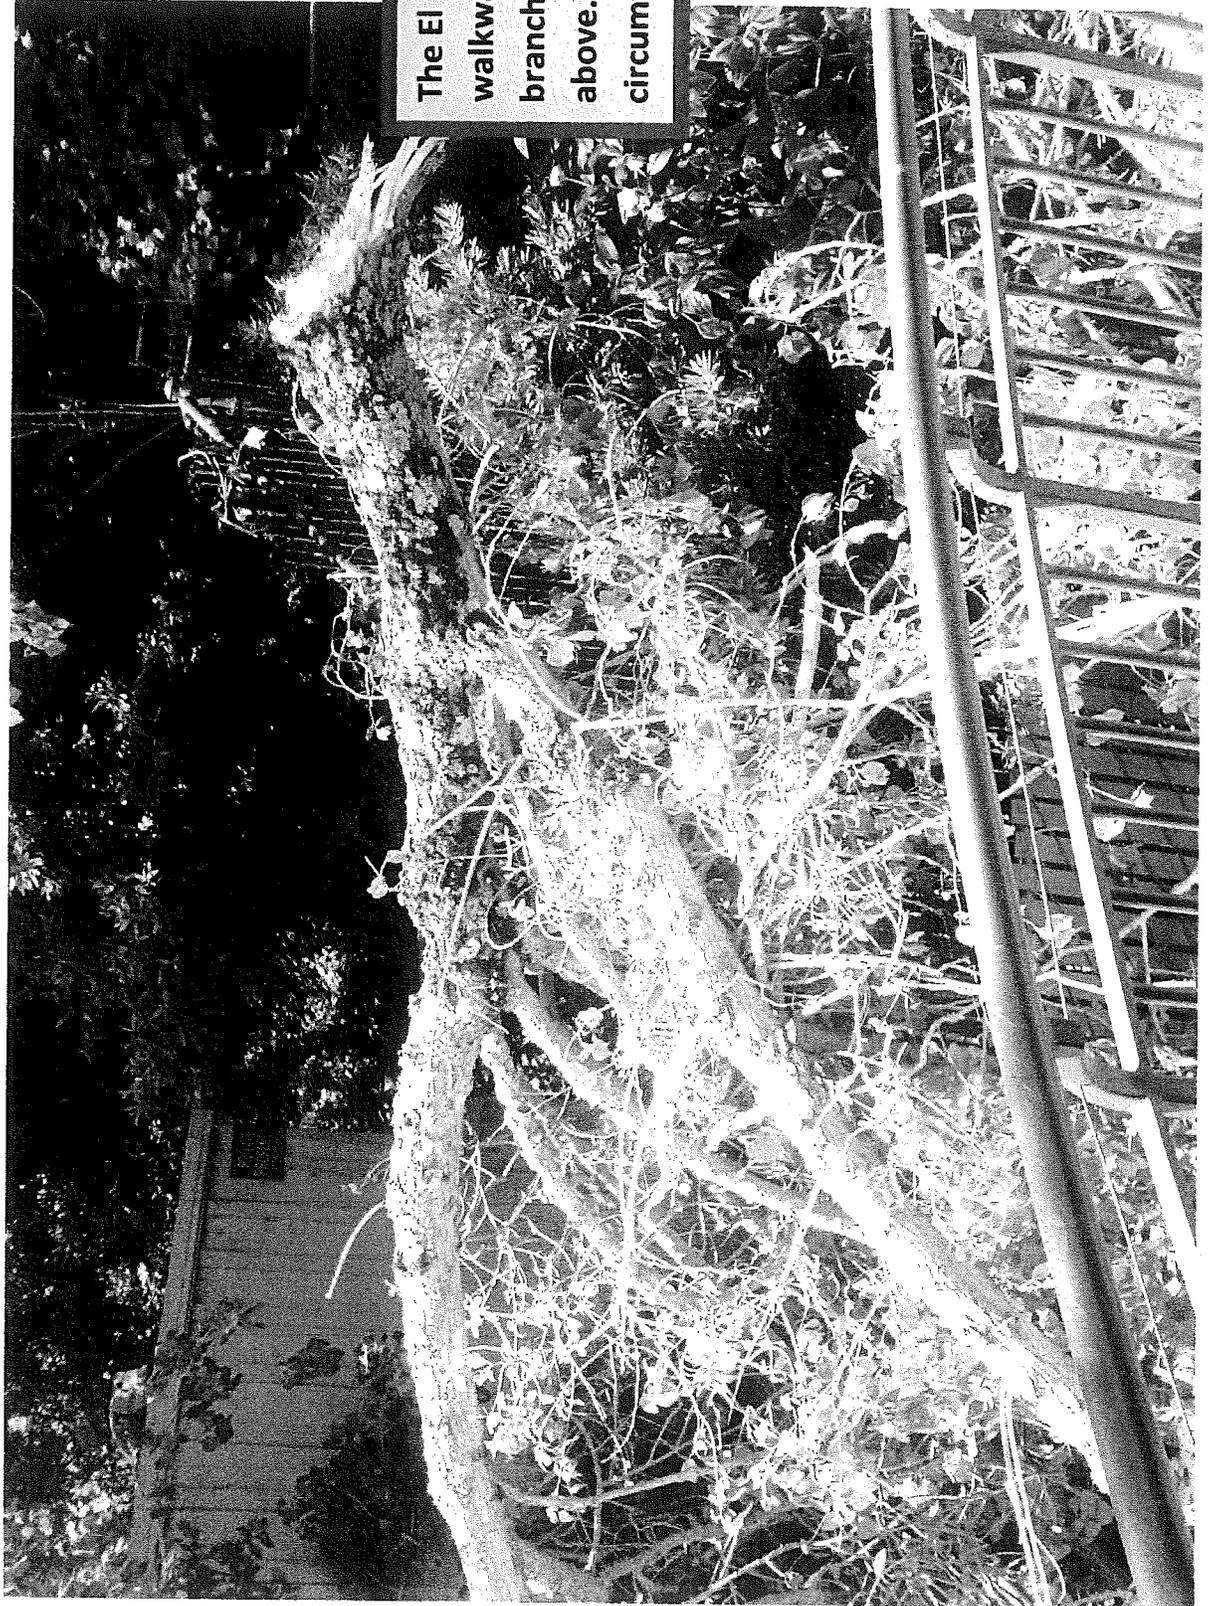
**PHOTO 1 OF 2**

**BROKEN TREE LIMB 6/17/12**

**(Photo taken from deck of guestroom 461)**

The El Monte Lane public  
walkway is below the broken  
branch and tree canopy  
above. Broken tree branch  
circumference was 36".

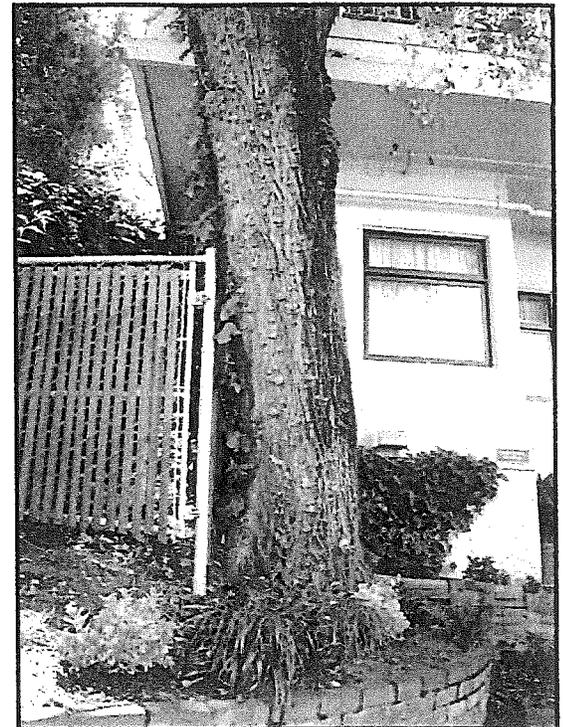
This tree is growing in a very restricted area. It is surrounded by a tiered planter bed, stairway, hotel guest buildings, and plumbing utilities that include water supply piping, drainage pipes, and fire lines for fire hookups. See the map sketch on page 4 of this report. The tree's root system has damaged the drainage lines that carry excess water away from the hotel grounds.

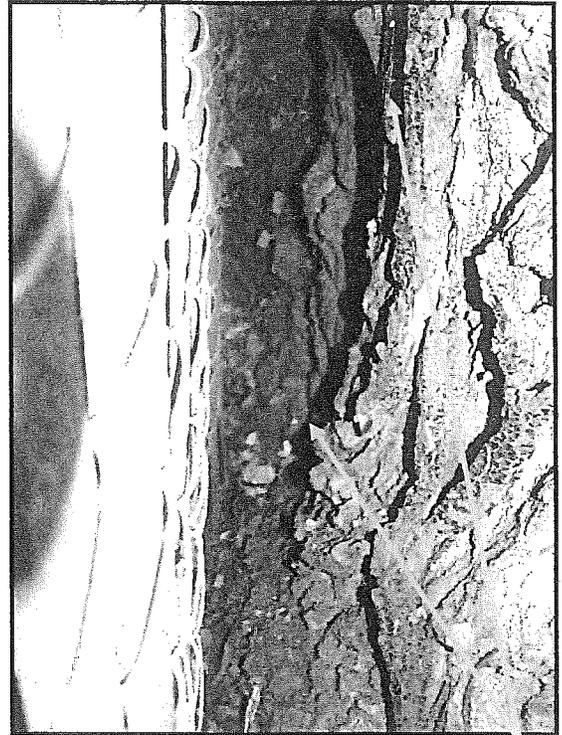
Inspection of the trunk base revealed that the east side of the trunk, obstructed by a wooden vertical-slat fence, has a concave recession. The trunk is flattened here in comparison to the concentricity of the rest of the trunk base. Within this flattened area at the trunk base a white growth appearance on the outer bark surface was noticed. This substance is consistent with a fungus growth very likely caused by constant shade and moisture accumulation created by the slat fence's close proximity to the trunk base. These conditions are the result of the tree's growth and expansion, the lack of natural light, and the confinement of a restricted space. Removing the fence would not correct the trunk's concave shape or reverse the fungal growth and is a concern as this suggests the Poplar tree's trunk base has a serious weakness that can cause this tree to fail. The fungal disease may also have originated in the root system and advanced into the trunk base. The disease is very consistent with Armillaria fungus.

Concave section of Poplar trunk against fence where fungal growth is present.

The tree must be removed immediately and before winter conditions increase the failure potential. It is recommended that once the tree permit is issued and the tree is removed a smaller replacement tree is planted in an approved location on the hotel grounds.
