DEPARTMENT OF PUBLIC WORKS TREE MAINTENANCE ACTIVITIES PERFORMED AND PENDING JULY 2012

Ed Gurka, Consulting Arborist Services Member, American Society of Consulting Arborists Certified Arborist, International Society of Arboriculture, Western Chapter, # 0418

October 16, 2011

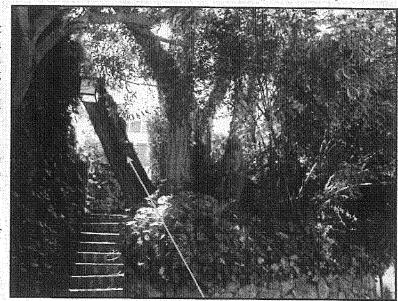
The limb with a 5.5-foot CBH that extends over the stairway to 53 Glen Drive is leaning at a 28 degree angle. In comparison, the other limbs are leaning at a 10 degree angle. Gleditsia trees have a spreading canopy structure, and therefore, a slight lean is expected.

The limb with the 28 degree lean is partially obstructing passage along the stairway leading to and from the residence. A visual inspection of the stem did not reveal open decay cavities. A basic sounding test was performed to a section of the limb to determine if internal decay could contribute to the lean. Hollow tones were noted at breast height levels, and internal wood decay is suspected on the stem area approximately 4.5 feet above the stem's base. Based on the sounding tests the

Locust tree with leaning stem over stairway 53 Glen Drive.

decay area does not appear to be extensive or consume a great deal of trunk area. Sounding tests were performed only to the lower portion of the leaning stem.

To reduce excessive leveraged weight on the leaning stem of the Locust tree, pruning operation shall be performed before cabling installation. Work shall be completed by workers skilled and knowledgeable in pruning weight reduction, and cabling methods.

- publication shall be used as requirements and guidelines for the pruning operation.
- To brace and anchor the leaning limb following the pruning operation, cabling the leaning stem to the tree's other stems is recommended to increase stability of the leaning stem. The ANSI A-300 for Tree Care Operations, -Tree, Shrub, and Other Woody Plant Maintenance, Standard Practices, (Support Systems a.

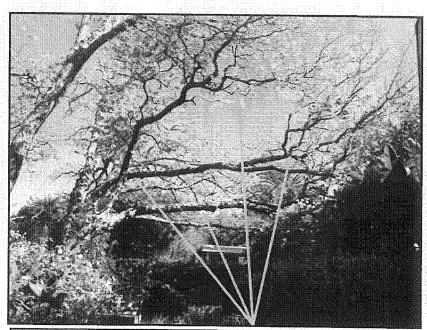
Selective end weight reduction of scaffold limbs. The removals of parallel scaffolds are considered pruning objectives to reduce excessive weight on the leaning Locust tree limb.

- A reduction of over-extended scaffold limbs requires end reduction pruning cuts to reduce the excessive leverage at limb attachment points and weight reduction on the leaning main stem. Scaffold limbs shall be reduced selectively by 25 percent where possible and cuts made to side branches that can assume future growth.

- Where similar diameter scaffold limbs are extending distally and in parallel to one another the redundant limb shall be considered remaining removal. The scaffold limbs shall be pruned for end reduction. These two requirements are recommended to reduce weight on the leaning stem.
