DEPARTMENT OF PUBLIC WORKS  
 TREE MAINTENANCE ACTIVITIES PERFORMED AND PENDING  
 JULY 2012

Tree Maintenance Activities July 18, 2012

## Arborist Report

**Arborist Report  
View Restoration Request  
190 Harrison Avenue, Sausalito**

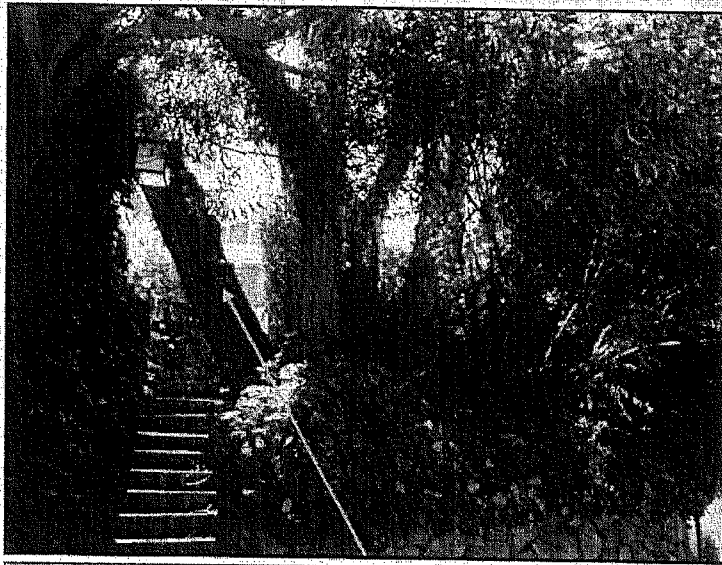
The limb with a 5.5-foot CBH that extends over the stairway to 53 Glen Drive is leaning at a 28 degree angle. In comparison, the other limbs are leaning at a 10 degree angle. *Gleditsia* trees have a spreading canopy structure, and therefore, a slight lean is expected.

The limb with the 28 degree lean is partially obstructing passage along the stairway leading to and from the residence. A visual inspection of the stem did not reveal open decay cavities. A basic sounding test was performed to a section of the limb to determine if internal decay could contribute to the lean. Hollow tones were noted at breast height levels, and internal wood decay is suspected on the stem area approximately 4.5 feet above the stem's base. Based on the sounding tests the decay area does not appear to be extensive or consume a great deal of trunk area. Sounding tests were performed only to the lower portion of the leaning stem.

Locust tree with leaning stem over stairway 53 Glen Drive.

To reduce excessive leveraged weight on the leaning stem of the Locust tree, pruning operation shall be performed before cabling installation. Work shall be completed by workers skilled and knowledgeable in pruning weight reduction, and cabling methods.

- To brace and anchor the leaning limb following the pruning operation, cabling the leaning stem to the tree's other stems is recommended to increase stability of the leaning stem. The ANSI A-300 for Tree Care Operations, -Tree, Shrub, and Other Woody Plant Maintenance, Standard Practices, (*Support Systems a*

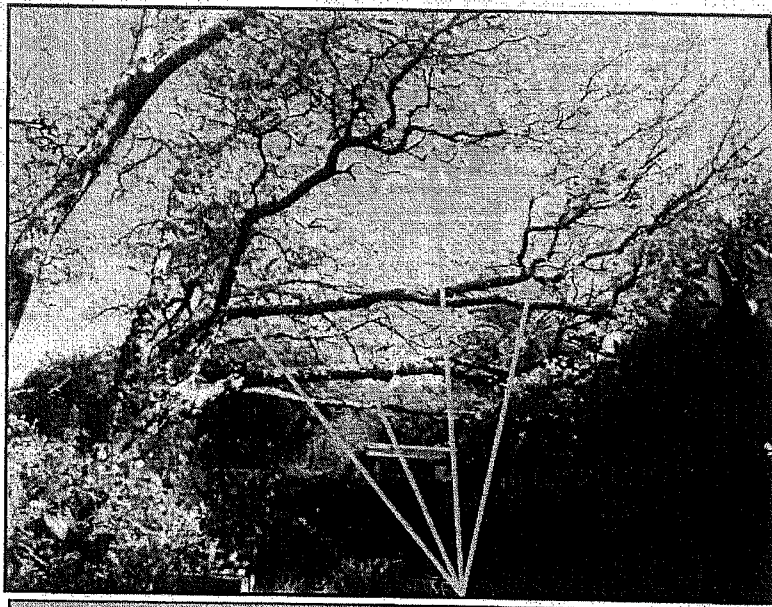
Selective end weight reduction of scaffold limbs. The removals of parallel scaffolds are considered pruning objectives to reduce excessive weight on the leaning Locust tree limb.

- A reduction of over-extended scaffold limbs requires end reduction pruning cuts to reduce the excessive leverage at limb attachment points and weight reduction on the leaning main stem. Scaffold limbs shall be reduced selectively by 25 percent where possible and cuts made to side branches that can assume future growth.

- Where similar diameter scaffold limbs are extending distally and in parallel to one another the redundant limb shall be considered for removal. The remaining scaffold limbs shall be pruned for end reduction. These two requirements are recommended to reduce weight on the leaning stem.

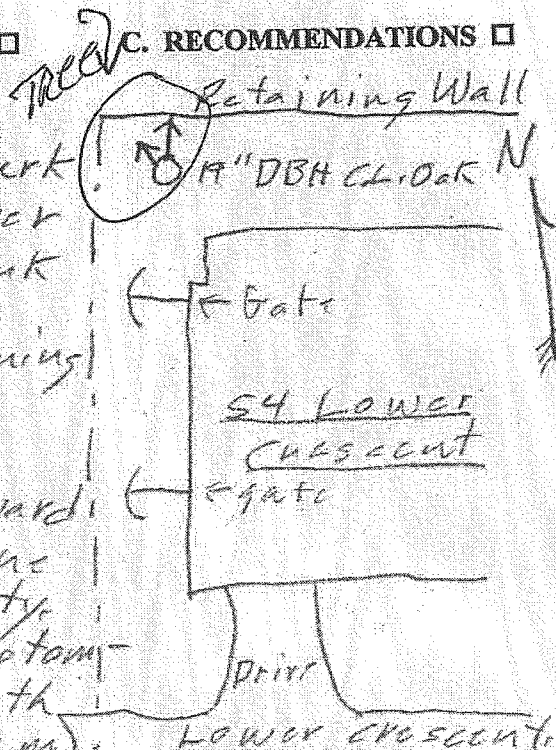
- 1) Bleeding canker and bark checking (cracking up) over more than 40% of trunk circumference. Dark red-brown staining of bark.
- 2) Lean and balance to North Northeast towards two homes below the #54 Crescent Property.

B. Conclusion: Highly symptomatic of Sudden Oak Death (*Phytophthora ramorum*)

1. Lean and balance toward 2 Target Homes
  2. Highly symptomatic of S.O.D.
  3. Canker covers close to half of the trunk circumference
  4. Hypoxylon Rot has not yet invaded
- conclusion: Risk is moderate but developing toward high risk.

- A) Remove as soon as possible.  
SOD infected oaks are known to fall without warning, even when their canopies are still green.
- This tree targets two homes below.
  - Removal will have no effect on adjacent vegetation.
