Ed Gurka, Consulting Arborist  
Member, American Society of Consulting Arborists

February 8, 2010

I received a call from Andrew Davidson, City of Sausalito, Staff Engineer, and Manager of a project for an ADA access path to Vina Del Mar Park in the business district of Sausalito. The proposed pathway in the park would pass within the root zone of trees in the park and questions on the impact to the trees are considered as a component of the project. A comprehensive December 1996 Arboriculture Report commissioned by The City of Sausalito when the park opened to the public, included all trees within the park. As the years have passed, an update for specific trees affected by the ADA pathway is necessary.

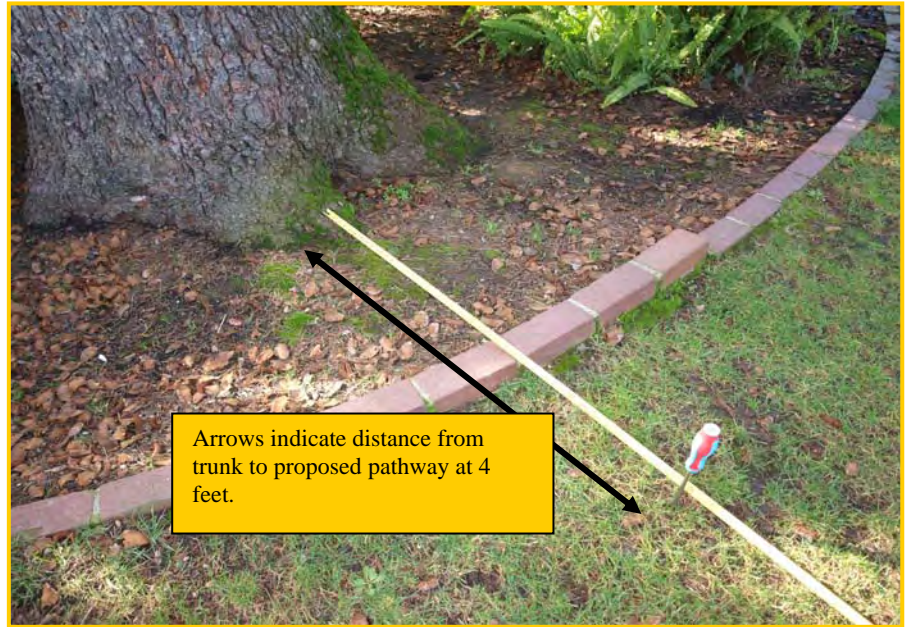
One proposal is for the pathway to pass within ten feet to the south of the Cedar trunk. This is in the same location as an ADA accessible ramp for access to the Vina Del Mar Park Plaza. In the second proposal, the pathway for access to the park and fountain would pass within four feet to the north of the Cedar trunk. These two proposed pathways for access to the park and fountain will pass within ten feet of the trunk on either side of the tree. A choice for the pathway location is required for the project to proceed. The root zone, within ten feet of the trunk, is considered a critical area because it is where buttress roots are closest to the soil surface. The impact is considered an alteration by the Sausalito Tree Ordinance and requires identifying what the best methods are to accomplish the project and reduce a negative impact to the health of the tree.

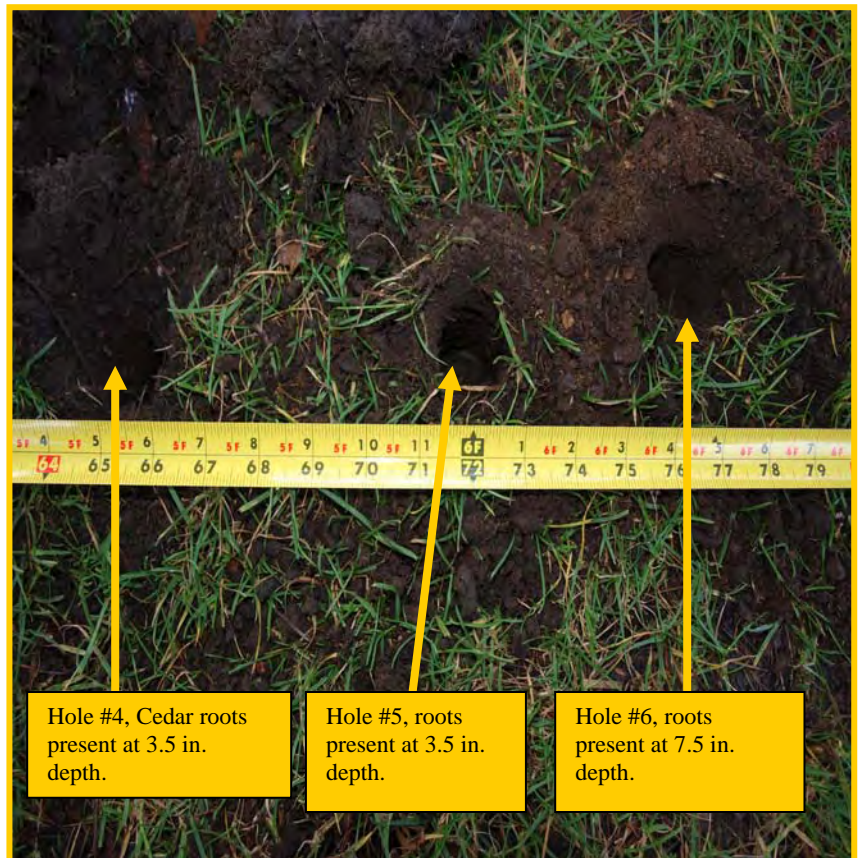
The next group of three boreholes was made and produced the following results. Hole #4 drilled to a depth of 3.5 inches revealed cedar tree roots. At hole #5 roots were found at 3.5 inches and at hole #6, roots were found at 7.5 inches, (see photograph to the right.)

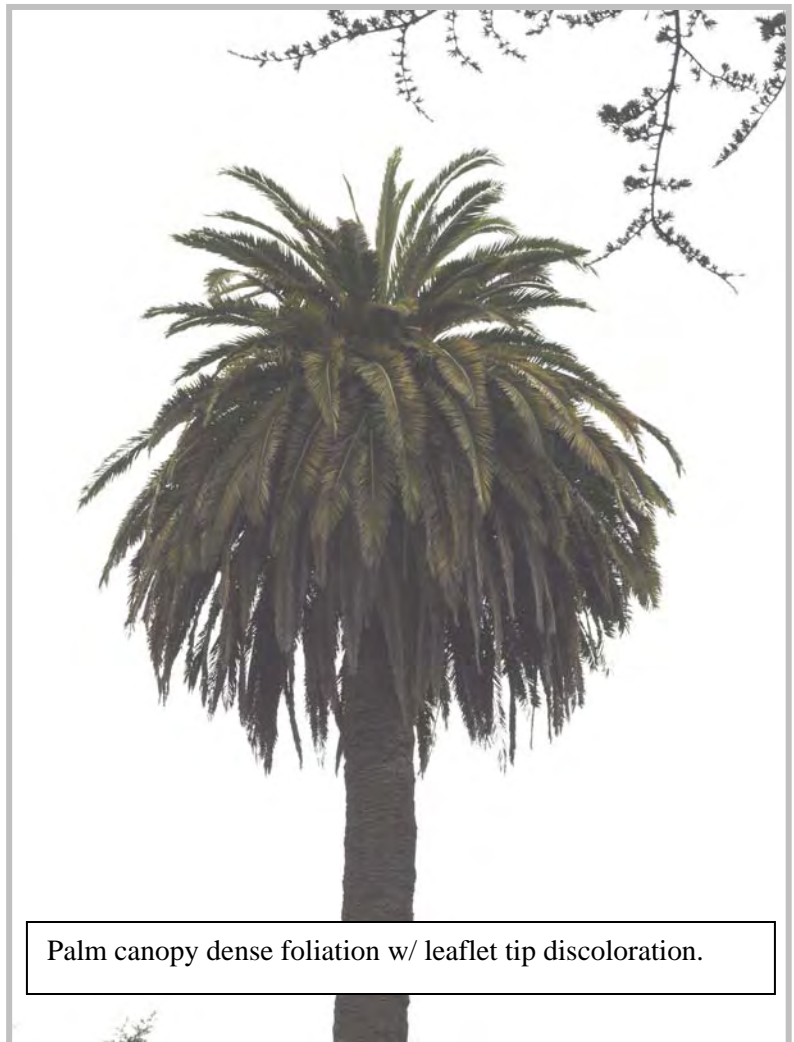
Palm canopy dense foliage w/ leaflet tip discoloration.

trunk appeared to be from unauthorized climbing equipment used to ascend the tree. The canopy has a normal amount of foliage. Palm literature indicates Phoenix canariensis canopy cover on average have fifty fronds and visual inspection indicated a full canopy. Canopy cover is an indicator of a plant's vigor.

A slight discoloration on leaflet tips was noticed that could be related to a nutrient deficiency or salt spray damage. The Palm tree is near the bay and salt-water wind spray from the bay can accumulate on leaflet tips to cause this discoloration. Nutrient deficiency can be corrected with specifically formulated Palm fertilizers. Salt spray from the bay's waters generated by winds is uncontrolled because it is a climatic condition. Shredded frond tips is very likely wind damage and not critical to the tree health. Soil testing for nutrient deficiency specifically, magnesium and potassium would determine if a nutrient deficiency exists and how to correct the deficiency, see photograph on page 3.
