Re: **View Claim Application – Supplemental Arborist Report
June Schwarcz – 18 Wray Avenue**

EXHIBIT H
(13 PAGES)

Addendum to Schwarcz residence "View Obstruction Arborist's Report" dated April 4, 2013.

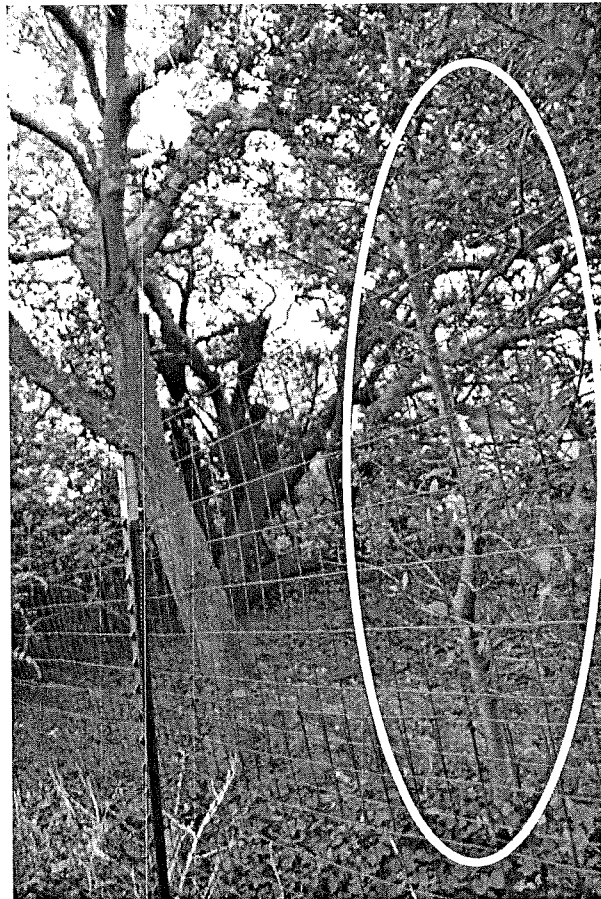
There are two small coast live oaks growing along the northern property boundary (Photo 1). These two trees do not obstruct the view from either residence at this time, however they have the potential to be a problem in the future. Because the trees are growing near the property boundary they will create problems for both property owners as they grow taller and their crowns cross the property boundary.

Photo 1: The photo to the right shows one of the two small coast live oaks growing near the property boundary.

I would recommend removing these trees now while they are small and easily removed before they become an issue years from now.

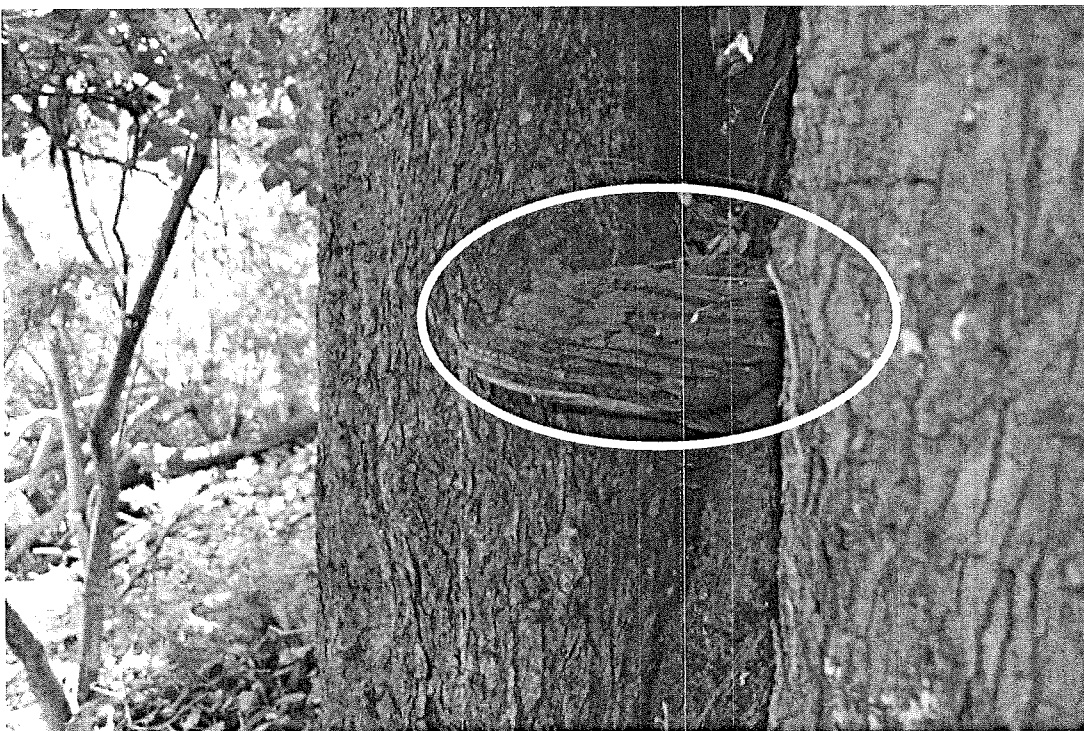
The casuarina has three main stems, is located behind the middle coast live oak, and has a trunk diameter of approximately 24 inches. The main stems have been previously topped at approximately 30 feet above grade and there are adventitious sprouts originating near the old cuts. There is an old "Artists Conk" (*Ganoderma applanatum*) growing near the main stem attachments (Photo 2).

The casuarina is in poor health and has poor structure. There are positive indicators of decay at the ends of the main stems where the tree was topped and in the attachment where the conk is located. One stem is completely dead.

Photo 2: The photo above is of the main stem attachment and the "Artists Conk".

The casuarina should be removed and it does not provide visual or auditory screening or have significant beneficial use or economic value to the property.

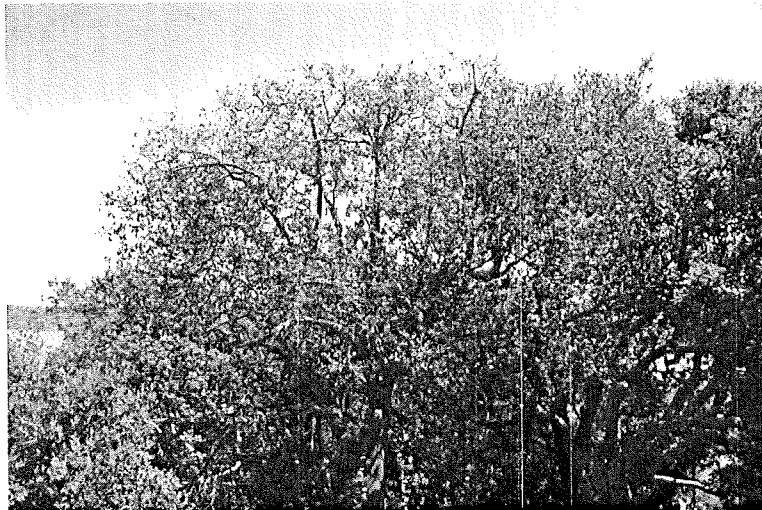
The coast live oak has sparse foliage that has a yellow hue (Photo 3). Chlorosis, the whitish or yellowish leaf discoloration is caused by a lack of chlorophyll, which is often caused by nutrient deficiencies. The yellowing of the foliage, sparse crown, and sporadic leaf dieback are all indicators of stress and potential root, leaf, or nutrient problems. The tree is declining in health.

Topping or crown reduction, even within the maximum of 25 percent reduction in live foliage, may cause the tree to go into a spiral of decline. Removal of significant amounts of foliage could cause irreversible decline because the tree is already declining.

Photo 3: Sparse crown of the northern most tree.

Removal of this coast live oak proactively rather than topping or significant reduction may be a more appropriate long term solution.

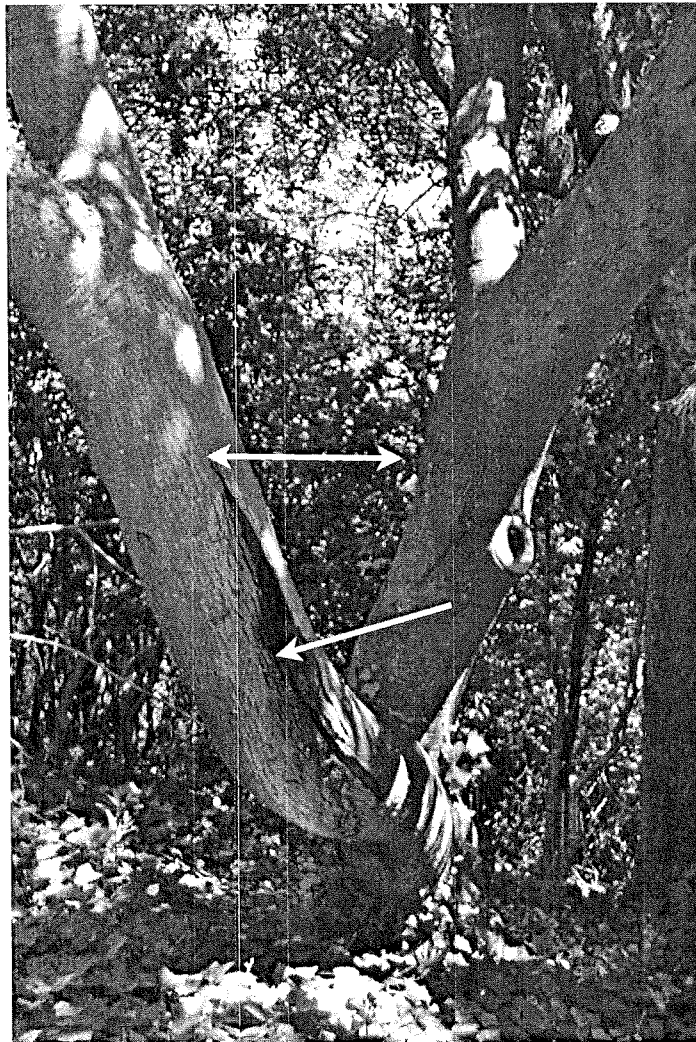
The tree has codominant stems that originate between two and four feet above grade with one stem being upright and the other extending west before sweeping upward (Photo 4). Codominant stems are branches of relatively equal size that join at the same point on the main stem. Usually, codominant stems do not have normal branch attachments and are prone to failure especially when the stems are similar in size (diameter) (Smiley, Fraedrich and Hendrickson, 2007). The lower foliage on the tree has been removed creating poor branch and stem taper with overextended limbs. The western leader is oozing from bacterial flux where the limb is cracked. The vertical crack is formed on the compression side of the stem where gravity is pulling the stem toward the ground. This is sometimes referred to as a "banana crack" because the fracture is the same as you would see if you were to bend a banana. The oozing or bacterial flux is caused by several different kinds of bacteria and/or yeast that colonize areas where wounds occur (Dreistadt, 2004), in this case the crack. Although it is unsightly the affected wood may still be strong underneath. Typically, bacterial flux has little to no effect on healthy trees.

The tree has poor structure, codominant stems, poor stem taper, and a cracked stem, but is in good health. Crown reduction, especially on the western most leader, could help the structure by reducing weight while reducing the risk of stem failure.

Photo 4: Coast live oak with codominant stems and oozing compression crack.

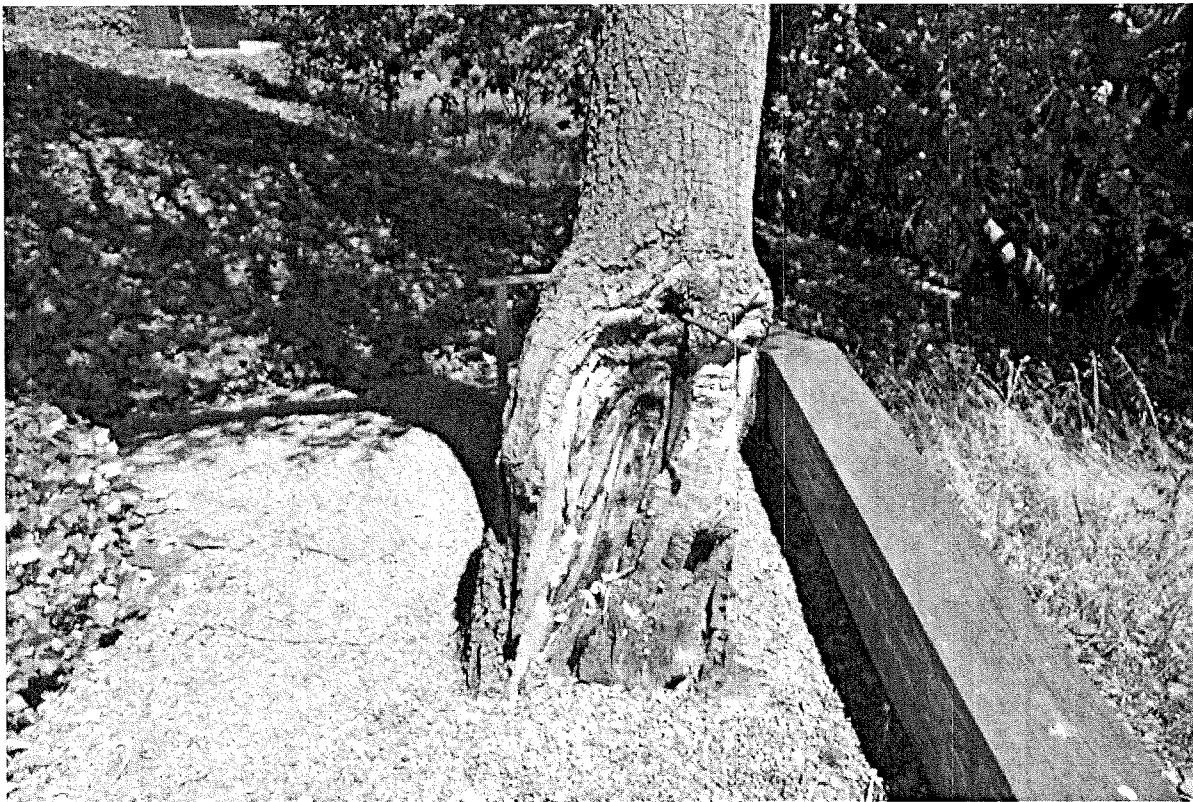
The southern most live oak was not considered in the original view obstruction claim. The tree has a trunk diameter of approximately 24 inches and is about 25 feet tall. There is a large wound on the south side of the tree where a codominant stem failed. The failed stem created a wound that is half the circumference of the original stem (Photo 5). The tree has been pruned in a "windowing" fashion and all the lower foliage has been removed. The tree has poor structure and its potential for failure is increased due to the wound at the base. When wounds encompass greater than 33 percent of the original branch or stem circumference, failure is likely to occur at that point and the limb or stem poses a high risk. When 50 percent or more of the branch or stem is decayed or missing the branch poses a critical risk of failure (Smiley, Fraedrich and Hendrickson, 2007). The stem of the tree has approximately 50 percent of the original circumference of the stem remaining.

Photo 5: Wound at the base of the southern most coast live oak.

There are views from 18 Wray Avenue that are obstructed by this tree and crown reduction similar to that performed on the middle oak will help to restore those views (Appendix B).

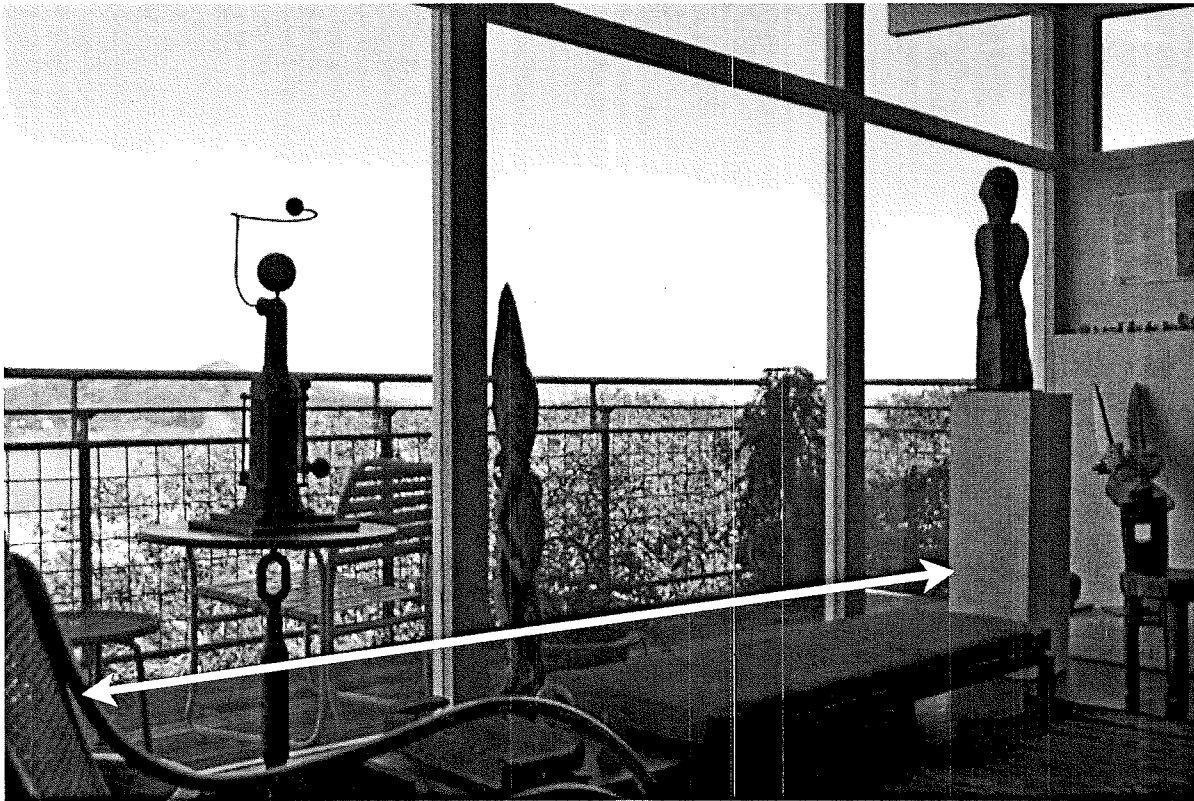
Photo 6: The arrow line in the photo above indicates the level the trees should be reduced below to restore the views.

Objective: Reduce the height of the trees below the deck level of 18 Wray Ave to help improve the views from 18 Wray Avenue (Photo 6).

- Reduce the crown heights below the level of the back deck. Prune back to appropriate sized lateral limbs no less than 50 percent the diameter of the parent branch or stem at the cut. Reduction cuts shall consist of branches no greater than four inches in diameter at the point of the cut. Heading and topping cuts shall be avoided where possible.

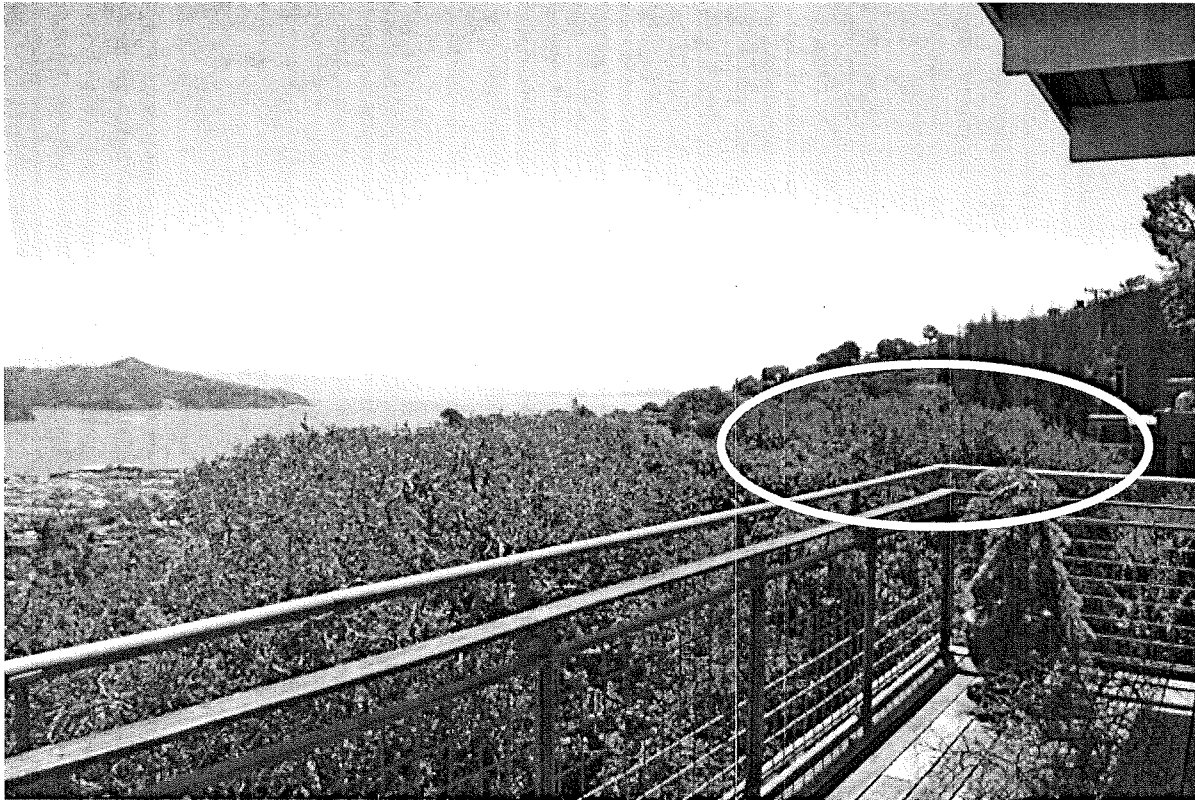
Appendix B: Southern Most Coast Live Oak

The photo above shows the views and the third coast live oak.

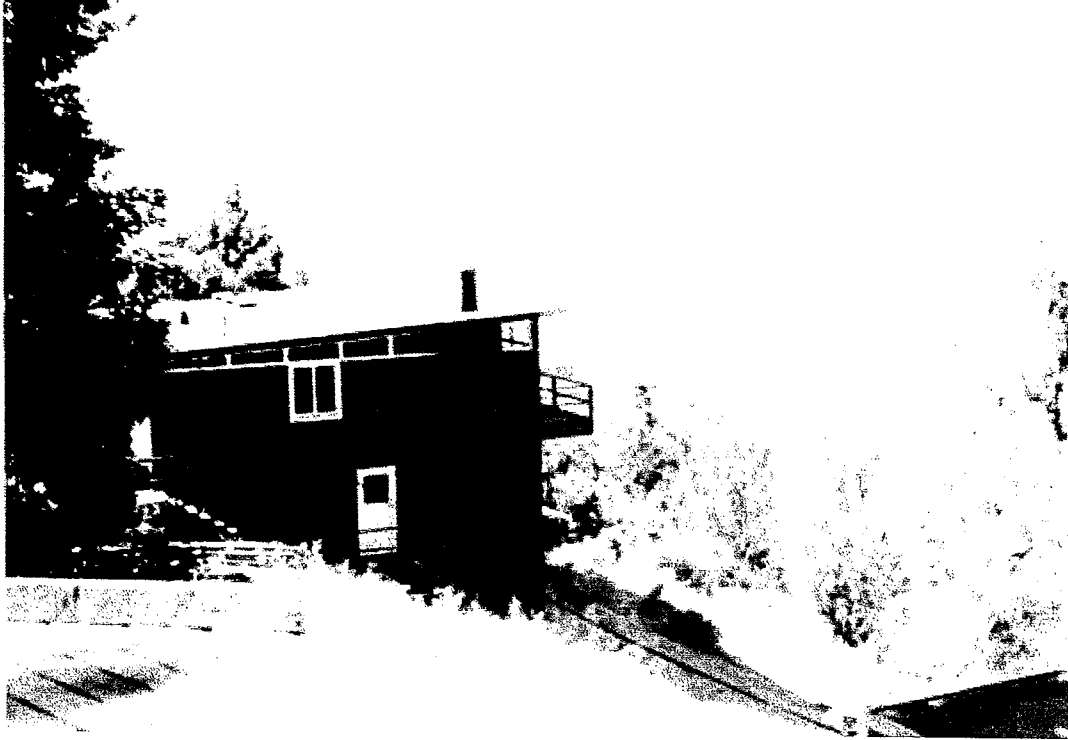
Photo below of the residence in 1954 with the edge of the deck in the middle of the photo and no trees on the slope.
