STAFF REPORT

Project Langsam Trees / 62, 64, 66, 68 Lower Crescent Avenue
Tree Removal Permit
TRP 13-312

ARBORIST FIELD REPORT

WORK PERFORMED AT:
62, 64, 66, and 68 Lower Crescent Avenue
Sausalito, California

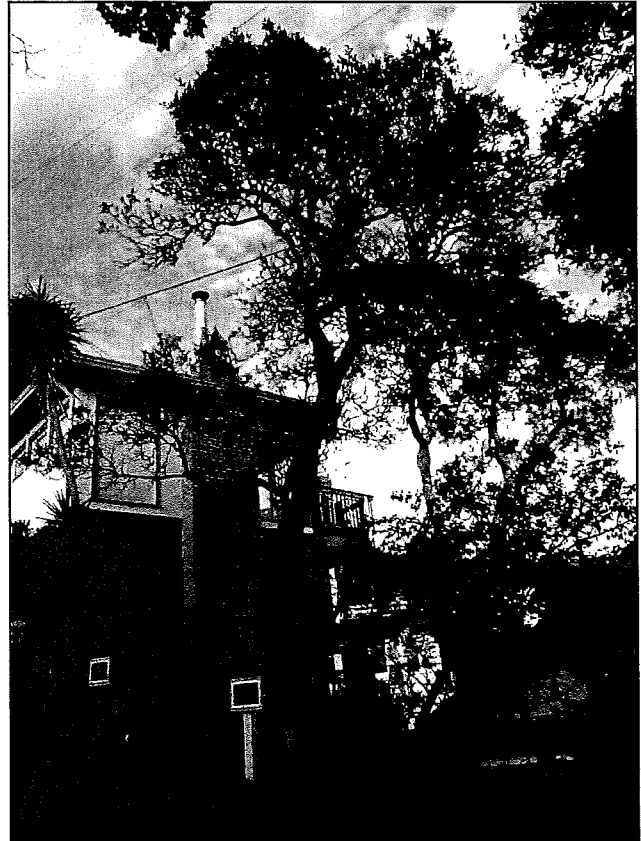
Tree #1

A large pruning cut is noted at the south base of the trunk. The cut measured twenty two inches in diameter with decay beneath the face of the cut cross section. The decay has progressed into the main trunk of the tree. There are occasional 1/8th inch holes in the face of the remaining pruning cut and just beneath in the main trunk.

The Oak tree is in advanced stage of decline. The large pruning cut at the base of the trunk has contributed to decay progressing into the main trunk. Boring insects are entering the main trunk just below the decay section at soil level. The fact that only 10 percent of the foliage remains on one small section is further indication that the tree will be completely dead soon. The targets are the residence walkway and entrance to 68 Lower Crescent Avenue. **This Oak tree must be removed immediately before it falls.** Replacement vegetation considerations once the tree is removed are either a small tree or shrub because the planter area is very limited, and constricted in space.
