Friar Associates, Incorporated . Engineers . Consultants Soils . Foundations . Geology . Geotechnology

June 24, 2019 Project 1942

Report Geotechnical Investigation New Residential Development 654 Sausalito Boulevard Sausalito, California

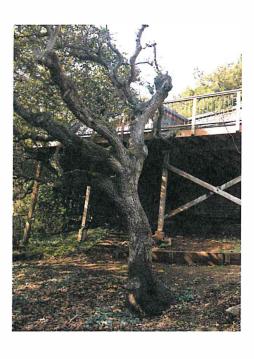
#### Tree #5 (16 in. Quercus agrifolia)

branch dieback root and crown root rot (phytophthora sup.) decay poor growth excessive lean

The trees at 654 Sausalito Blvd. were examined, catalogued and appraised for their economic value. They are in poor condition and recommended for removal. The trees' visible symptoms have been photographed and notated on pages 4 & 5. Replanting of a native variety and/or approved trees by the City of Sausalito is recommended. A Certified Arborist or Landscape Professional should supervise the installation. There may be some effects on neighboring vegetation but only on the owners property. Any loss of soil can be replenished with new high quality soil and mulch. Overall a new well-cared for landscape can be installed, developed and maintained after years of neglect.

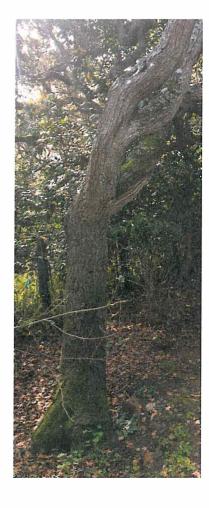
Tree #6 (16 in. Quercus agrifolia)

Anthracnose / twig blight / aphid damage / cavity at root crown / decay
