Proposed Duplex Project

Environmental
Survey
for Renovation

429 1/2 Johnson St. Sausalito, CA Date: 5-10-24

Asbestos Survey for Proposed Duplex Vacant Dwelling 429 ½ Johnson Street Sausalito, CA

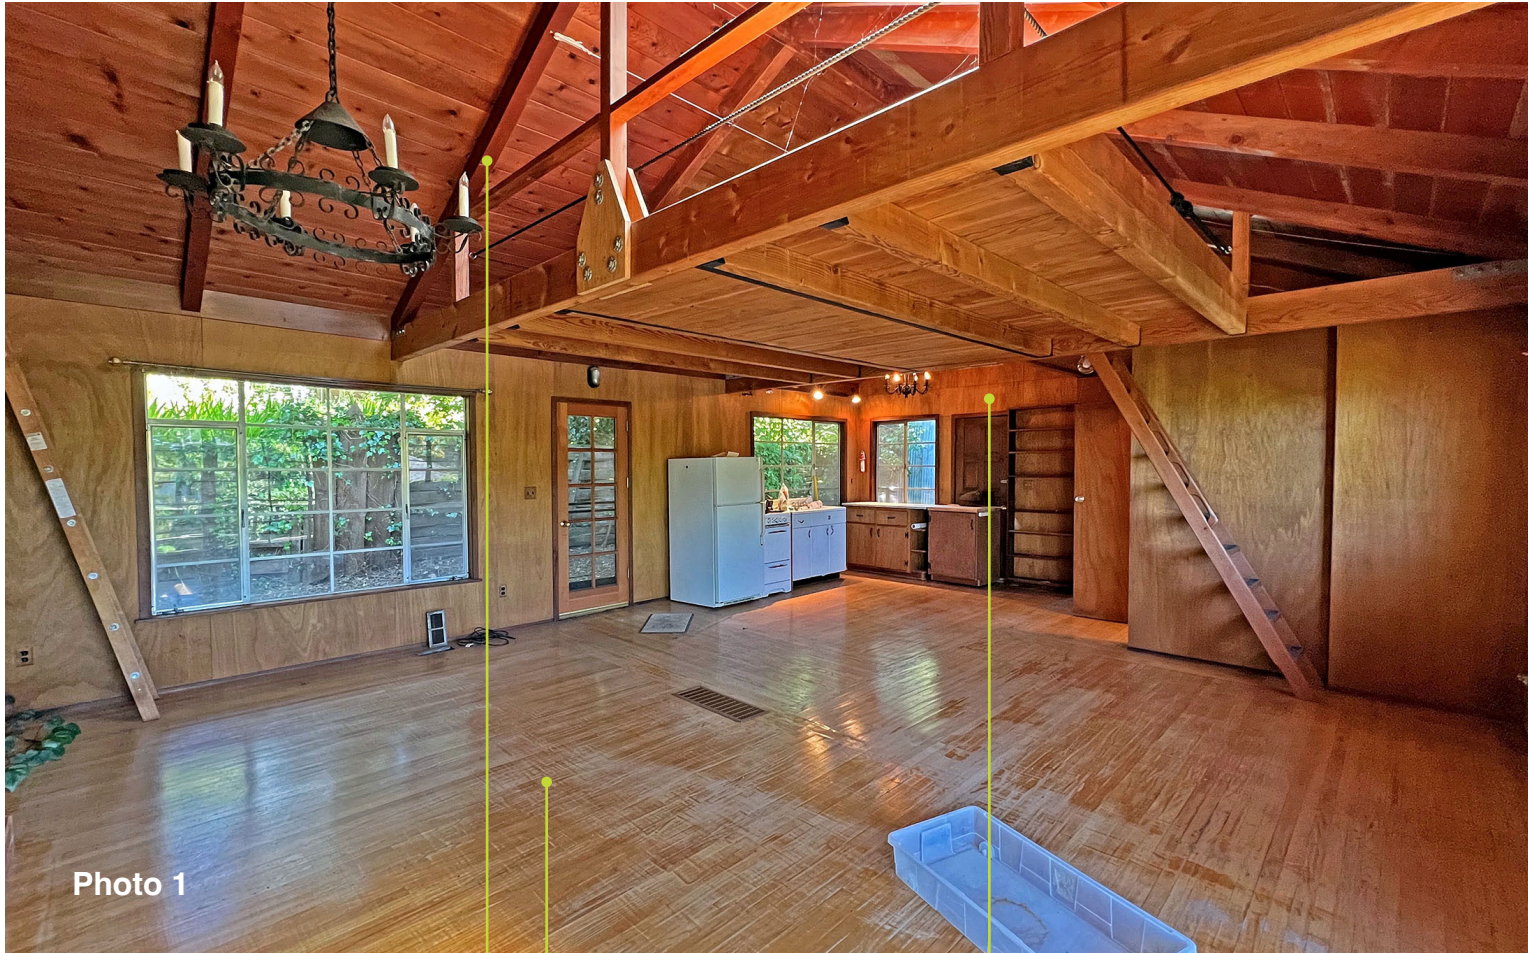
Photo 1

The second level ceiling is wood beams and wood planks.
The ceiling at the lower floor is mostly gypsum board and compounds.
The roof and exterior materials were not included in the survey.

The flooring in most areas is wood strip over wood framing at the second level. The basement is mostly Terrazzo or concrete slab on grade. No asbestos was detected in floor samples.

The partition walls in the building are wood framing in all areas. Most of the second level walls use wood paneling. The lower levels use gypsum board finished with joint tape compounds.
The gypsum board, joint compounds, are non detect for asbestos.

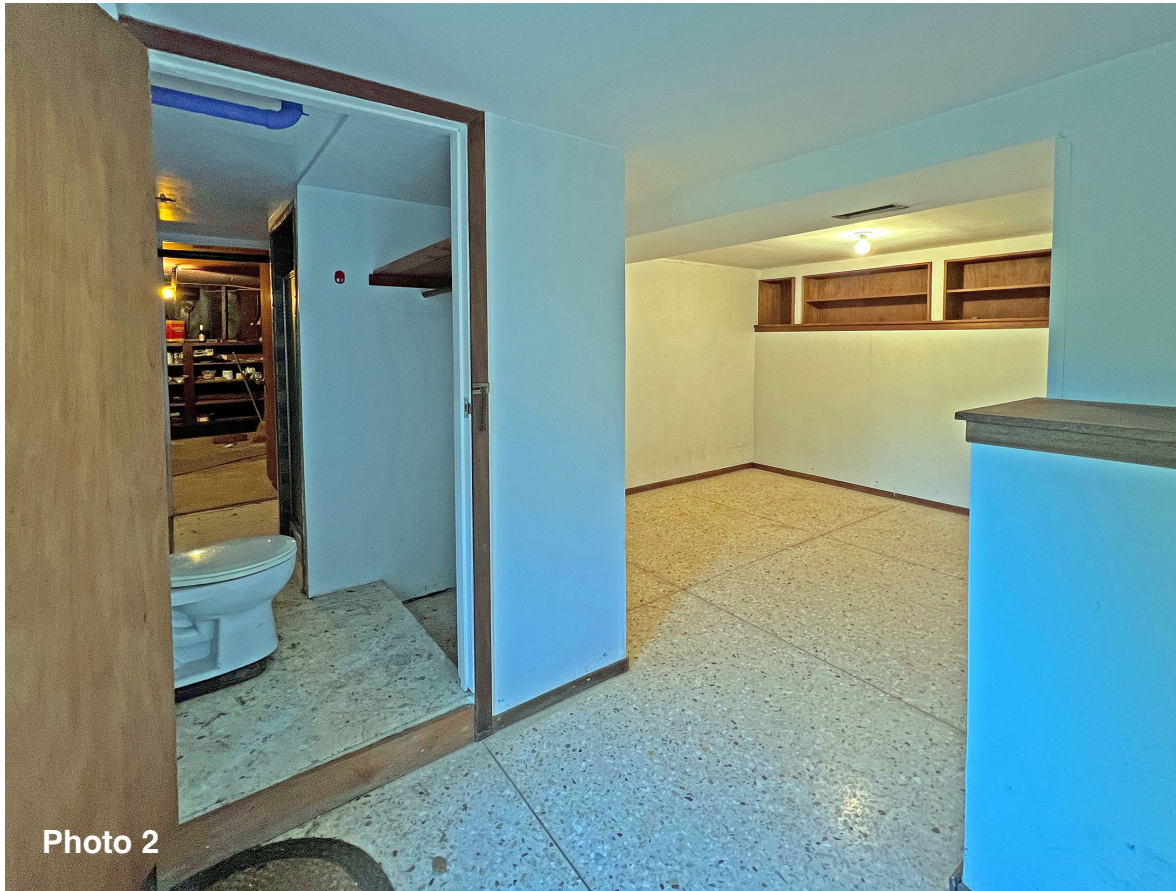
The first floor main room uses Terrazzo concrete flooring as shown in Photo 2. The walls and ceilings of the lower level are gypsum board. Drywall joint tape compounds are used to finish the drywall surfaces. The shower in the bathroom uses ceramic tile and grout for the wall surfaces. The foundation at the lower level is a concrete perimeter system, with limited areas of concrete block or CMU in the garage storage area.

Based on the PLM sampling and laboratory analysis the drywall, ceramic tile, Terrazzo, concrete, and duct tape samples were non detect for asbestos content.

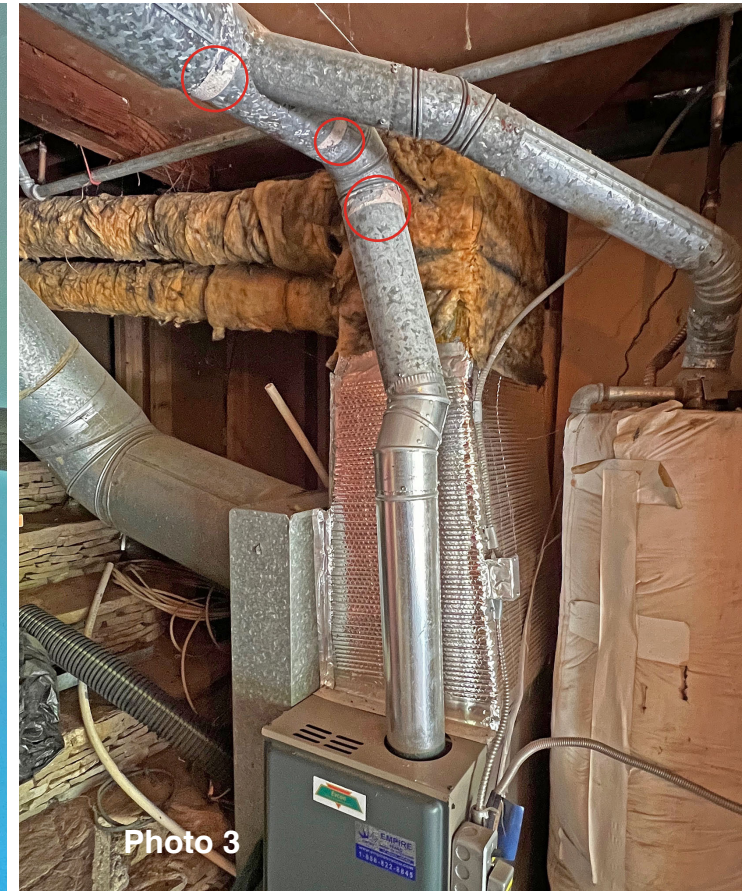
The hard cast flue tape is friable asbestos.

- The hard cast tape on the HVAC flue pipes contain 60% asbestos.
- The 9 x 9 vinyl tile was non detect for asbestos.
- The HVAC duct insulation and silver duct tape do not contain asbestos.
- The drywall and joint compounds do not contain asbestos.
- The ceramic and grout tiles do not contain asbestos.
- The concrete / Terrazzo flooring does not contain asbestos.
- The concrete block/ CMU at the basement does not contain asbestos.
- The exterior glazing compound does not contain asbestos.

The gas fired furnace and water heater is located in the garage area of the basement. The forced air furnace uses sheet metal duct work, sealed with a silver colored duct tape at pipe seams. Fiberglass is used for insulation on the duct work in the basement / crawl space. The flue pipe for the furnace and water heater is galvanized sheet metal. A hard cast tape is used at the joint between the flue pipe sections. Much of the hard cast tape is missing, but about 1 square foot remains. The hard cast tape contains 60% asbestos and is classified as friable. The residual hard cast tape must be abated by a qualified asbestos abatement contractor prior to removal of disturbance. The red circles in Photo 3 show some of the hard cast tape locations.

1. The hard cast tape on the flue pipes for the furnace and water heater is in poor condition and must be abated prior to demolition or disturbance. The abatement must follow Cal / OSHA 8 CCR Section 1529 regulations for friable thermal system insulation materials. Wet methods, containment, performed by qualified asbestos contractors will be required
