STAFF REPORT

SAUSALITO TREES AND VIEWS COMMITTEE

Hothem Tree / 122 San Carlos Avenue

TRP 11-185

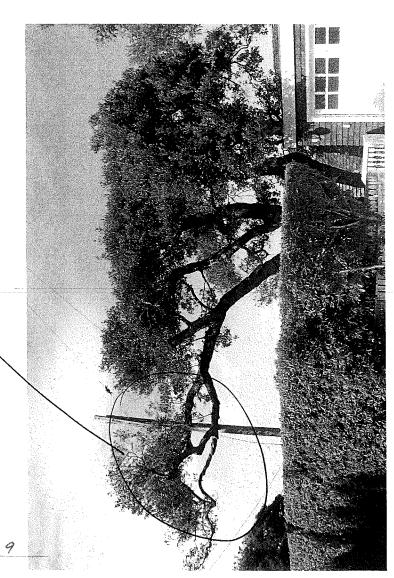
Itaning into pole

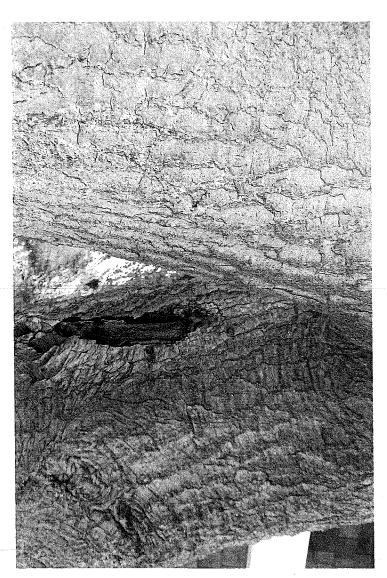
many cavarties visable indicates 1707 and unstable Structure

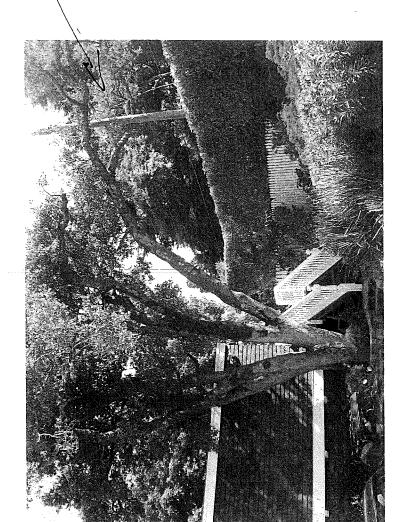
Oak planted in very small container. Thinning canopy indicates sever stress.

Thee is Iraning against power/savia pour.

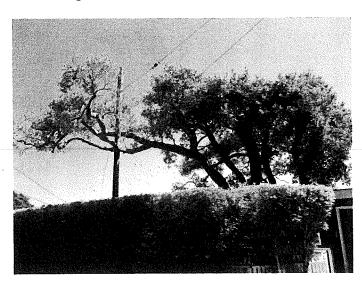
The tree is in fair health condition due to past severe topping of the crown and limited root space. One of the major limbs hangs over San Carlos Ave and is showing signs of decline. This branch is thin, with small discolored foliage and decay close to the point of attachment to the main trunk (See Picture 1). The remaining of the crown is full with green leaves of normal size.

Picture 1. Declining lateral branch hanging over San Carlos.

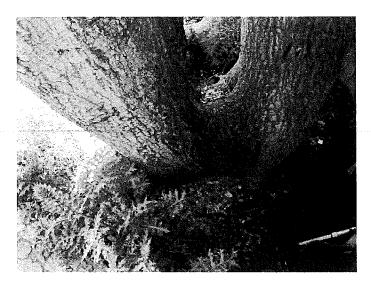
The root collar of the tree is buried and should be excavated to allow for inspection of insect and disease infestation, to detect the presence of girdling roots and to promote plant health (See Picture 3). Roots should be sampled and tested for Phytophthora root rot.

Picture 3. Root collar should be excavated to allow for inspection.

In my opinion, the root collar of the tree should be excavated and the roots should be tested for Phytophthora root rot before the decision is made as to whether or not the tree be removed.
