**Tree-Report**  
**Arboricultural Consultations**  
**c/o Dan McKenna**  
**P.O. Box 814**  
**Forest Knolls, CA 94933**  
**415 488-1621**  
**415 602-1621 (cell)**  
**dan@tree-report.com**

July 1, 2011

As requested, I have conducted a site evaluation for a mature *Quercus agrifolia* tree located at 122 San Carlos Dr. in Sausalito, CA. I conducted the site visit on June 30th at 7 AM and took field notes, conducted measurements, and photo documented the condition of the tree. I have also reviewed the City of Sausalito's Arborist Report authored by Mr. Juan Ochoa. I understand my report will be used in your efforts to obtain a tree removal permit from the City of Sausalito.

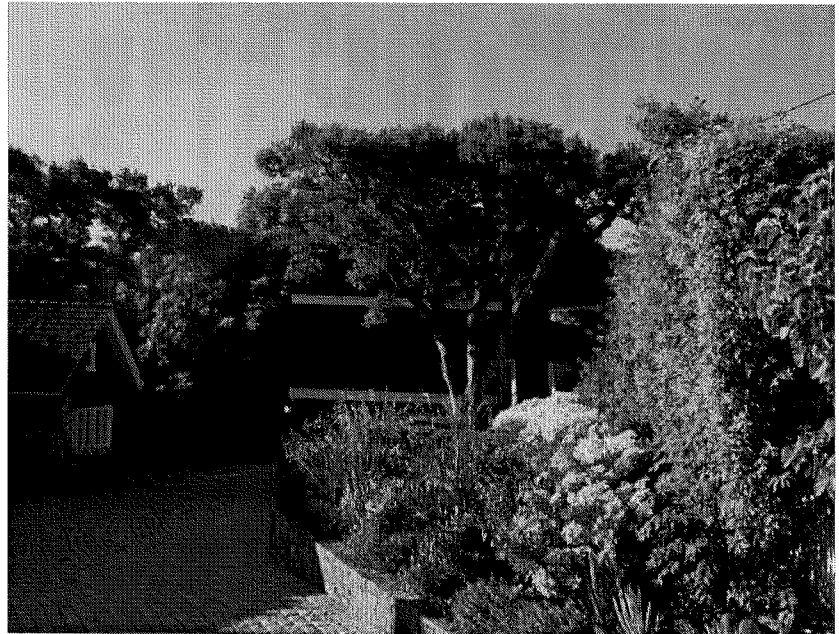
The subject tree is approximately 30' in height, with a spread of 40' and has two main stems (North stem is 31" in diameter and South stem is 23" in diameter). The tree as seen in the photo to the right is growing in a retaining wall planter and the root crown has been buried at some point in the past. The overall vigor of the tree is fair to poor with current annual shoot growth at approximately 2 to 3 inches. The long scaffold branch growing over the roadway has some die back and is showing signs of vascular failure possibly leading to an eventual total die back.

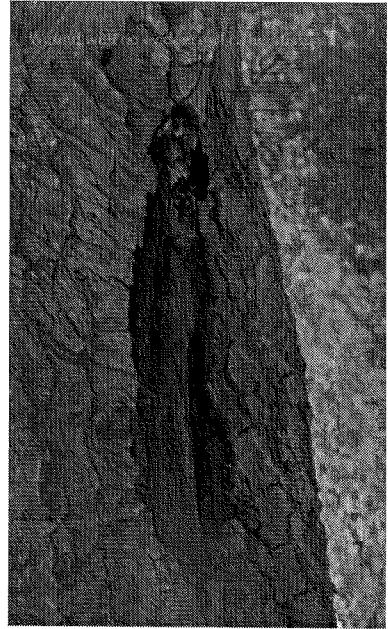
The lack of overall vigor might indicate a soil pathogen has infected the tree's vascular system as mentioned in the Ochoa report. The photo to the right shows a wound in the northern stem with no evidence of callous wood development. This is another sign of poor vigor and an overall state of decline.

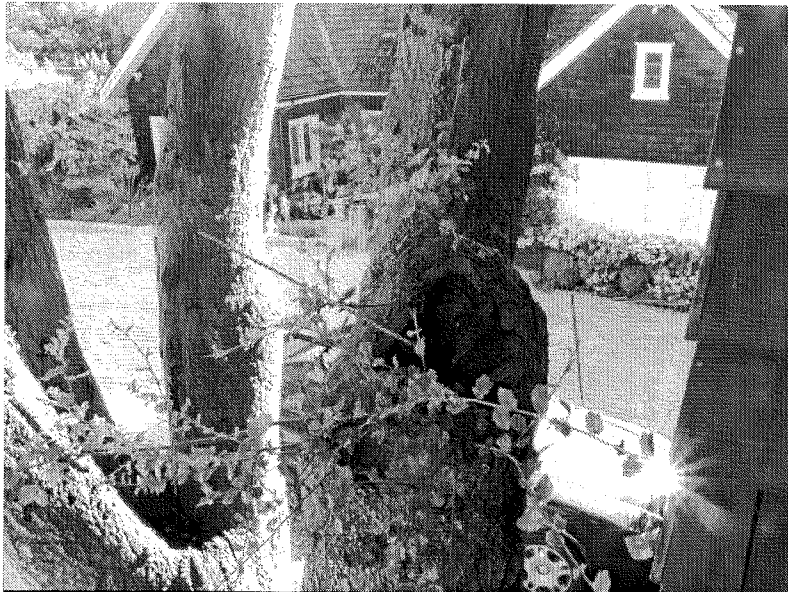
Since the Ochoa report was conducted for the City of Sausalito it is natural

that the report focuses on

stabilizing the declining branch over the roadway in order to protect general public safety. I too agree that this major scaffold branch should be removed, but my focus was also on the major defects on the branches over the private property. I believe these decay pockets to be significant, and do not believe that cabling alone can stabilize the tree.

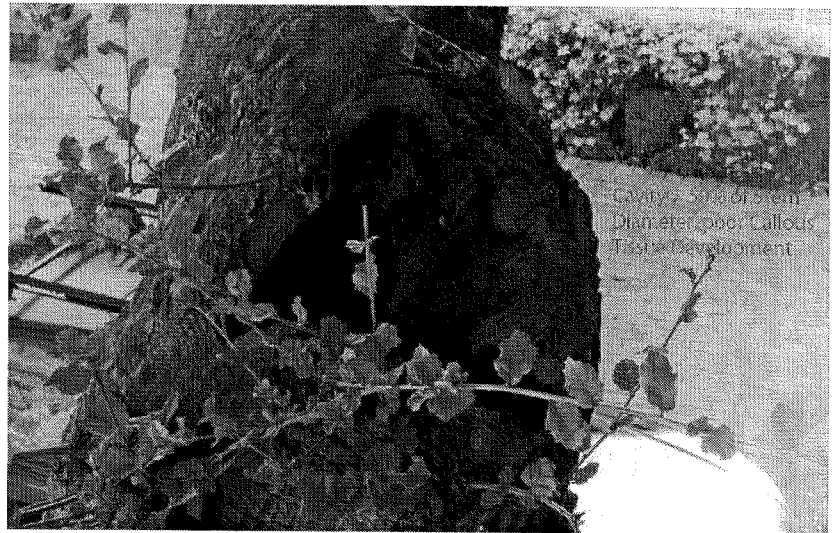
The only alternative would be a cable system, plus the installation of a bracing system that installs legs into the driveway and landscape planting areas. Custom fabricated steel legs would stabilize each stem and provide vertical support, while the more traditional cables would reduce torque associated with the poor canopy structure.

The downside to this solution is the area where the braces would have to be installed serves the occupants as a driveway into the lower garage area. The installation of braces would effectively change the use of the area.

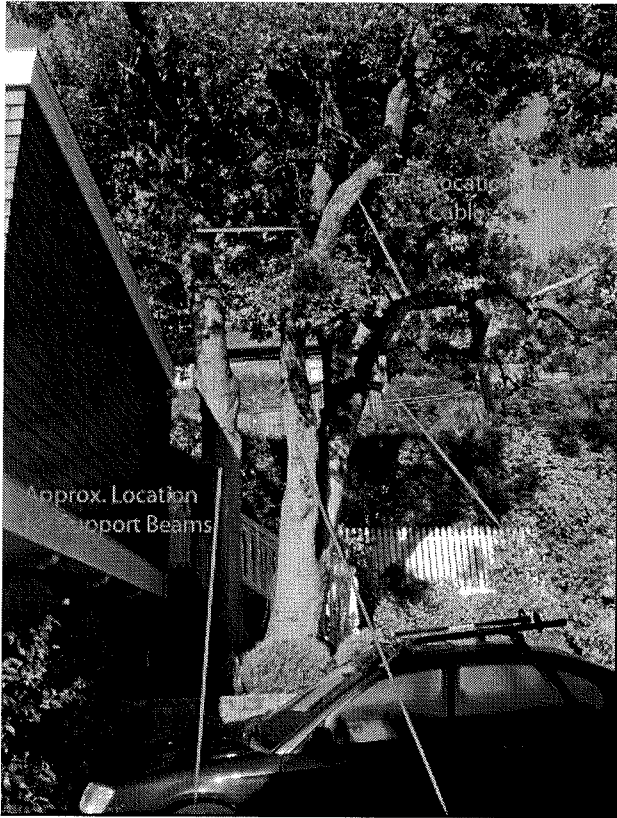
As the photo below describes the legs would displace the current use of the driveway. In addition, because of the close proximity of the adjoining garage, the location of the southern leg is not ideal in order to support the southern stem. Ideally, this leg would be positioned within the garage structure in order to effectively support the southern stem. In my view this is not a practical solution. This is especially significant since this stem has the most significant cavity (>50% of stem dia.) and poses the greatest hazard to the property.

Therefore, I would recommend that the tree be removed. I do not believe that extraordinary measures should be employed for a tree exhibiting signs of senescence that is
