DEPARTMENT OF PUBLIC WORKS
 TREE MAINTENANCE ACTIVITIES PERFORMED AND PENDING
 JULY 2011

BARTLETT TREE EXPERTS

RE: Black Acacia (*Acacia melanoxylon*) located at the intersection of Currey Ave, Platt Ave and Monte Mar Dr in Sausalito.

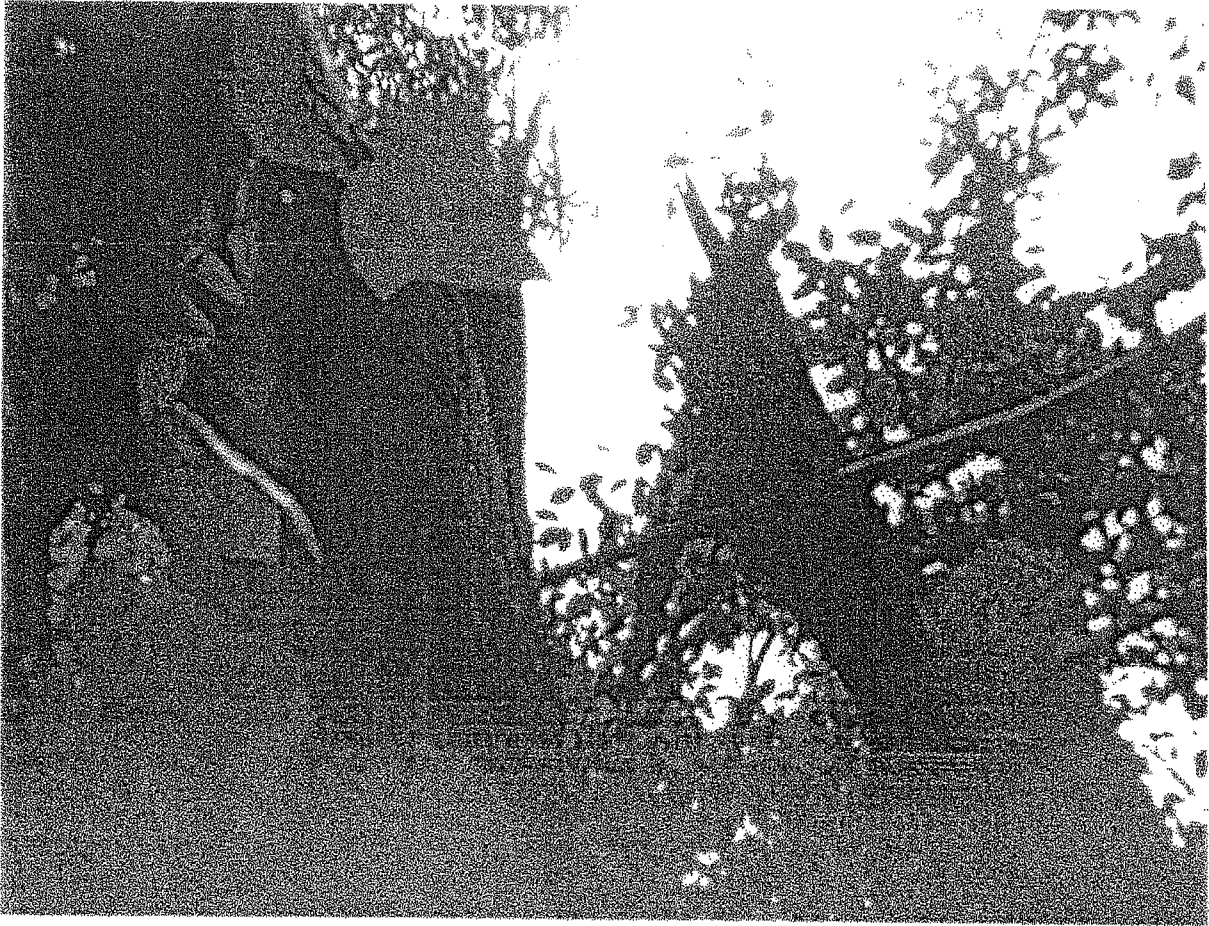
3

This situation causes numerous problems, such as tip die back and even total death of one of the leaders. When examining the leaders I noted that the plane in which several of the limbs emanate from and have tight crotches of greater than 60° which is ideal in the tree world. This species happens to be weak structurally in regards to where the limbs attach, which is a cause of limb failure. Photo #3 depicts a limb failure in the lower canopy.

Conclusion: I recommend that the tree be removed as soon as possible to prevent damage to the home below and the possibility of injury to persons or vehicles on the street. If the city does not act to remove the tree, then they will have to pay the cost of an accident or indemnify themselves.

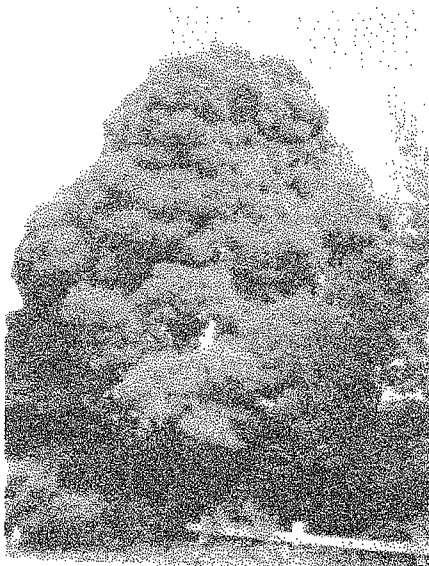
The current health condition of the tree is good, based on a visual inspection of the trunk, limbs and foliage. The canopy of the tree is full indicating good vigor (Picture 1).

Picture 1. *Acacia melanoxylon* at the intersection of Currey Ave, Platt Ave and Monte Mar Dr.

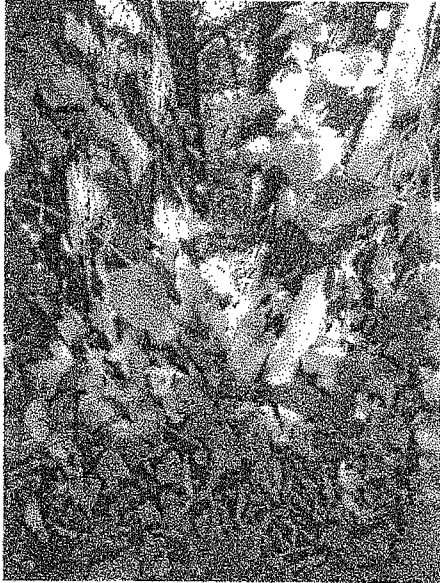
The tree has multiple trunks that seem to be sprouts from a stump of an old tree that was removed years ago. The root collar area will need to be exposed to allow for inspection to determine how safely attached these stems are at the base (Picture 2).

Picture 2. Soil and ivy from the base of the tree need to be clear to expose the root collar and allow for a better inspection.

The current condition of the tree does not allow for a proper safety inspection. Therefore, before a decision is made as to whether or not the tree be removed, I recommend that the root collar be exposed and that the tree be pruned according to the following specifications:

- Remove ivy growing from the bottom of the tree to the upper canopy.
- Clean to remove dead and broken branches that are 2 inches in diameter and larger throughout crown.
- Thoroughly inspect crotches to determine the presence of included bark.

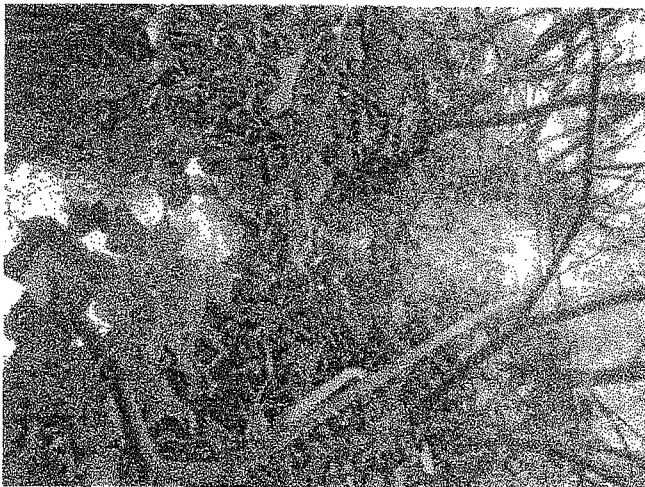
There are dead and broken branches that have accumulated in the crown of the tree as well as dense ivy that has grown from the base of the tree, along the trunks to the upper canopy that should be removed (Picture 3).

Picture 3. Ivy, dead and broken branches should be removed to allow for a better inspection of the tree.

Exposing the root collar and removing dead and broken branches will allow for a much better inspection of the safety condition of the Acacia. If after these procedures are performed and if structural defects are considered a hazard, the tree should be removed to eliminate the risk of failure.
