DEPARTMENT OF PUBLIC WORKS  
 TREE MAINTENANCE ACTIVITIES PERFORMED AND PENDING  
 AUGUST 2011

Arborist Report, Monterey Pine Tree, Spencer & Miller Avenue, Sausalito, CA.  
Prepared by Ed Gurka Independent Services, San Rafael, California

## View Obstruction Arborist Report 81 Cazneau Avenue, Sausalito, CA

View Obstruction Arborist Report  
141 Santa Rosa Avenue  
Sausalito, CA

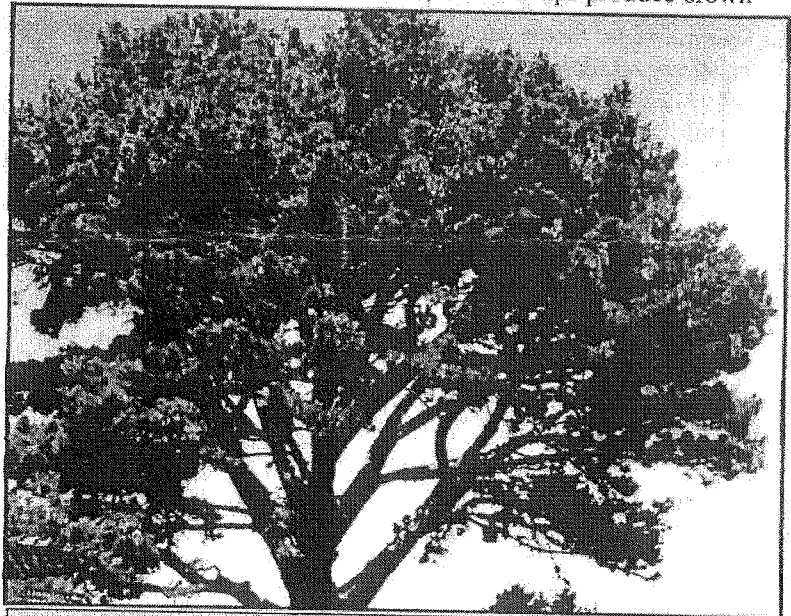
The Monterey Pine canopy inspection noted that there is tip dieback of terminal growth points throughout the upper canopy. In other limb tips, where smaller branches terminate, there appeared brown foliage, described as needles that result in bare limb tip branches indicating a condition described as "dieback." This condition appears randomly throughout the canopy.

This dieback of branch tips and needle browning is a sign of Pine Pitch Canker, a fungal disease that most commonly occurs through wounding from pruning cuts or insect attacks.

Brown needles on Pine branch tips. 11.19.2010

This Monterey Pine tree is in a stressed condition that has compromised its defense mechanisms. This is exhibited by the symptoms identified and discussed in this report. The tree will continue to decline and will be determined by factors such as continued beetle attacks, advancement of the fungal disease and climate conditions. There are multiple high value risk targets present in the failure path from falling branches and debris from the tree. A heavy pinecone production will also add to the debris produced by the tree. These events will increase with frequency as the tree declines and risk associated within the fall path must be evaluated by the City if the tree is on public right of way. The recommendation, based on these discovered findings from the site inspection, is that the tree should be removed to eliminate the risk.

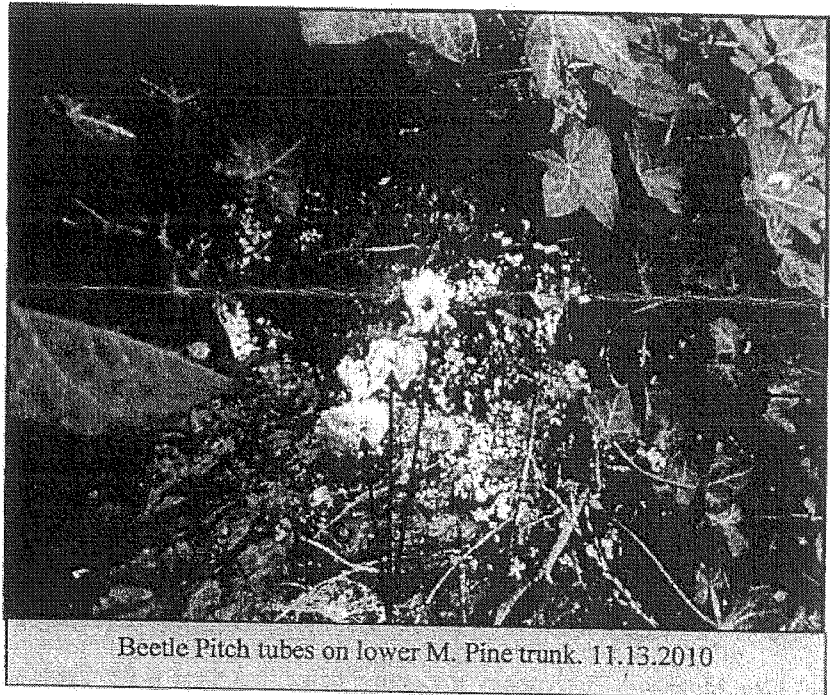
Pruning cuts performed during the growing season produce a sap pitch attracting pine beetles that are also active during the late spring, summer, and early fall months of the year. Since Pine Pitch Canker was noted during the time of visual inspection, the lower trunk area was examined for the presence of *Dendroctonus valens*, Red Turpentine Beetle. This beetle attacks the lower base of Pine trunks and exposed roots just below the soil surface. The Red Turpentine Beetle was detected in multiple locations on every side of the lower tree trunk. The beetle produces pitch tubes visible on the outer bark illustrated in the photograph from just one location on the lower trunk of this pine tree.

Beetle Pitch tubes on lower M. Pine trunk. 11.13.2010

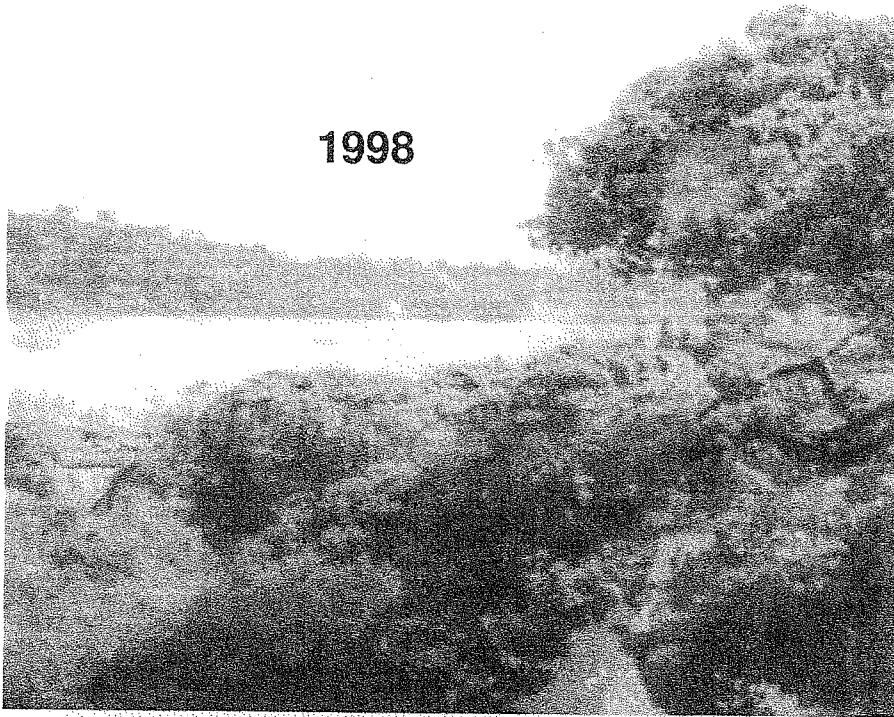
On the next page are two photographs showing the views from the Wells living room that were present in 1998 and in 2011. The approximate line of proposed pruning is shown on the 2011 photo in red.

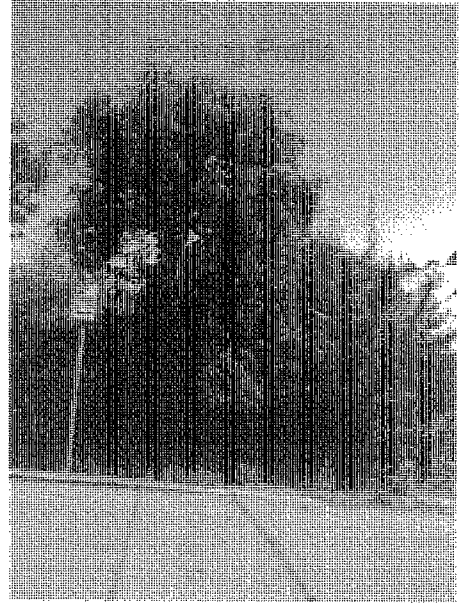
Description and reasons for alteration. Ms. Wells proposes to prune one coast live oak downslope of her property to restore a documented, pre-existing view of Richardson Bay and Sausalito Yacht Harbor from her living room. Approximately 2-4 feet of the upper canopy would be pruned per American National Standards Institute (ANSI A300) pruning standards. See pruning profile in photo at right.

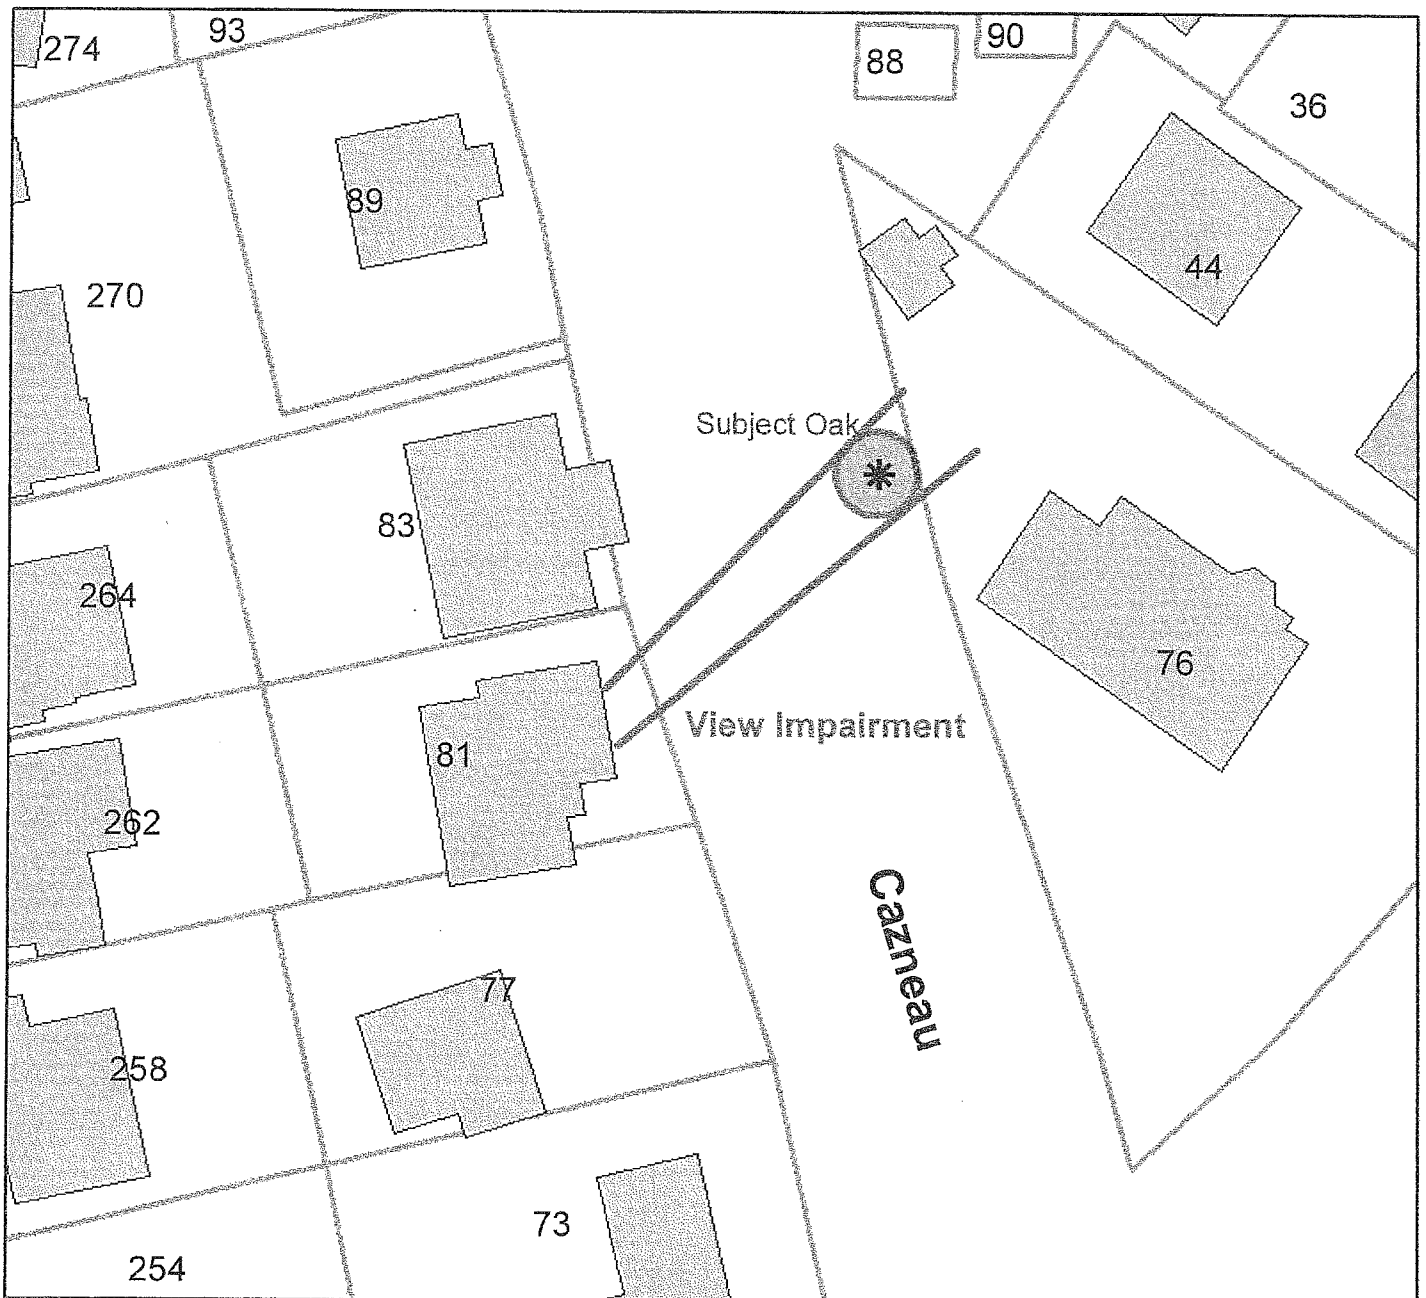
Site Map for Pruning Application  
 81 Cazneau Avenue  
 Sausalito, CA

Tree	Species	CBH (in)	DBH (in)	Height (ft)	Value
Subject Oak	Quercus agrifolia	37.7	12.0	16	\$3,000

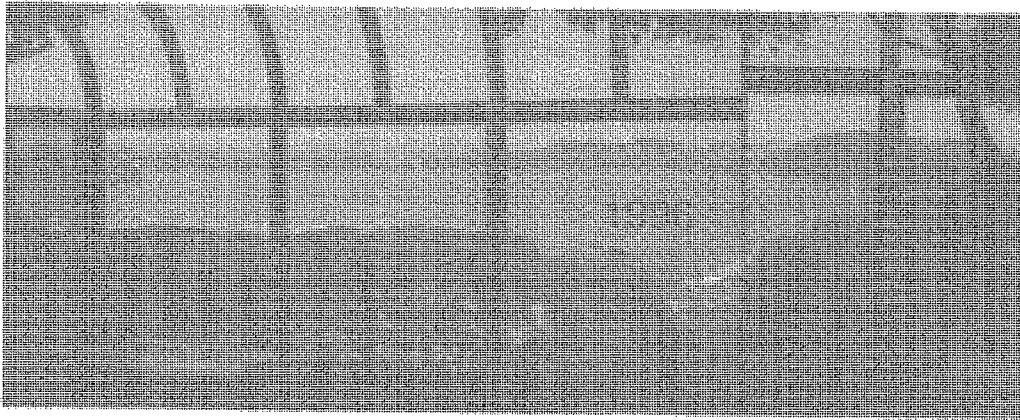
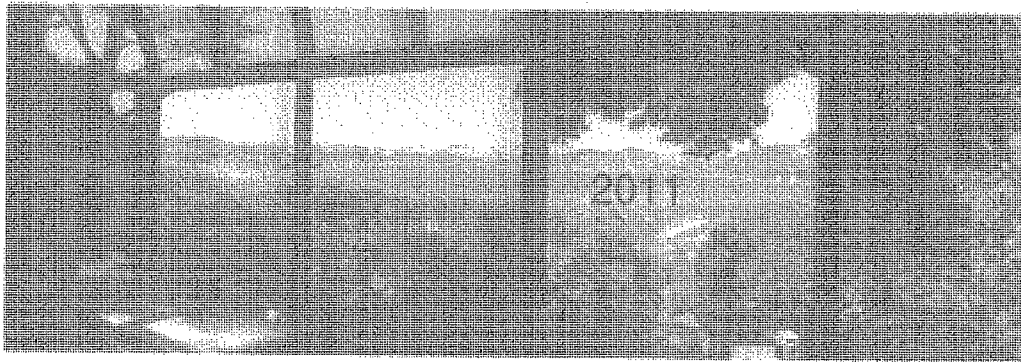
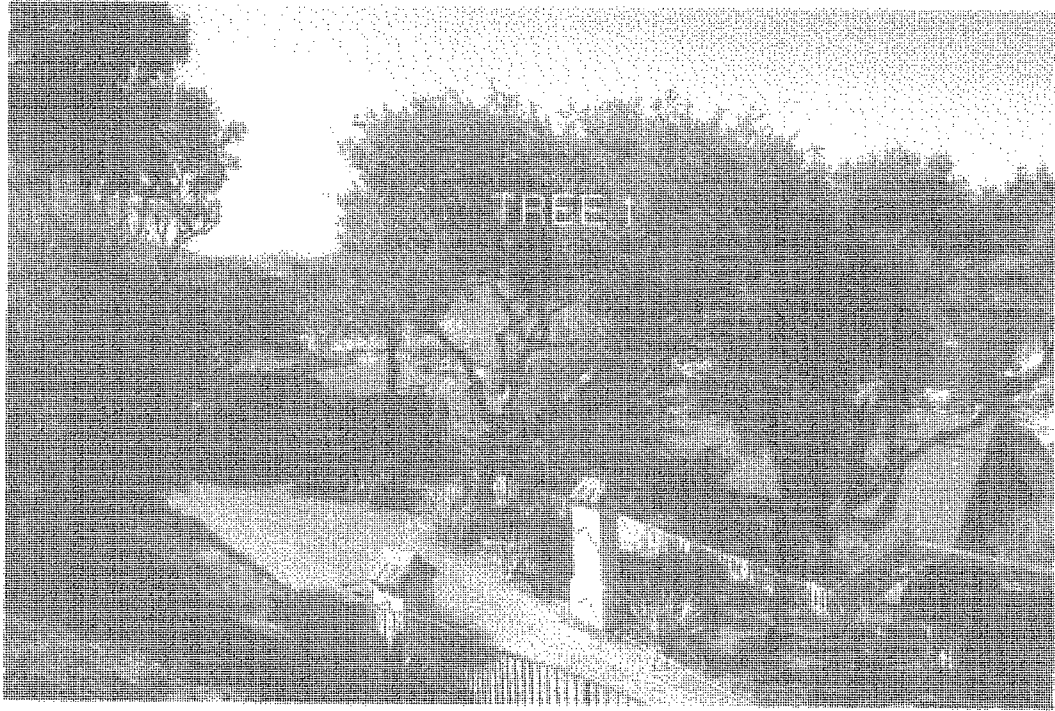
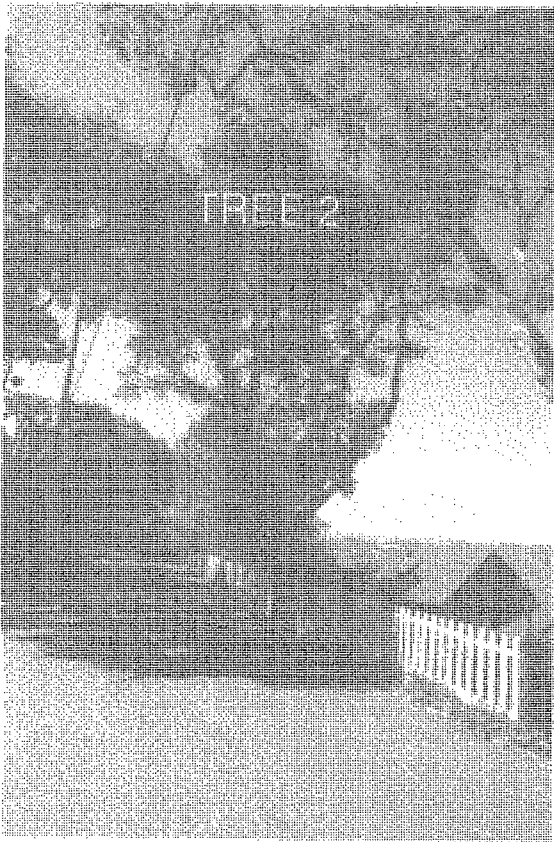
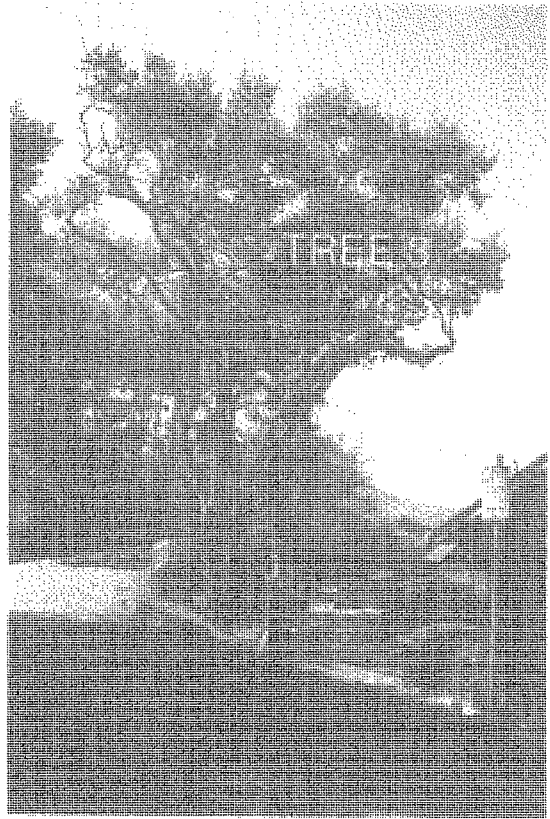
Below are two photographs showing the view from the Skunda sun room that were present in 1996 and in 2011. Also included are ground photographs of the four subject trees for which pruning is requested.

Suggestions for improving the health of the tree, such as improving root or soil conditions beneath the tree. I have no recommendations for improving the health of the subject trees. All three trees show no symptoms of sudden oak death (*Phytophthora ramorum*) and are growing under stable soil conditions. Tree #3 has incipient trunk decay that warrants regular safety inspections.

Description and reasons for alteration. Mr. Skunda proposes to maintain three coast live oaks downslope of his property to restore pre-existing views of Strawberry Point, Richardson Bay, and the Tiburon Peninsula from his sun and living rooms. Approximately 2-4 feet of the upper canopies will be pruned per American National Standards Institute (ANSI A300) pruning standards.

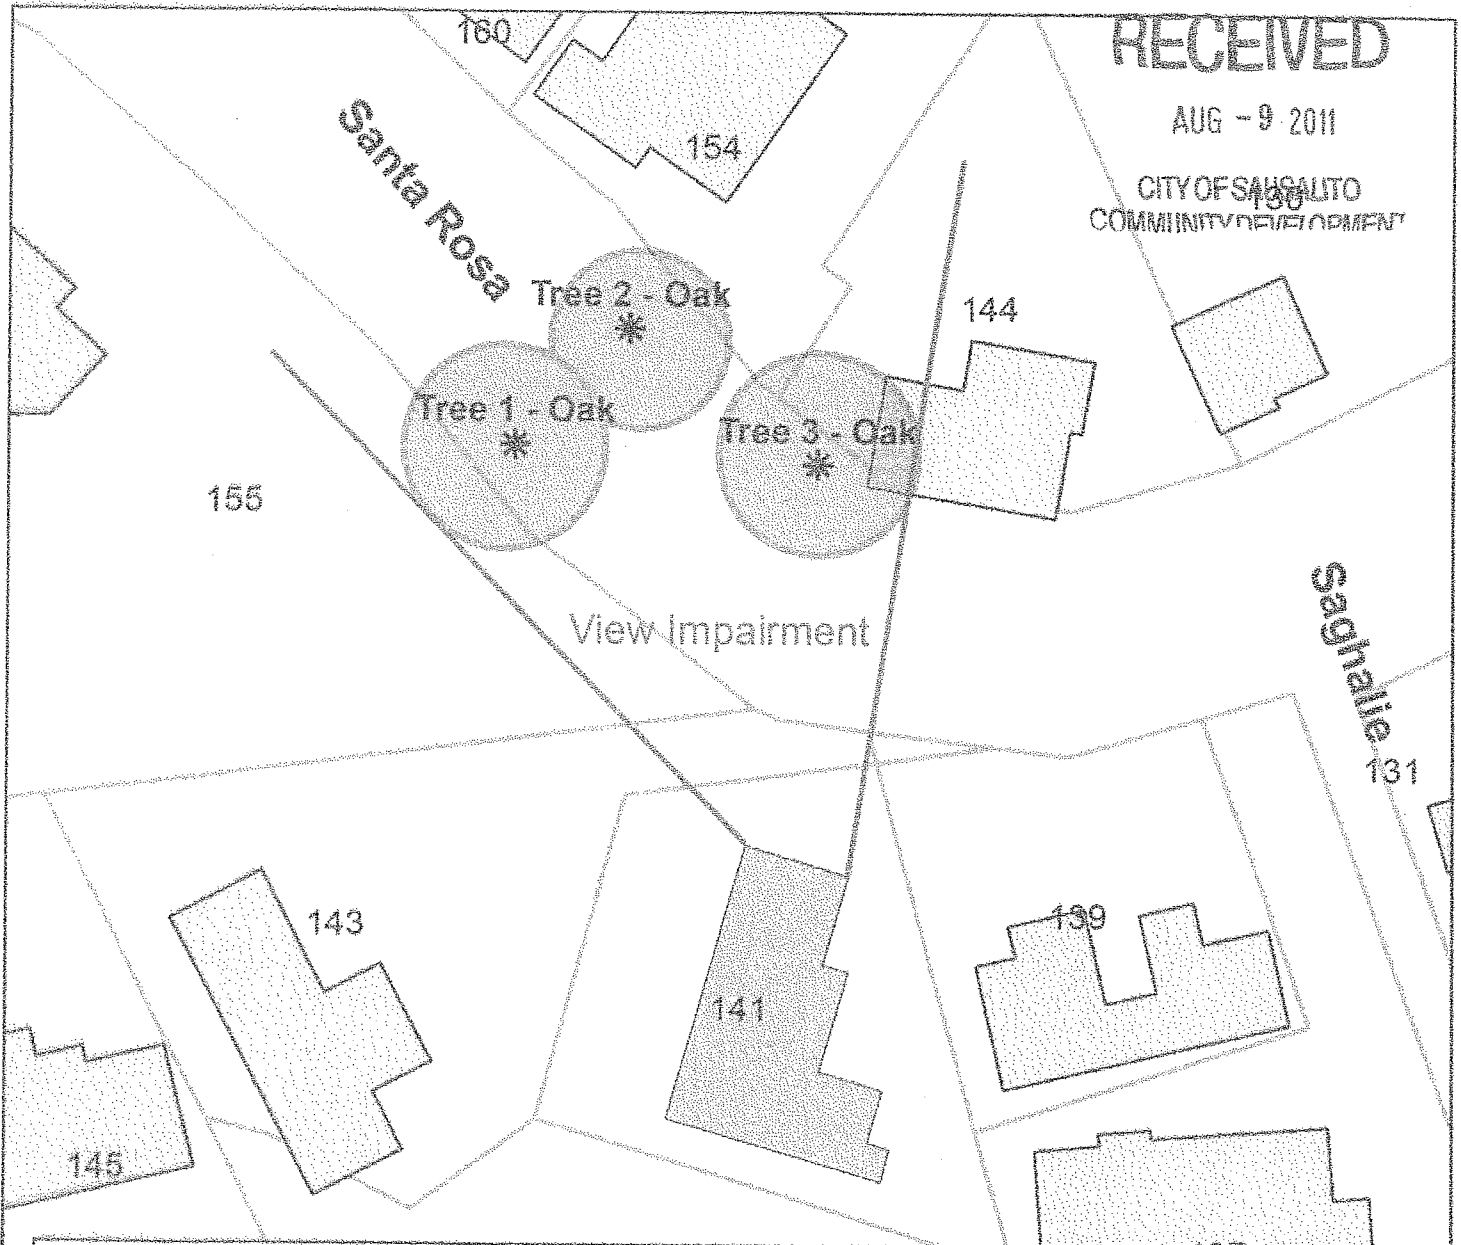
Site Map for Pruning Application  
 141 Santa Rosa Avenue  
 Sausalito, CA

Tree #	Species	CBH (in)	DBH (in)	Height (ft)	Value
1	<i>Quercus agrifolia</i>	57.2	18.2	35	\$ 8,000
2	<i>Quercus agrifolia</i>	61.6	19.6	40	\$ 8,800
3	<i>Quercus agrifolia</i>	96.8	30.8	48	\$ 17,900
