August 1, 2011

ASSIGNMENT:

A request to provide an Arborist Report for Stefan Hastrup, Turnbull Griffen & Haeslopp and Daphane Edwards, MLA, for the Collier Reynolds Residence located at 2-2 $\frac{1}{2}$ Bulkley Avenue construction project. Plants scheduled for removal, and replacement are located on public right of way and private property locations. The proposed removals will include replacement of landscape plants with plants suitable to the designated location. This report will provide information on trees within the front yard area and make recommendations for future construction plans.

Arborist Report 2 Bulkley Avenue, Sausalito, CA
Prepared by Ed Gurka, Independent Services, San Rafael, California

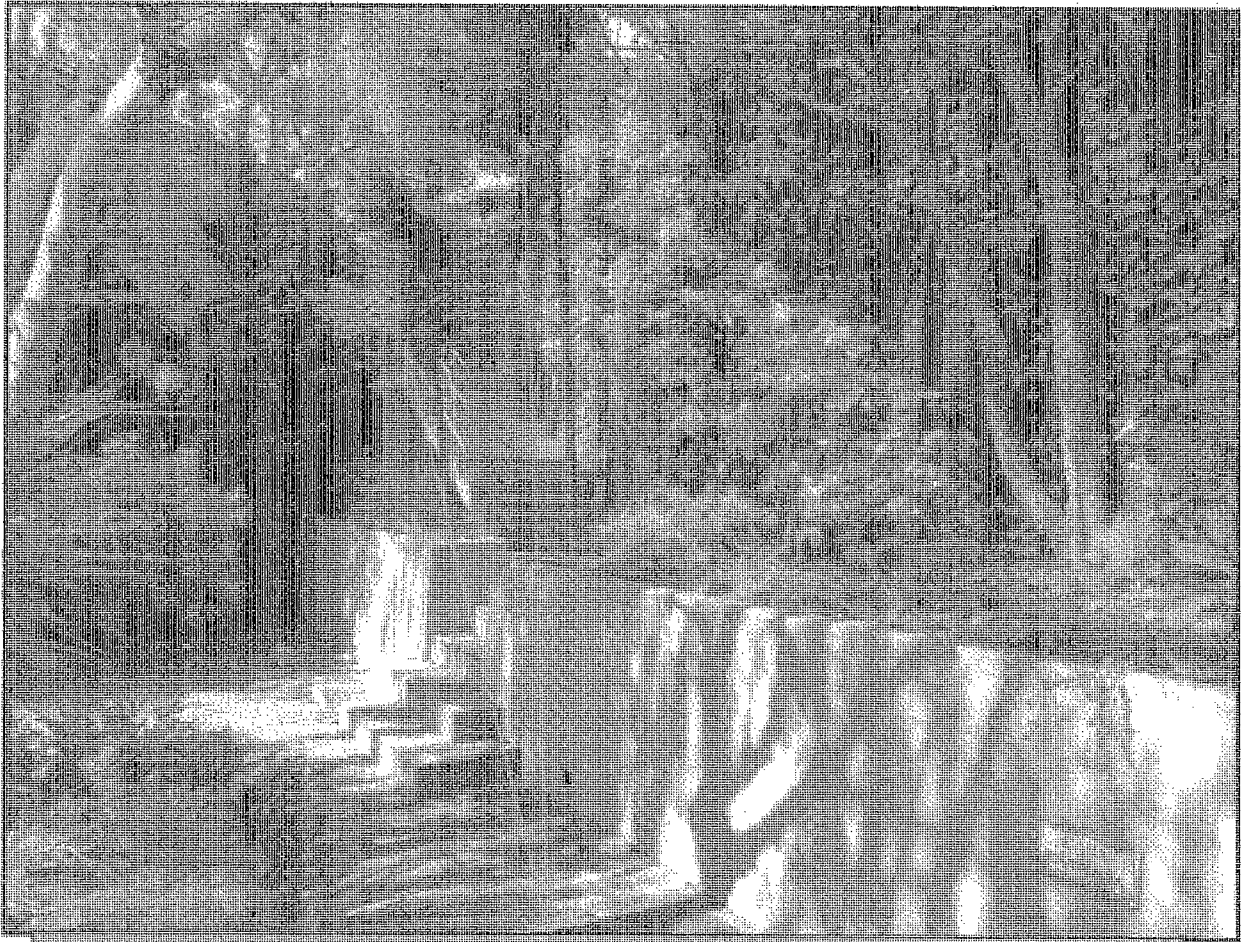
- #1, *Chamaecyparis*, False Cypress, Arborvitae. CBH (Circumference at Breast Height) 5.7 inches, located 57 inches from retaining wall in raised planter bed between the courtyard and retaining wall. Photograph page 3.

- #2 *Chamaecyparis*, False Cypress, Arborvitae. CBH 2.3 inches, located opposite tree #1 in raised planter bed between the courtyard and retaining wall. Photograph page 3.

Trees #1 & 2, *Chamaecyparis, obtuse* on either side of stairway recommended for removal.

Chamaecyparis trees 1 and 2, removal is recommended. The location in a very constricted space for a tree of this size roots will soon damage the planter and retaining wall if not removed. This planter is 5 feet wide and appropriate plants for this location are small shrubs, small perennial plants.

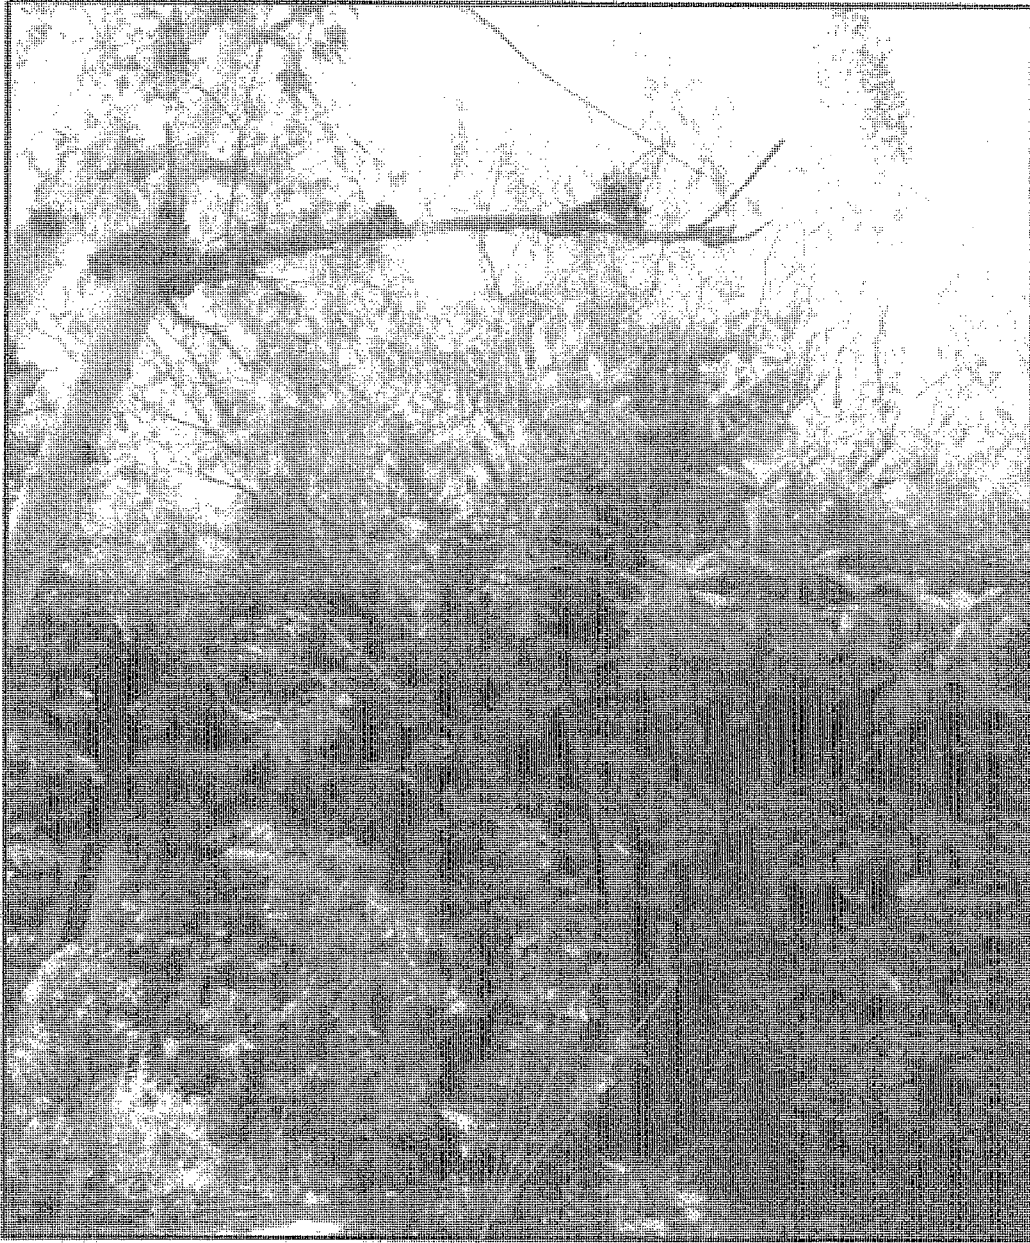
- #3 *Magnolia, soulangiana*, CBH 2.4, 1.2, 1.3 feet and 8.2 inches. The tree's height is 18 feet. The tree consists of four stems originating at the base of the tree. The tree placement is directly against the retaining wall and 43 inches from the outer edge. Upper canopy branches are defoliated on alternate branch tips. The bare branch tips indicate a root problem from the restricted space location. Photograph page 4.

Tree #3, a multi stem Magnolia against the retaining wall is recommended for removal.

Trees #3 and #4, *Magnolia* and *Acer palmatum* both located in the public right of way area of the landscape are recommended for removal. The planter bed size cannot contain the root system of these trees. When they mature the root confinement will crack the retaining wall requiring extensive repair work and this wall supports Bulkley Avenue directly 6 feet above the patio. The retaining wall and planter is the only buffer to Bulkley Avenue. The separation is now visible in the lower section of the wall nearest the *Acer* tree along the outer planter wall. Replacing the removed trees is not advised. Planting even a small tree would eventually require removal when roots conflict with the retaining wall. The narrow shallow planter is only suitable for small shrubs or annual perennial flower plants such as *Santolina*, *Erigeron*, or *Nandina*.

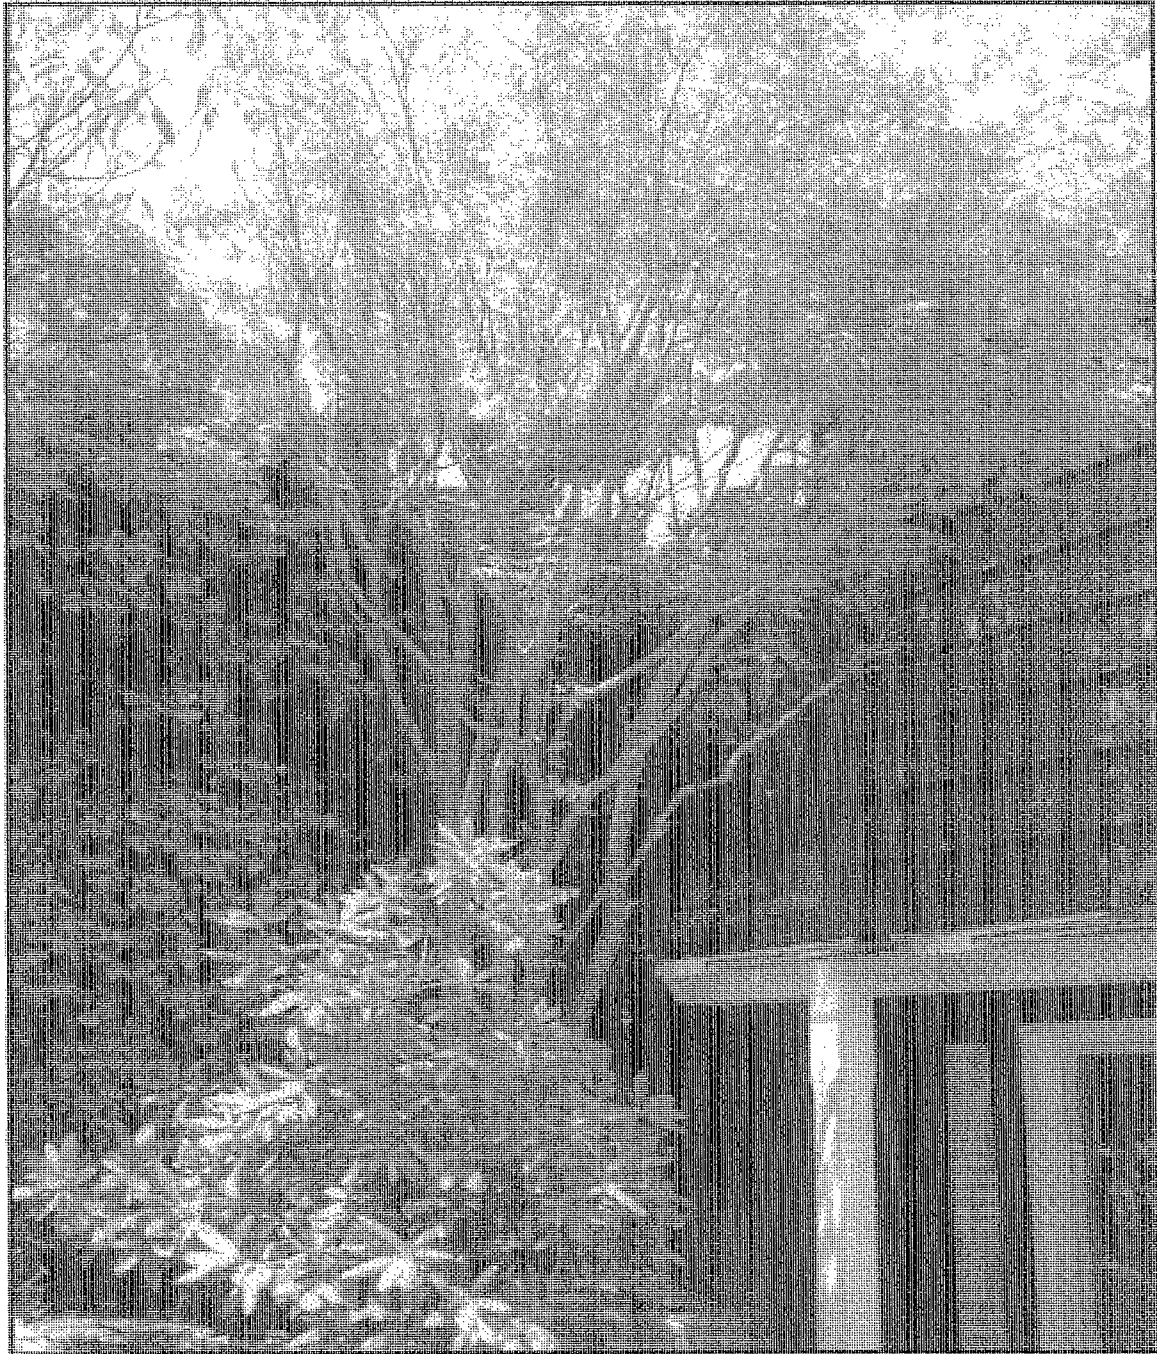
- #4 *Acer palmatum*, Japanese Maple, CBH 4.5, 4, 1.5, and 7 inches. This is a young multi-stem Maple tree with three upright stems originating at the base of the tree. It has a height of 18 feet. Photograph page 5.

Acer palmatum, Japanese Maple tree # 4, in outdoor planter with roots affecting planter bed wall

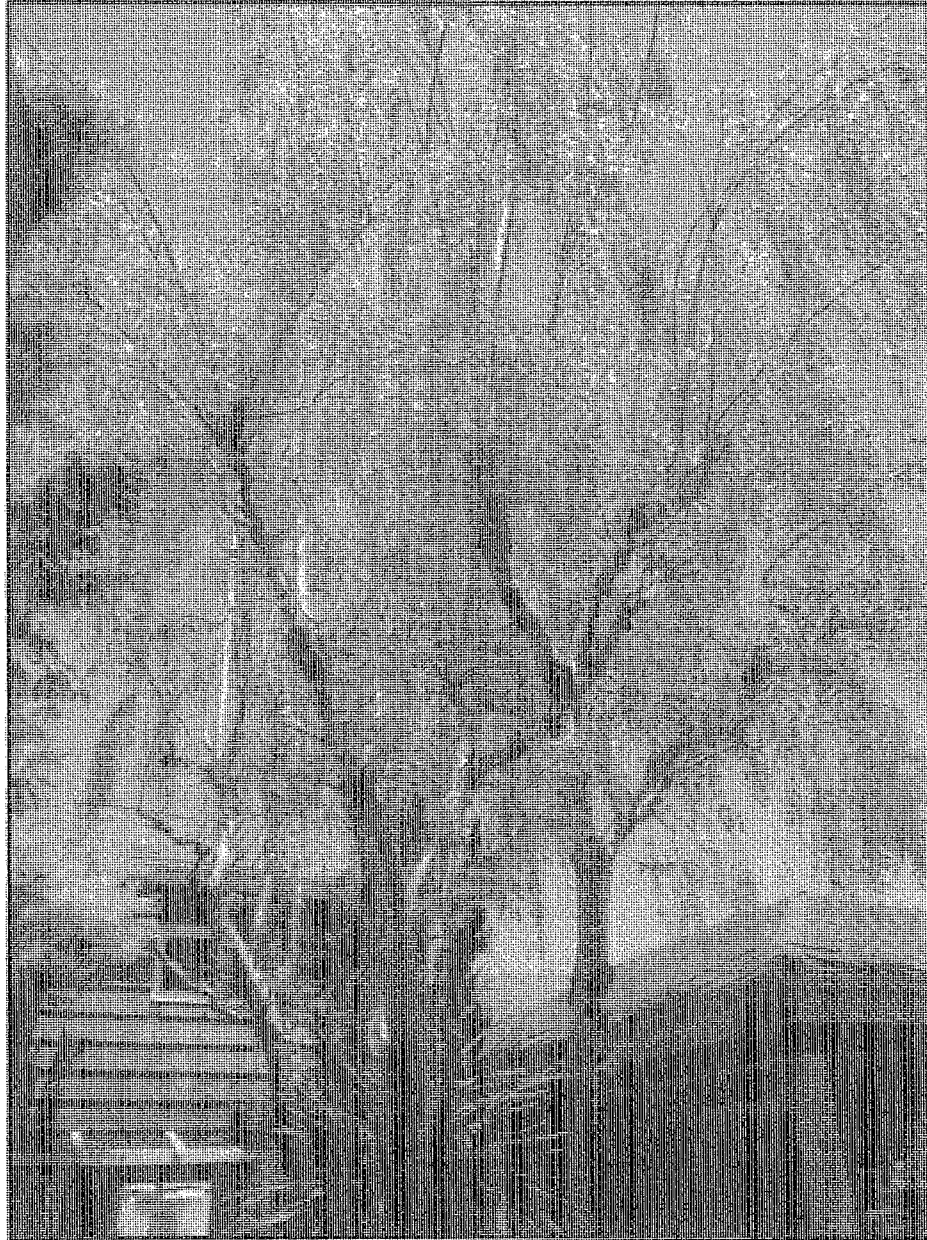
- **#5 *Betula pendula*, European White Birch.** The tree consists of three upright stems originating at the trunk base. The complete CBH is 1.9, 1.6 feet and 8 inches. This equals 50 inches. The tree is a non-native species and native to summer rainy climates. It does not perform well in California climates due to the lack of summer rainfall. The upper canopy exhibits branch tip dieback associated with root problems. The dieback can be attributed to the climate conditions. Condition is rated as fair to poor. See photograph page 6

- **#6 *Betula pendula*, European White Birch.** This tree is directly next to Birch number 5 in the courtyard. CBH is two, and 1.7 feet total CBH is 44 inches. Condition is rated as fair to poor. See Photograph page 6.

#5 and #6 two Betula trees in front courtyard of property in fair to poor condition. Recommendation is for replacement with a more suitable species for a Sausalito climate and a lower height when mature to accommodate views from neighboring properties.

Trees #5 and #6, the two Birch trees are recommended for removal and replacement with species more adaptable to a Sausalito climate. They are rated as fair to poor condition and maintaining them to fit the climate and conditions is difficult and would eventually require removal. *Betula* species are best suited in a climate with abundant rainfall throughout the year and best suited for riparian locations. Selection of a more suitable feature tree such as *Magnolia soulangiana* Saucer Magnolia, twelve species listed in *Western Gardening*, *Magnolia stellata* Star Magnolia, seven varieties, *Cercis occidentalis*, Western Red Bud, *Arbutus unedo*, Strawberry tree, or *Prunus yedoensis*, Flowering Cherry are species that provide features such as red color trunk, spring flowers, or fall color. All are deciduous with the exception of *Arbutus* species that are evergreen. These choices require less maintenance and are most adaptable to the climate and location. If removal is granted, the selections are an opportunity for a replacement tree that will not block neighboring views or require topping to reduce height.

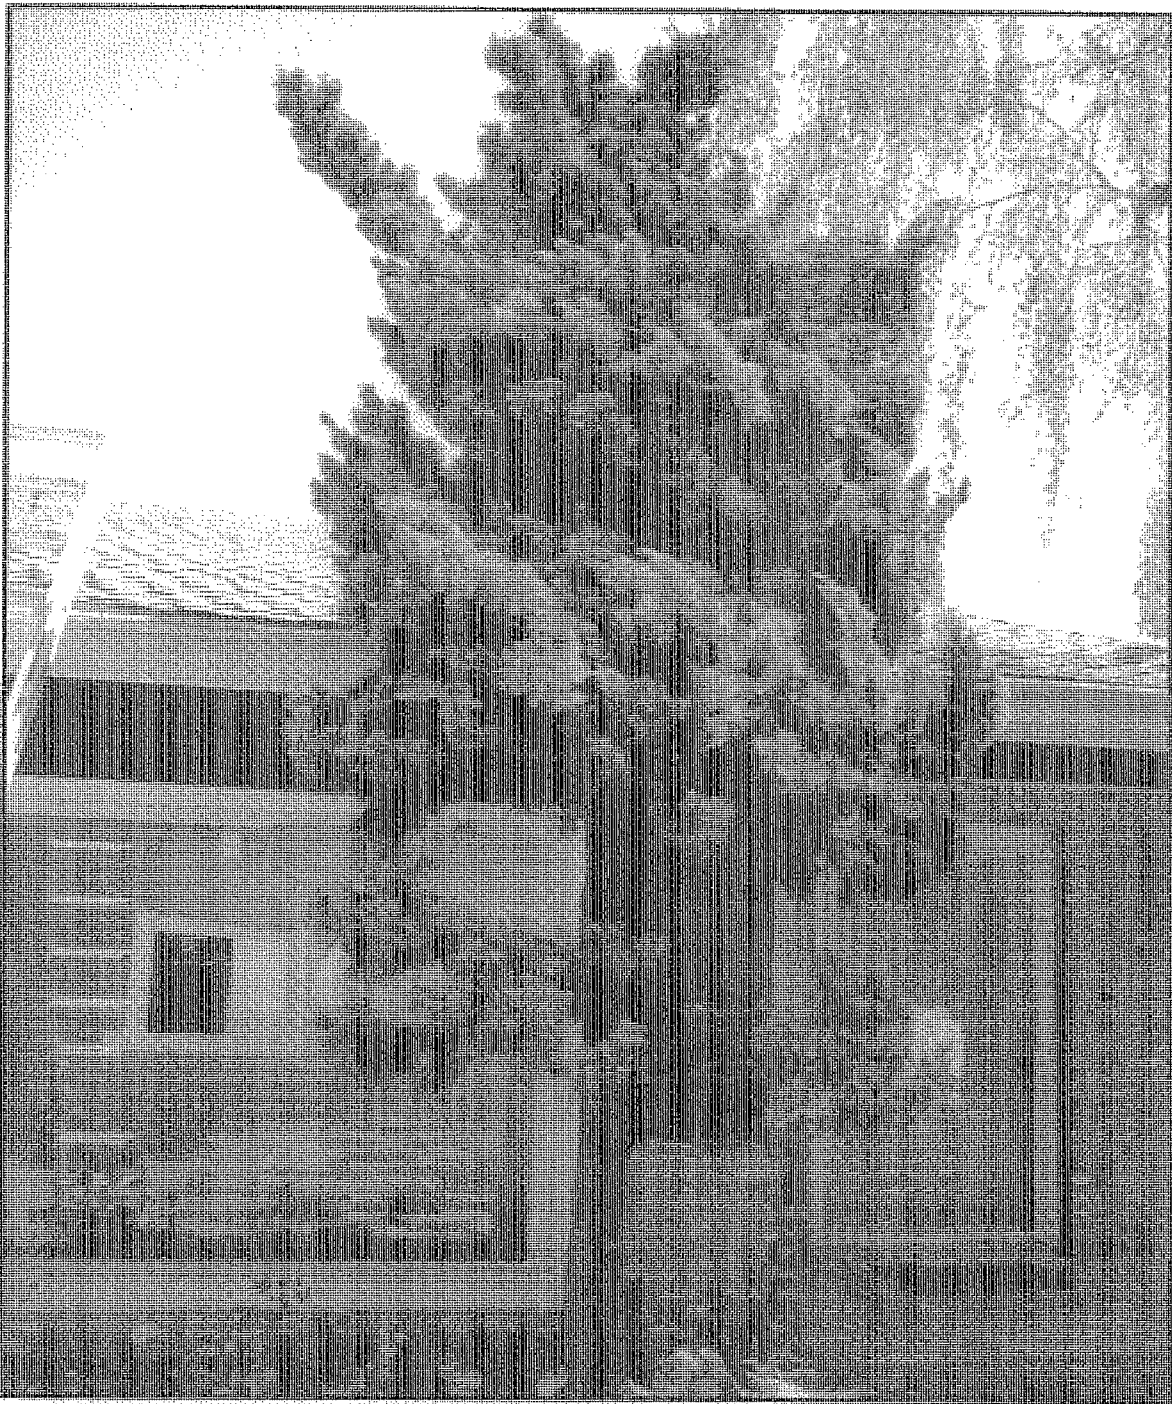
- **#7 *Chamaecyparis, obtusea*, Arborvitae. Cypress.** This tree is located 30 inches from the front wall of the home. CBH is 1.5 feet. This tree species and its varieties are native and non-native to California. The tree is in good condition and pruned to be displayed as a feature tree. See photograph on page 7.

Architect plans indicate front wall extension that is within the area of existing Cypress tree # 7.

Tree # 7 *Chamaecyparis obtuse* is recommended for removal. The tree is within the area if the front wall expansion a direct conflict with the building construction plans. The replacement of courtyard patio trees is suggested as the alternative to replacing this tree.

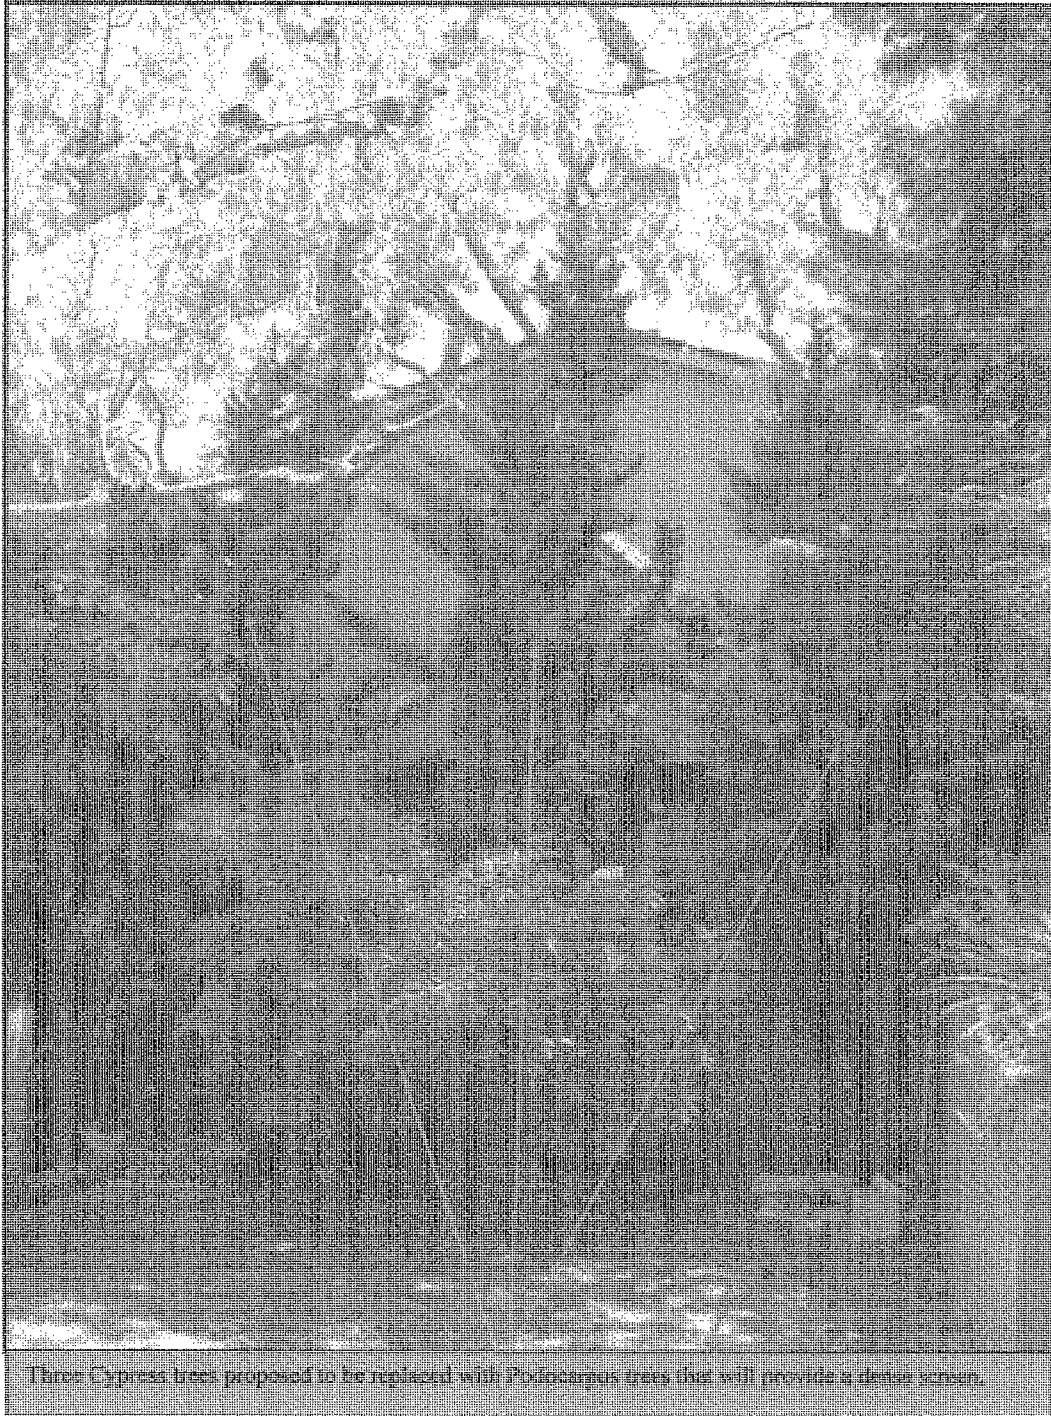
- **#8, 9, 10, Three *Chamaecyparis*, False Cypress, Arborvitae.** These trees form a screen between 2 Bulkley Avenue front yard and the neighboring property to the south. These three trees are in good condition. See photograph on page 8 of this report.

Three Cypress trees proposed to be replaced with Podocarpus trees that will provide a denser canopy.

Trees 8, 9, and 10, *Chamaecyparis, obtusa*, are planned as removals and replacement with *Podocarpus* species that form a denser screening at maturity. The recommendation is that the existing three *Chamaecyparis* trees planned for removal are replaced with four replacements to form the screen between 2 Bulkley Avenue and the neighboring property just to the south.
