DEPARTMENT OF PUBLIC WORKS
 TREE MAINTENANCE ACTIVITIES PERFORMED AND PENDING
 SEPTEMBER 2011

Tree Maintenance Activities September 22, 2011

Arborist Report, Monterey Pine Tree, Spencer & Miller Avenue, Sausalito, CA.
Prepared by Ed Gurka Independent Services, San Rafael, California

Arborist Report 2 Bulkley Avenue, Sausalito, CA
 Prepared by Ed Gurka, Independent Services, San Rafael, California

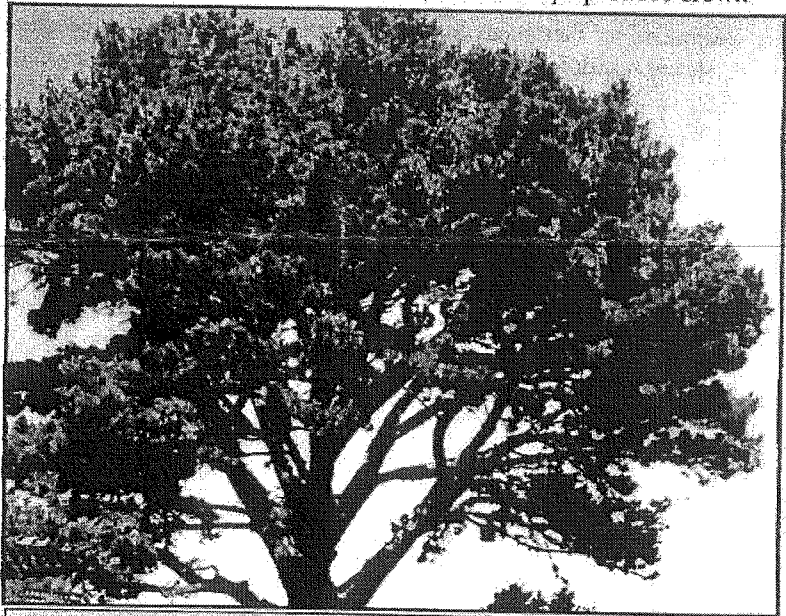
The Monterey Pine canopy inspection noted that there is tip dieback of terminal growth points throughout the upper canopy. In other limb tips, where smaller branches terminate, there appeared brown foliage, described as brown needle coloration. It is very possible that the two conditions are related. First, the limb tips produce brown needles that result in bare limb tip branches indicating a condition described as "dieback." This condition appears randomly throughout the canopy.

This dieback of branch tips and needle browning is a sign of Pine Pitch Canker, a fungal disease that most commonly occurs through wounding from pruning cuts or insect attacks.

Brown needles on Pine branch tips. 11.19.2010

This Monterey Pine tree is in a stressed condition that has compromised its defense mechanisms. This is exhibited by the symptoms identified and discussed in this report. The tree will continue to decline and will be determined by factors such as continued beetle attacks, advancement of the fungal disease and climate conditions. There are multiple high value risk targets present in the failure path from falling branches and debris from the tree. A heavy pinecone production will also add to the debris produced by the tree. These events will increase with frequency as the tree declines and risk associated within the fall path must be evaluated by the City if the tree is on public right of way. The recommendation, based on these discovered findings from the site inspection, is that the tree should be removed to eliminate the risk.

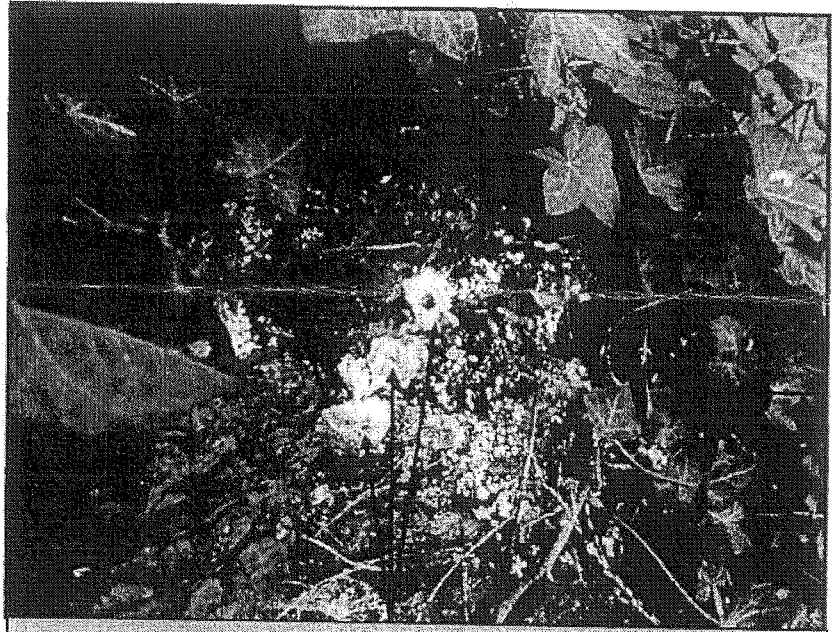
Pruning cuts performed during the growing season produce a sap pitch attracting pine beetles that are also active during the late spring, summer, and early fall months of the year. Since Pine Pitch Canker was noted during the time of visual inspection, the lower trunk area was examined for the presence of *Dendroctonus valens*, Red Turpentine Beetle. This beetle attacks the lower base of Pine trunks and exposed roots just below the soil surface. The Red Turpentine Beetle was detected in multiple locations on every side of the lower tree trunk. The beetle produces pitch tubes visible on the outer bark illustrated in the photograph from just one location on the lower trunk of this pine tree.

Beetle Pitch tubes on lower M. Pine trunk. 11.13.2010

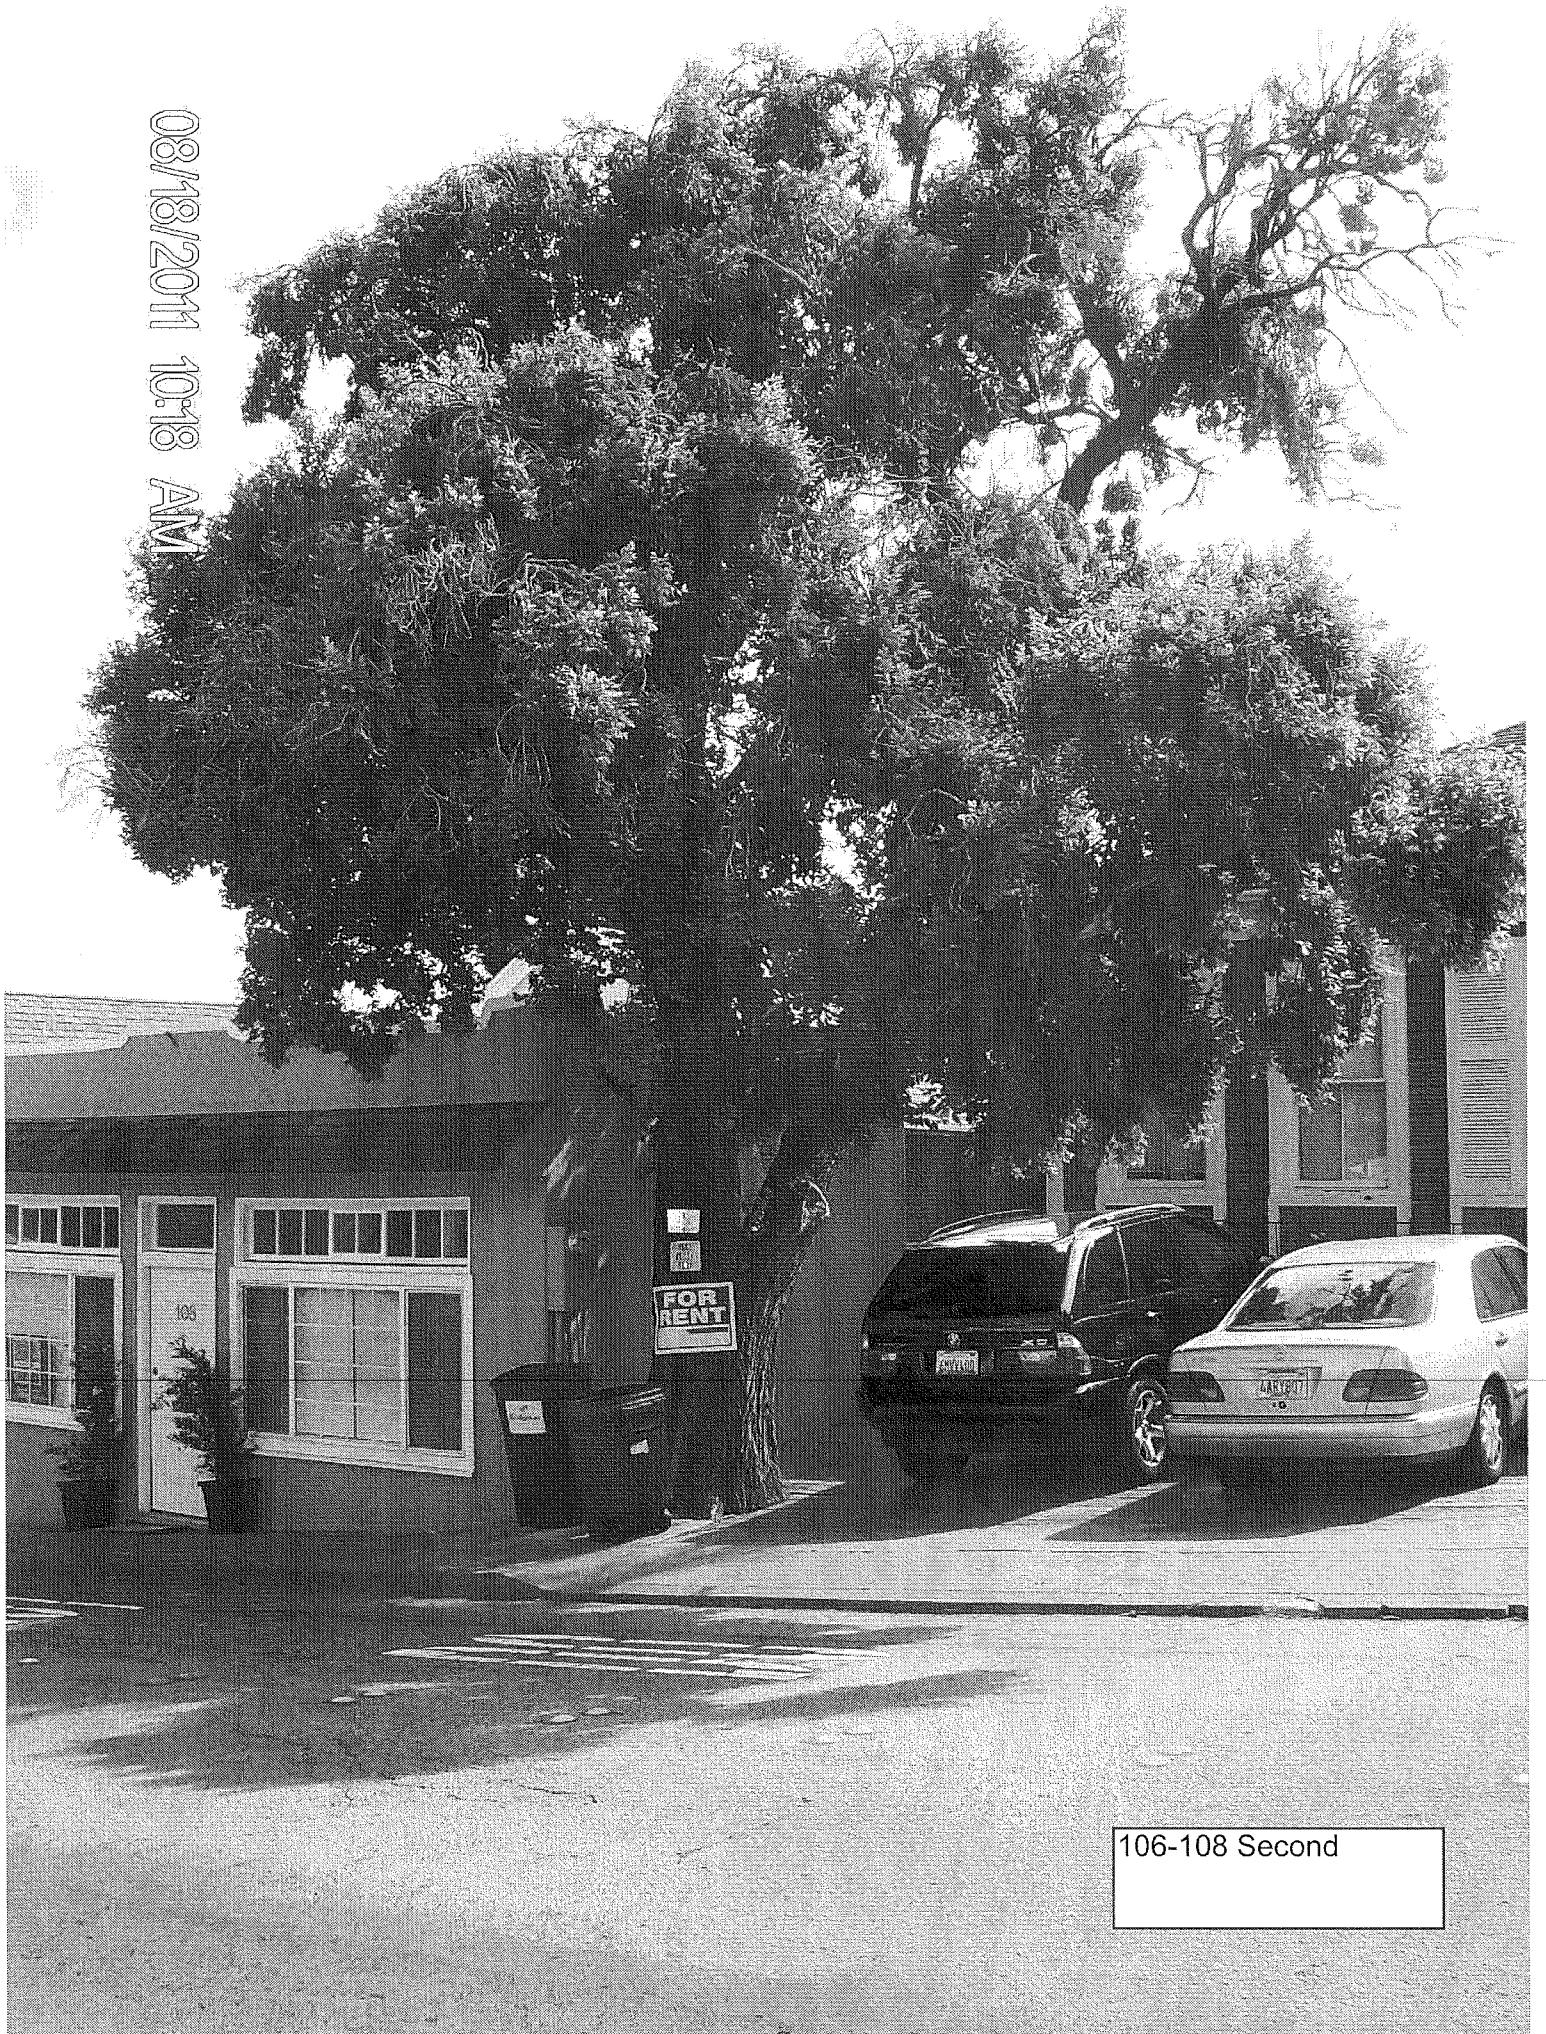
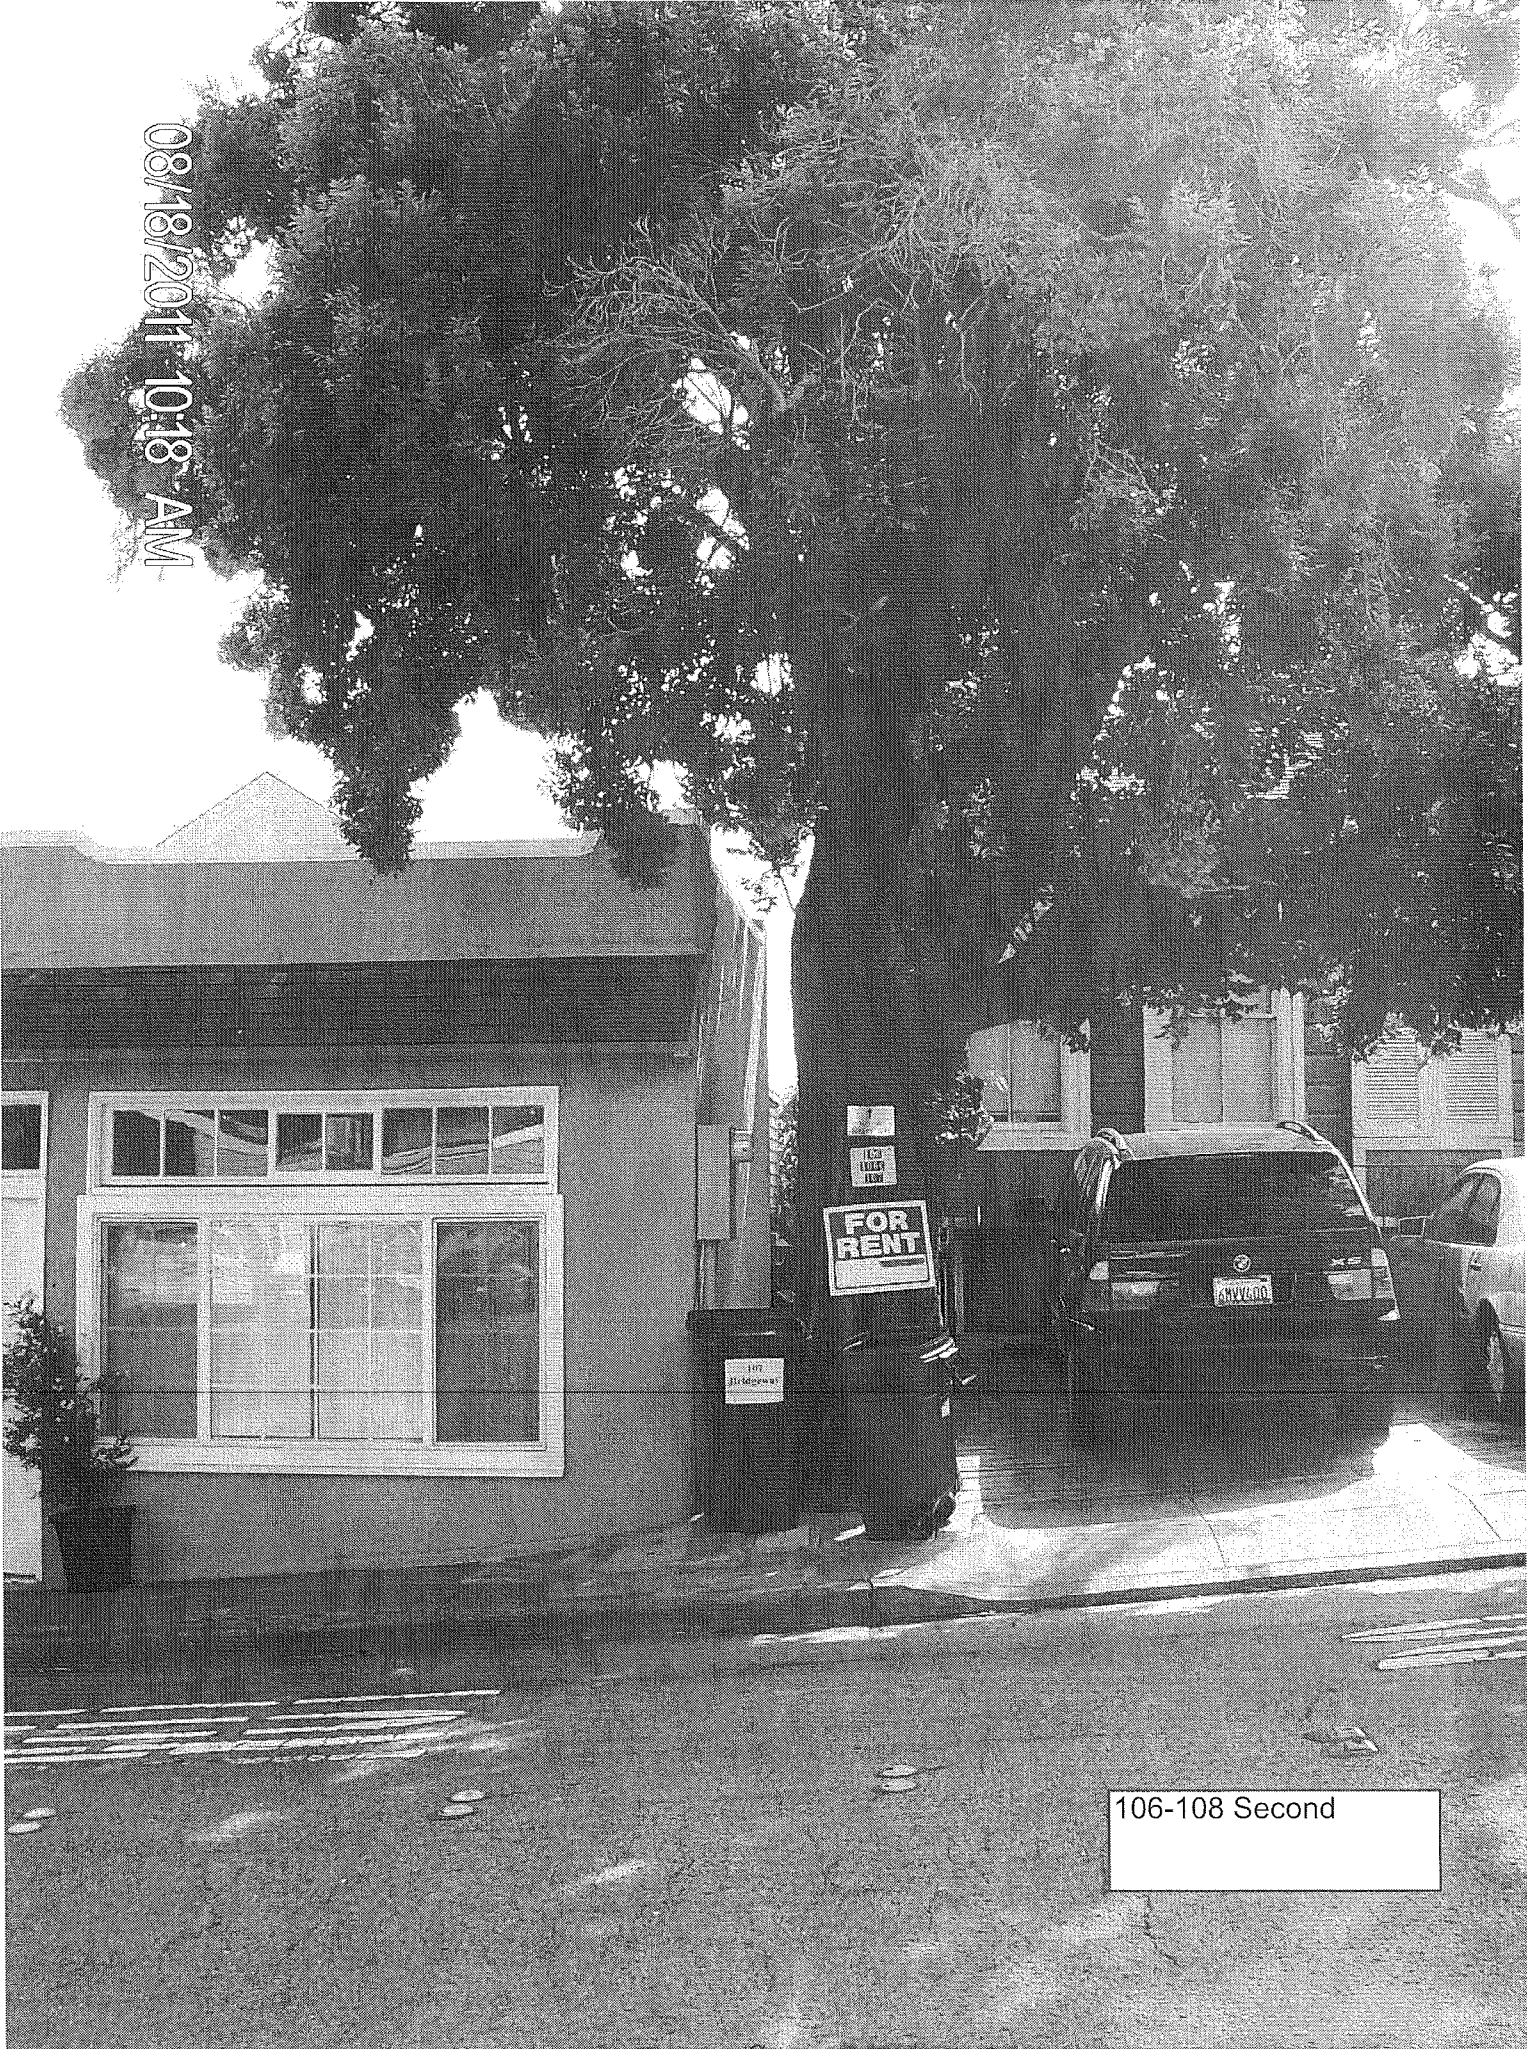
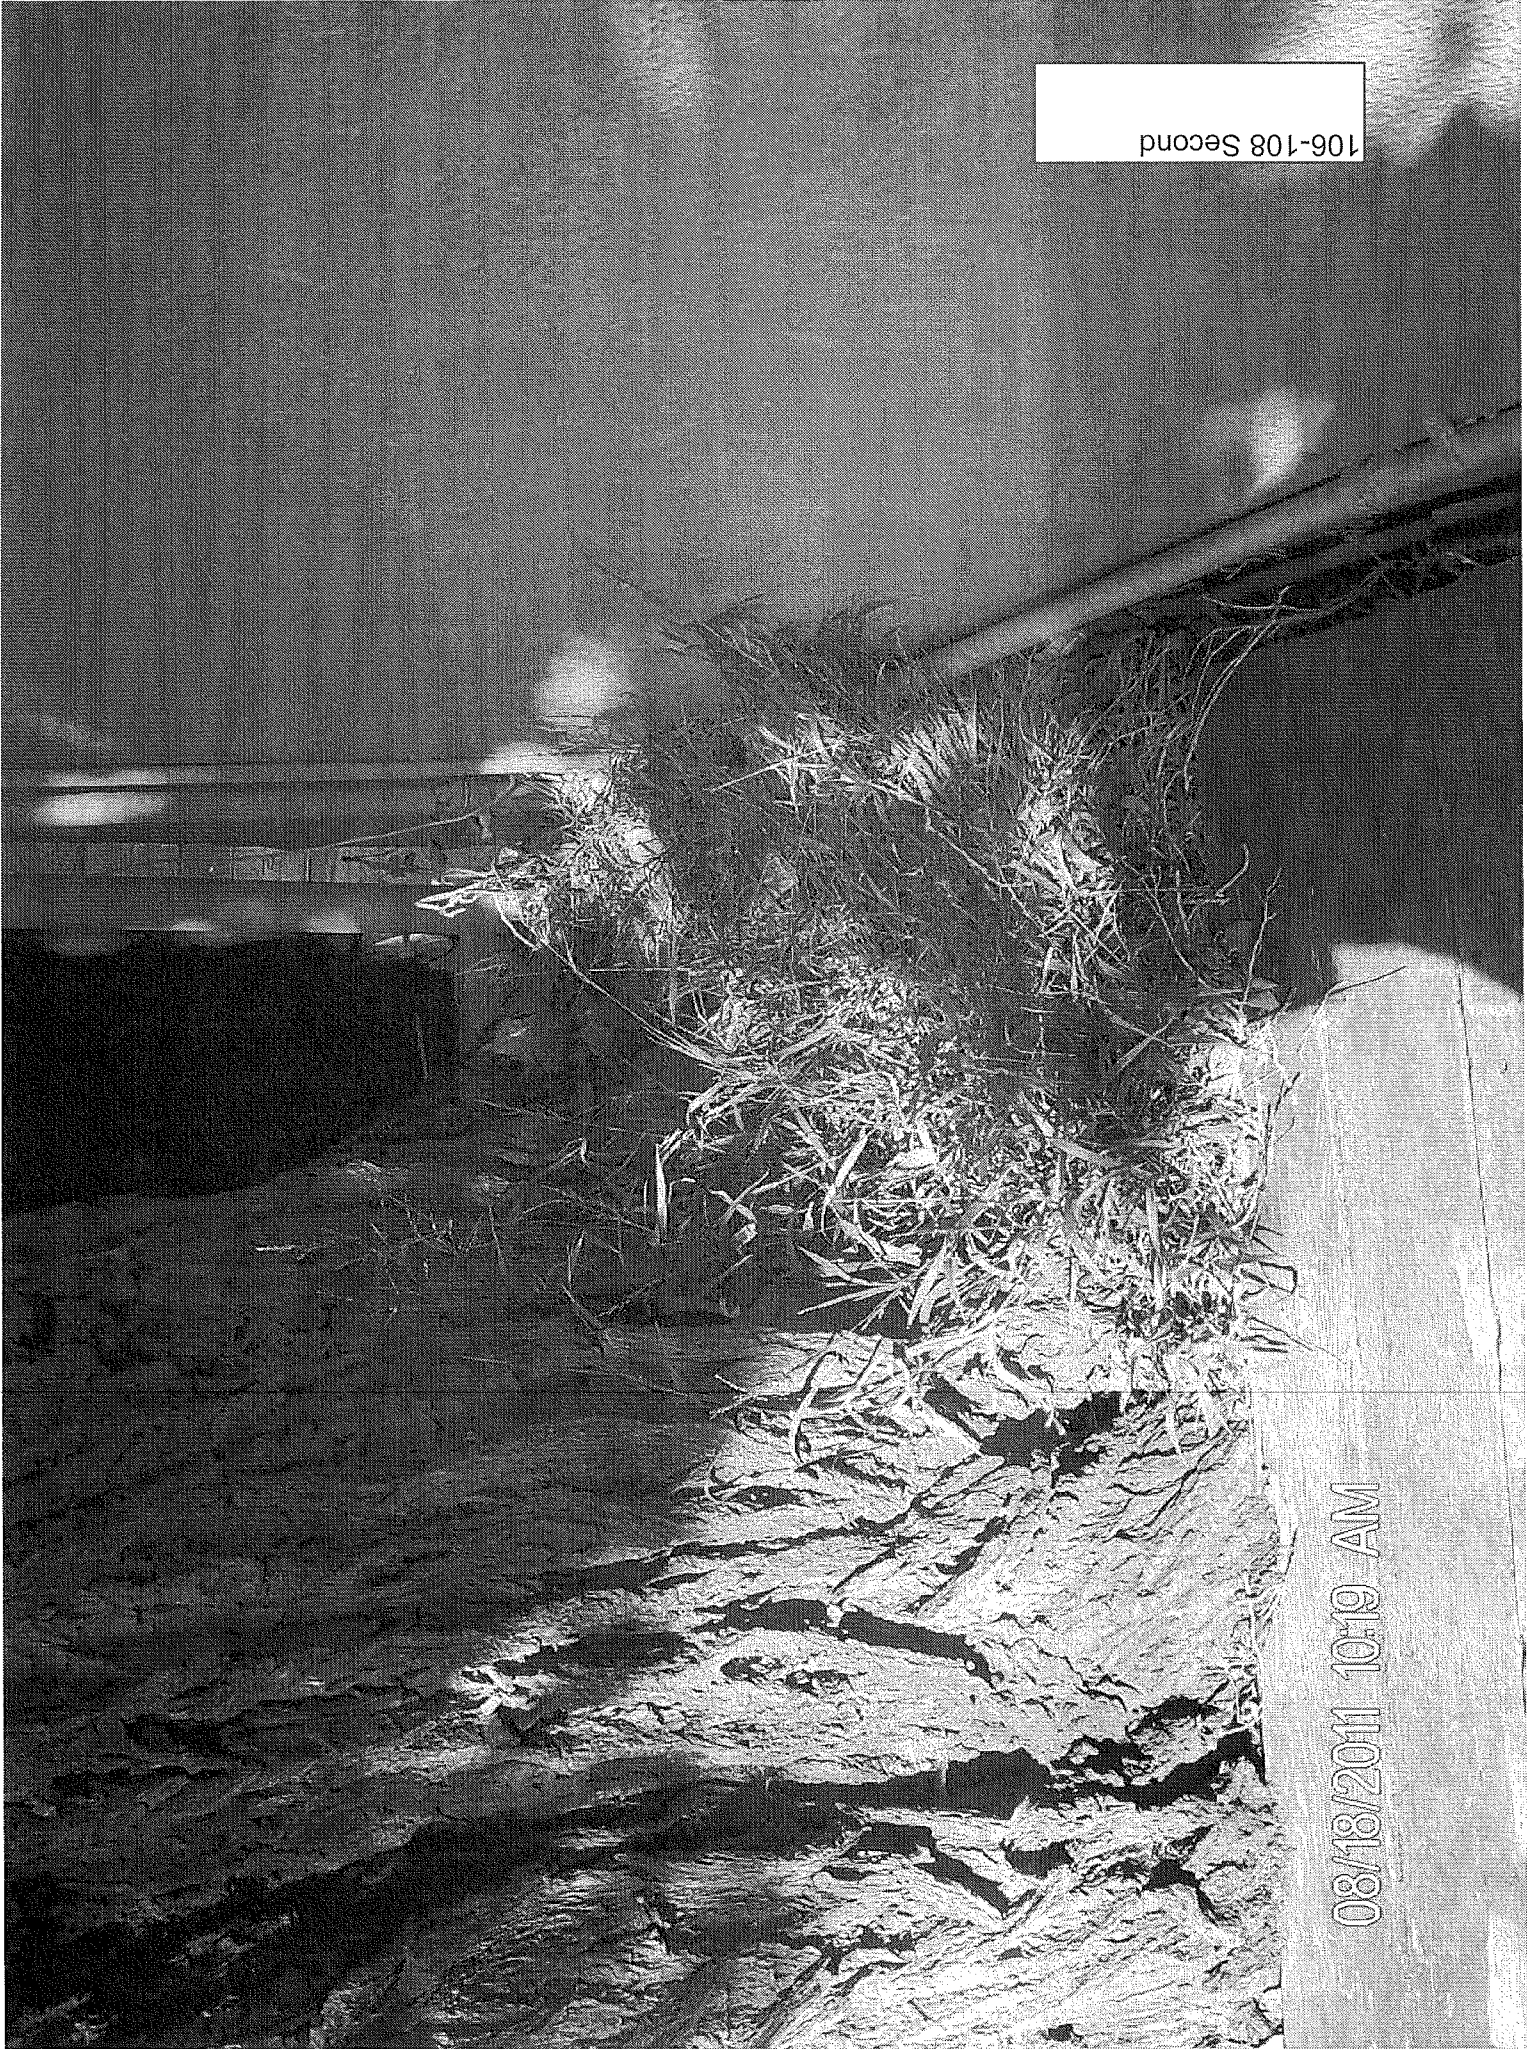
106-108 Second

THE SOUTHWEST CORNER OF HOME HAS A BOW IN THE SOUTH - OPPOSITE TO TREE; AND AN UPLIFT OF THE CORNER. THERE ARE THREE BUTTRESS ROOF EXTENDING FROM BASE TOWARDS HOME. THE CONCRETE TO SIDEWALK IS CRACKING AND UPLIFTED (PEDESTRIAN TRIP HAZARD). THERE ARE FOUR MAJOR ROOTS EXTENDING TOWARD UTILITIES (INCLUDING WATER). TREE BRIVELATES @ APPROX 6' ABOVE GRADE WITH AN ACUTE ANGLE CRACK WITH EMBEDDED BARK. THERE IS A WOUND FROM A FAILED LIMB APPROX. 18" FROM MAIN CRACK - WITH A DECAY COLUMN EXTENDING INTO THE MAIN CRACK. THERE IS BLEEDING ON BARK BELOW MAIN / COMMON ATTACHMENT. - THERE IS DECAY IN MAIN STEM THAT EXTENDS OUT TOWARDS THE ROAD. THERE ARE BRANCHES & FOLIAGE RESTING ON ROOF OF THE 108 BUILDING. NOTE: THERE IS A SEPARATION

OF UTILITY LINE AGAINST THE HOME, SIGNIFICANT & ~~EXTENSIVE~~ ^{EXTENSIVE} INTERNAL DECAY WAS DETECTED WITH THE SOUNDING OF HAMMER. - EXTREMELY HOLLOW - LESS THAN 6" OF GOOD WOOD IS SUSPECT, - THERE IS DIEBACK IN THE CANOPY ON WEST (STREET SIDE) & EAST SIDE. FOLIAGE IS CHLOROTIC (YELLOWISH).

B. THIS TREE HAS AN UNACCEPTABLE LEVEL OF RISK AND IS BOTH A NUISANCE AND FAILURE HAZARD TO LIFE & PROPERTY. THIS TREE IS A PUBLIC HAZARD*

≡. IMMEDIATE REMOVAL & KILLING OF STUMP TO ABATE HAZARD - & REPAIR OF NUISANCE DAMAGE TO PUBLIC SIDEWALK (TO ABATE TRIP HAZARD); AND STRUCTURAL DAMAGE TO THE 108 PROPERTY.

- APPLY FOR EMERGENCY REMOVAL PERMIT.

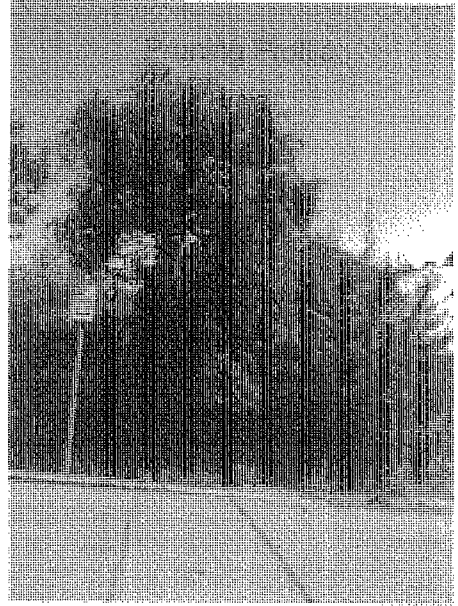
Description and reasons for alteration. Ms. Wells proposes to prune one coast live oak downslope of her property to restore a documented, pre-existing view of Richardson Bay and Sausalito Yacht Harbor from her living room. Approximately 2-4 feet of the upper canopy would be pruned per American National Standards Institute (ANSI A300) pruning standards. See pruning profile in photo at right.

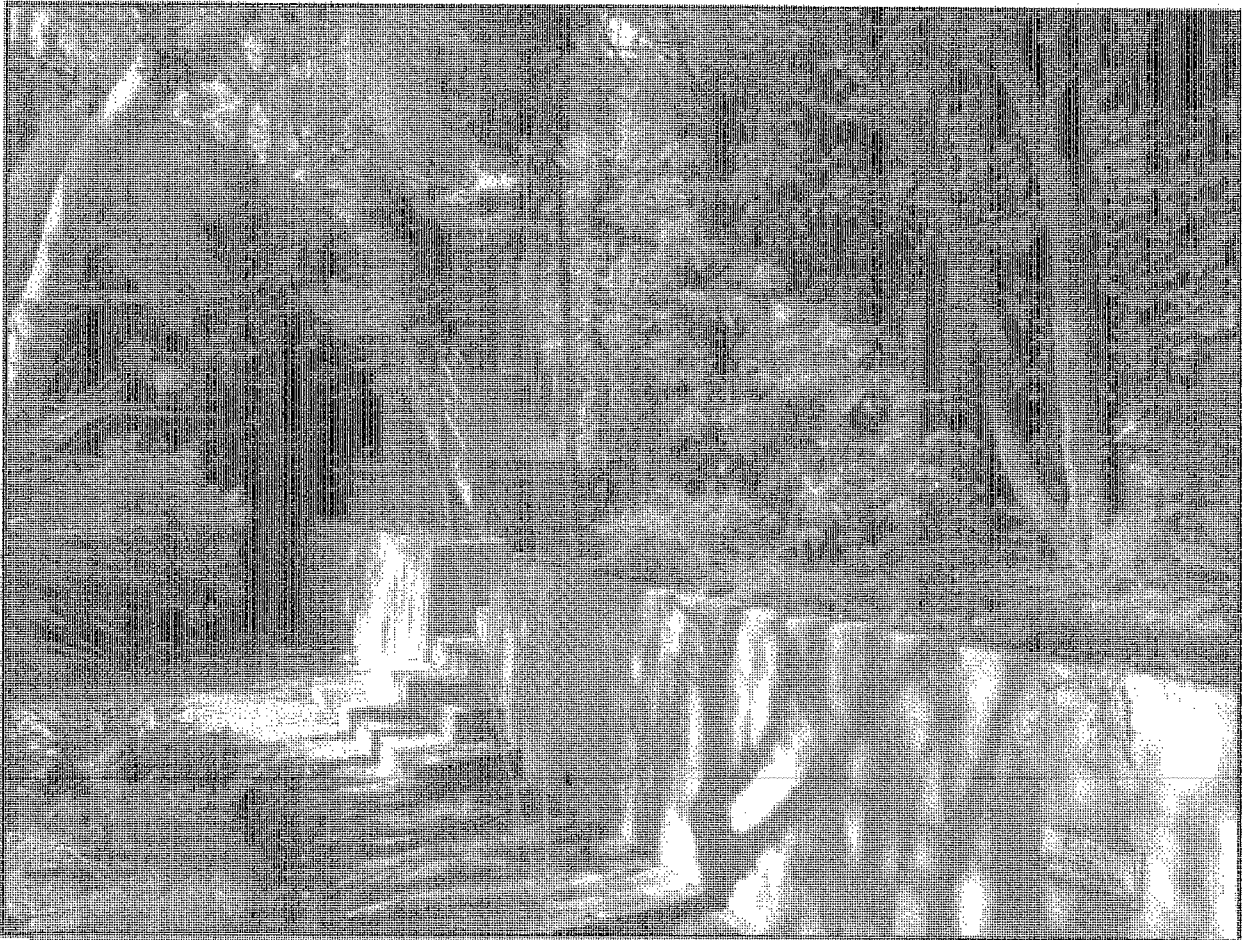
- **#8, 9, 10, Three *Chamaecyparis*, False Cypress, Arborvitae.** These trees form a screen between 2 Bulkley Avenue front yard and the neighboring property to the south. These three trees are in good condition. See photograph on page 8 of this report.

Trees # 8, 9, 10, *Chamaecyparis, obtusa* on either side of stairway recommended for removal.

Trees 8, 9, and 10, *Chamaecyparis, obtusa*, are planned as removals and replacement with *Podocarpus* species that form a denser screening at maturity. The recommendation is that the existing three *Chamaecyparis* trees planned for removal are replaced with four replacements to form the screen between 2 Bulkley Avenue and the neighboring property just to the south.

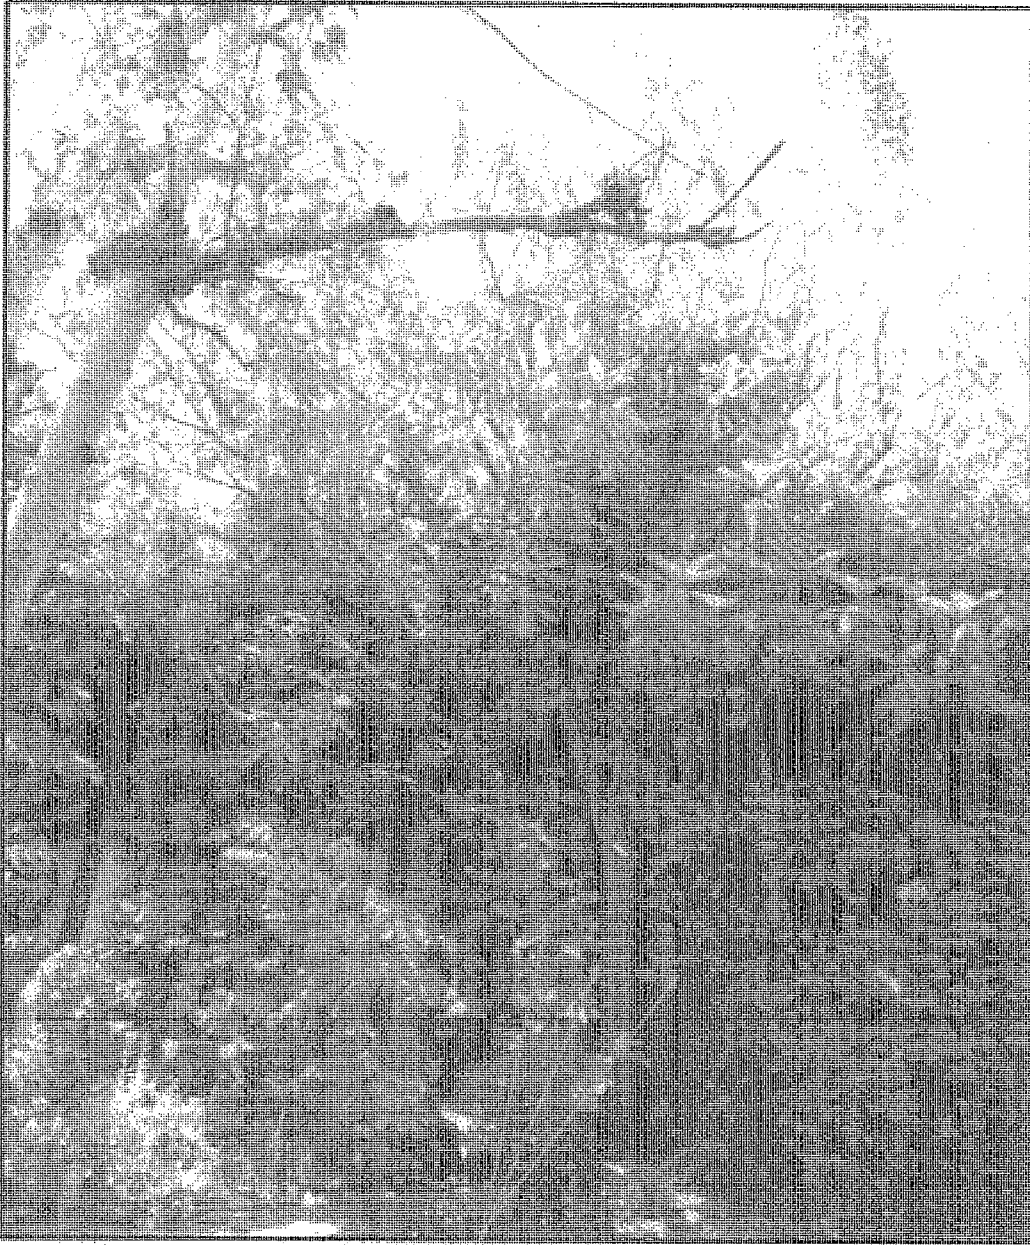
- #3 *Magnolia, soulangiana*, CBH 2.4, 1.2, 1.3 feet and 8.2 inches. The tree's height is 18 feet. The tree consists of four stems originating at the base of the tree. The tree placement is directly against the retaining wall and 43 inches from the outer edge. Upper canopy branches are defoliated on alternate branch tips. The bare branch tips indicate a root problem from the restricted space location. Photograph page 4.

Tree #3, a multi stem Magnolia against the retaining wall is recommended for removal.

Trees #3 and #4, Magnolia and Acer palmatum both located in the public right of way area of the landscape are recommended for removal. The planter bed size cannot contain the root system of these trees. When they mature the root confinement will crack the retaining wall requiring extensive repair work and this wall supports Bulkley Avenue directly 6 feet above the patio. The retaining wall and planter is the only buffer to Bulkley Avenue. The separation is now visible in the lower section of the wall nearest the Acer tree along the outer planter wall. Replacing the removed trees is not advised. Planting even a small tree would eventually require removal when roots conflict with the retaining wall. The narrow shallow planter is only suitable for small shrubs or annual perennial flower plants such as Santolina, Erigeron, or Nandina.

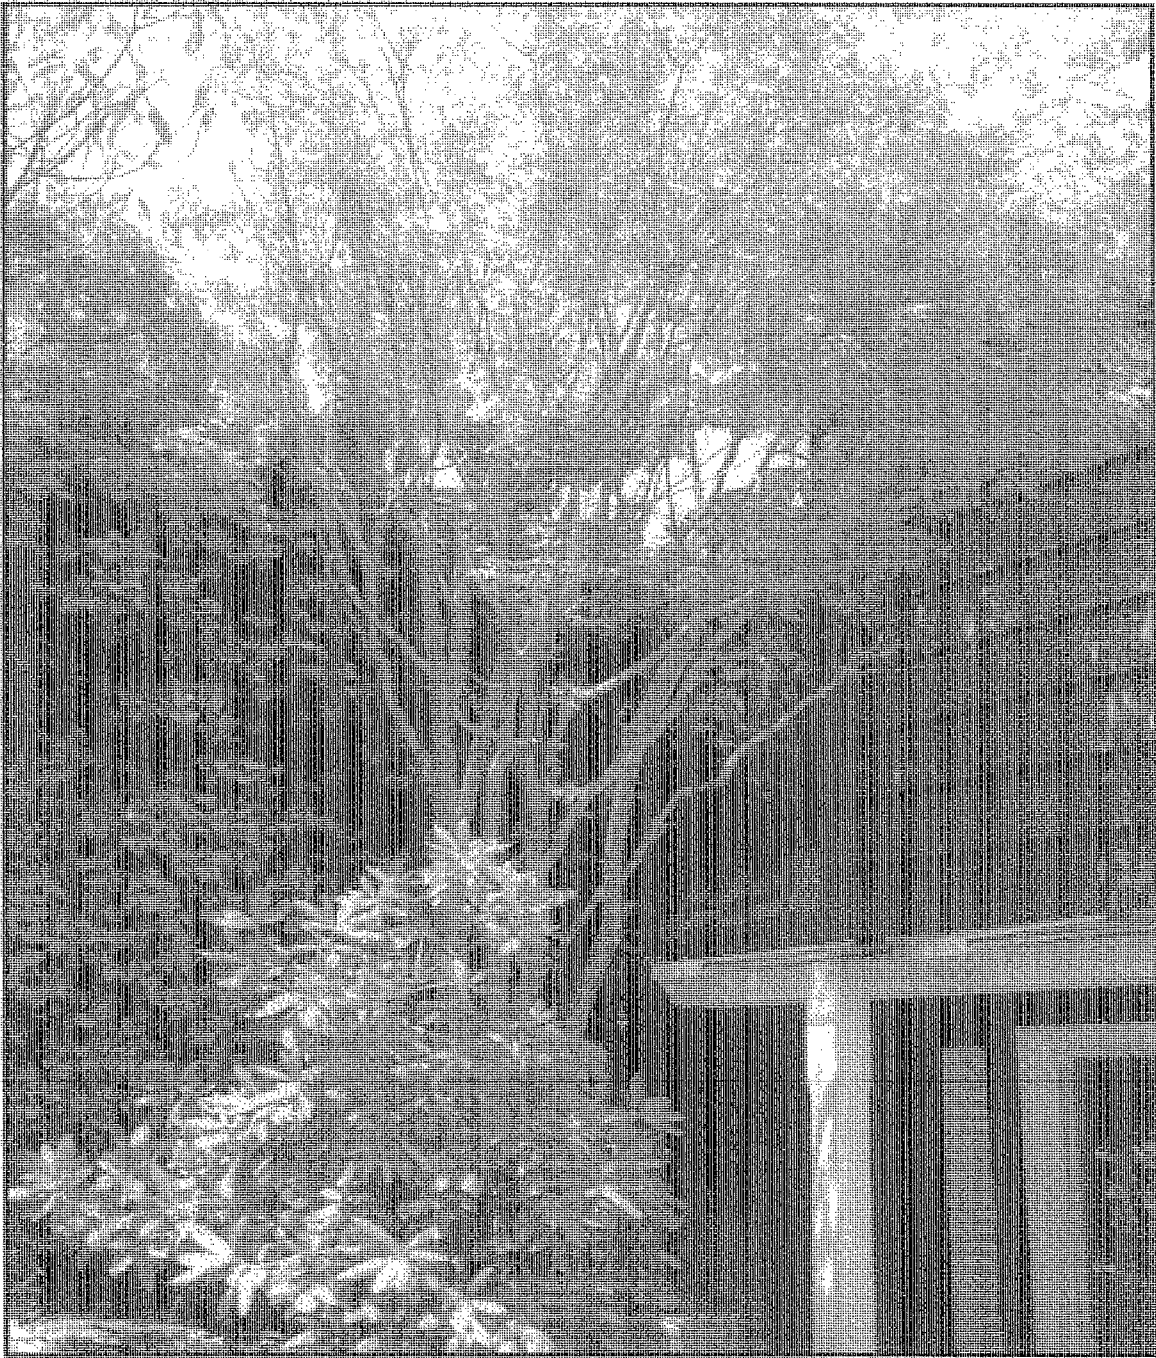
- #4 *Acer palmatum*, Japanese Maple, CBH 4.5, 4, 1.5, and 7 inches. This is a young multi-stem Maple tree with three upright stems originating at the base of the tree. It has a height of 18 feet. Photograph page 5.

Acer palmatum, Japanese Maple tree # 4, in confined planter with roots affecting planter bed wall

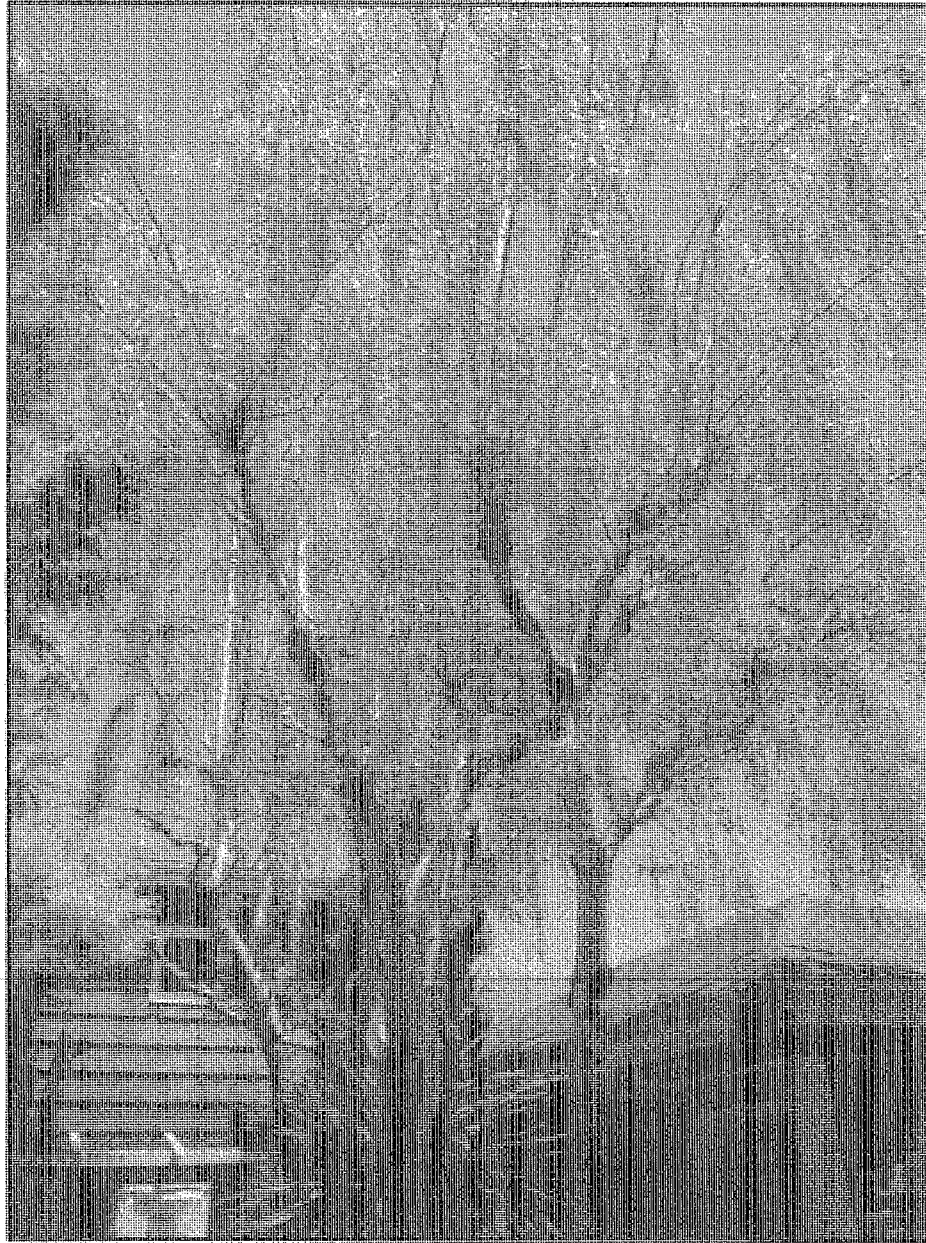
- **#5 *Betula pendula*, European White Birch.** The tree consists of three upright stems originating at the trunk base. The complete CBH is 1.9, 1.6 feet and 8 inches. This equals 50 inches. The tree is a non-native species and native to summer rainy climates. It does not perform well in California climates due to the lack of summer rainfall. The upper canopy exhibits branch tip dieback associated with root problems. The dieback can be attributed to the climate conditions. Condition is rated as fair to poor. See photograph page 6

- **#6 *Betula pendula*, European White Birch.** This tree is directly next to Birch number 5 in the courtyard. CBH is two, and 1.7 feet total CBH is 44 inches. Condition is rated as fair to poor. See Photograph page 6.

#5 and #6 two Betula trees in front courtyard of property in fair to poor condition. Recommendation is for replacement with a more suitable species for a Sausalito climate and a lower height when mature to accommodate views from neighboring properties.

Trees #5 and #6, the two Birch trees are recommended for removal and replacement with species more adaptable to a Sausalito climate. They are rated as fair to poor condition and maintaining them to fit the climate and conditions is difficult and would eventually require removal. *Betula* species are best suited in a climate with abundant rainfall throughout the year and best suited for riparian locations. Selection of a more suitable feature tree such as *Magnolia soulangiana* Saucer Magnolia, twelve species listed in Western Gardening, *Magnolia stellata* Star Magnolia, seven varieties, *Cercis occidentalis*, Western Red Bud, *Arbutus unedo*, Strawberry tree, or *Prunus yedoensis*, Flowering Cherry are species that provide features such as red color trunk, spring flowers, or fall color. All are deciduous with the exception of *Arbutus* species that are evergreen. These choices require less maintenance and are most adaptable to the climate and location. If removal is granted, the selections are an opportunity for a replacement tree that will not block neighboring views or require topping to reduce height.

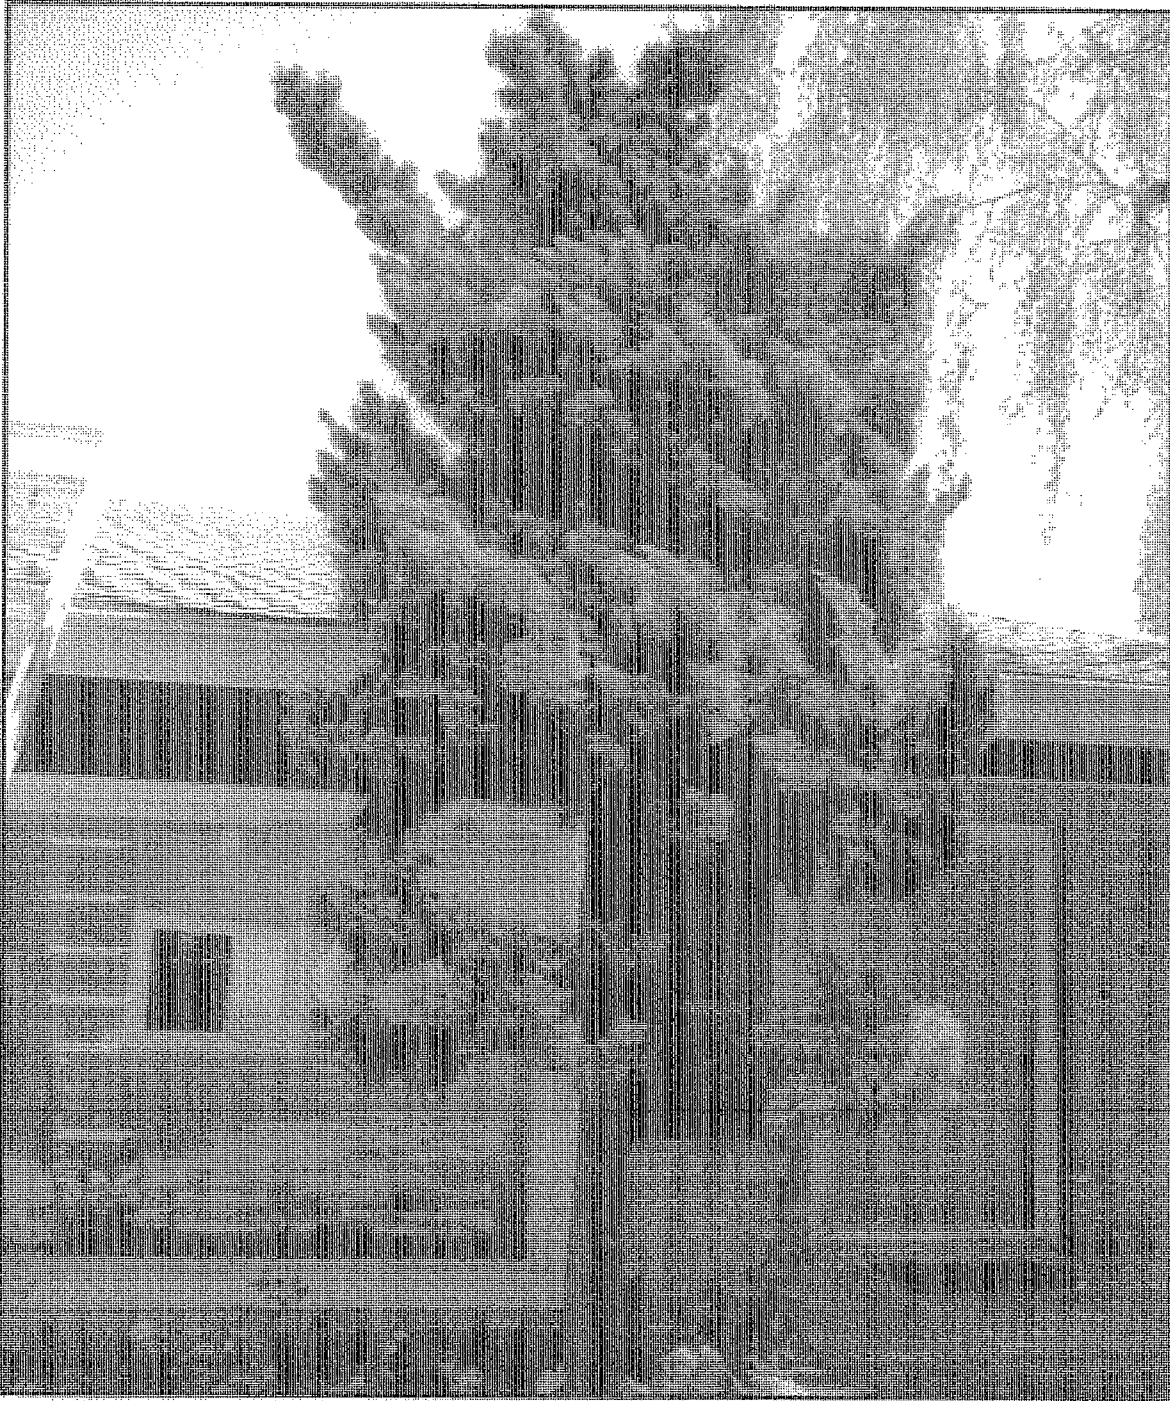
- **#7 *Chamaecyparis, obtusea*, Arborvitae. Cypress.** This tree is located 30 inches from the front wall of the home. CBH is 1.5 feet. This tree species and its varieties are native and non-native to California. The tree is in good condition and pruned to be displayed as a feature tree. See photograph on page 7.

Architect plans indicate front wall extension that is within the area of existing Cypress tree # 7.

Tree # 7 *Chamaecyparis obtuse* is recommended for removal. The tree is within the area if the front wall expansion a direct conflict with the building construction plans. The replacement of courtyard patio trees is suggested as the alternative to replacing this tree.
