ARBORIST REPORT

I have inspected 4 *Pittosporum undulatum* located at 254 Glen Drive and have made the following report.

View Obstruction Arborist Report
141 Santa Rosa Avenue
Sausalito, CA

Site Map for Pruning Application
 141 Santa Rosa Avenue
 Sausalito, CA

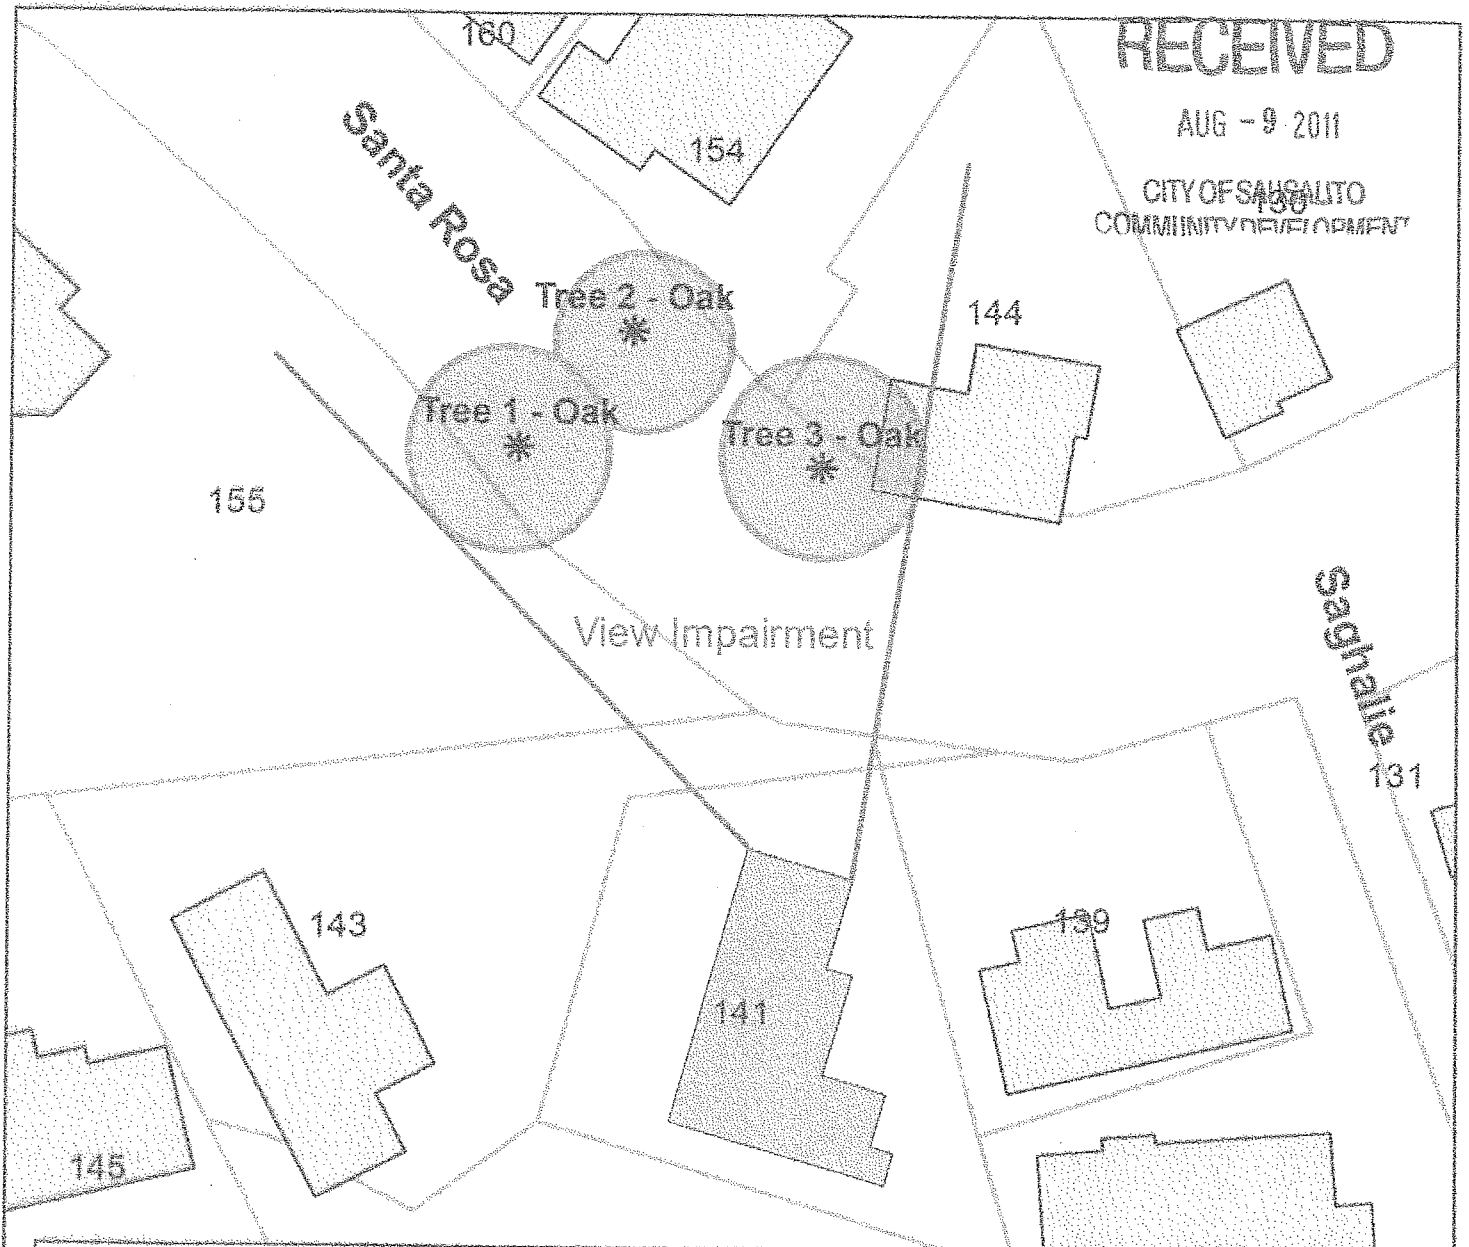
Tree #	Species	CBH (in)	DBH (in)	Height (ft)	Value
1	<i>Quercus agrifolia</i>	57.2	18.2	35	\$ 8,000
2	<i>Quercus agrifolia</i>	616	19.6	40	\$ 8,800
3	<i>Quercus agrifolia</i>	96.8	30.8	48	\$ 17,900

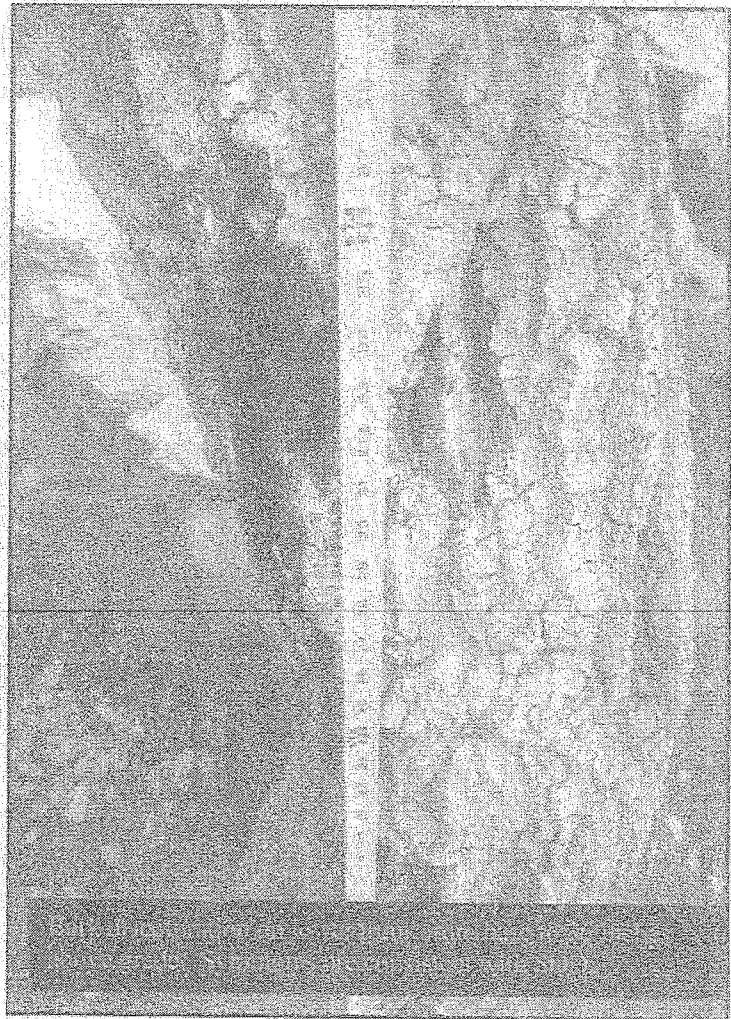
This tree is identified as a *Quercus agrifolia*, Coast Live Oak. The *Quercus agrifolia* is indigenous to Northern California.

The tree is located in the front yard on a bank above Lower Crescent Avenue. The tree is at the southeast corner of the property 7 feet from the south and east corner inside the property fence. It is 12 feet from the street curb with a height of 20 feet. Mr. Stroman stated a discoloration on the tree's lower trunk was discovered, and a tree company owner informed him that it appeared to be symptoms resembling Sudden Oak Disease, and he was referred to me. I inspected the tree, took a sample specimen, performed an odor test, measured and noted the location of the bark discoloration. The discoloration measured 36 inches in length and 8 inches in width, see photograph. The tree has a 40-degree lean towards Lower Crescent Avenue. The tree is marked with engineering tape around the lower trunk.

42" CBH

The tree has Sudden Oak Disease. The odor from the sample has a tannin odor that resembles a wine barrel odor. The discoloration is consistent with Sudden Oak Disease appearing on the lower trunk where the pathogens are in high concentrations. Experience and site inspections confirm the disease to be in the vicinity of and on a property, a short distance from this 49 Lower Crescent address. At this stage of the disease, the only course of action is to remove the tree. It is impossible to control or reverse the disease once established. Oak trees with this disease can fail suddenly without any indication of failure. The path of the failure is directly onto Lower Crescent Avenue. The recommendation is to remove the tree immediately. The removal permit for trees with Sudden Oak Disease should be waived because Sudden Oak Disease failures are unpredictable and trees with this disease can fail at any time.

The recommendation is to remove the two Coast Live Oak trees identified in this report. Coast Live Oak Tree #1 has Phytophthora ramorum, Sudden Oak Disease and this disease once established cannot be controlled or eliminated. Coast Live Oak Tree #2 has an extensive decay pocket that equals 80 percent of the total wood volume in the area of the trunk decay. The amount of decay cannot support the canopy over the home, and the decay will slowly increase until it cannot support the canopy. At 80 percent of total volume, this is very close to failure point.

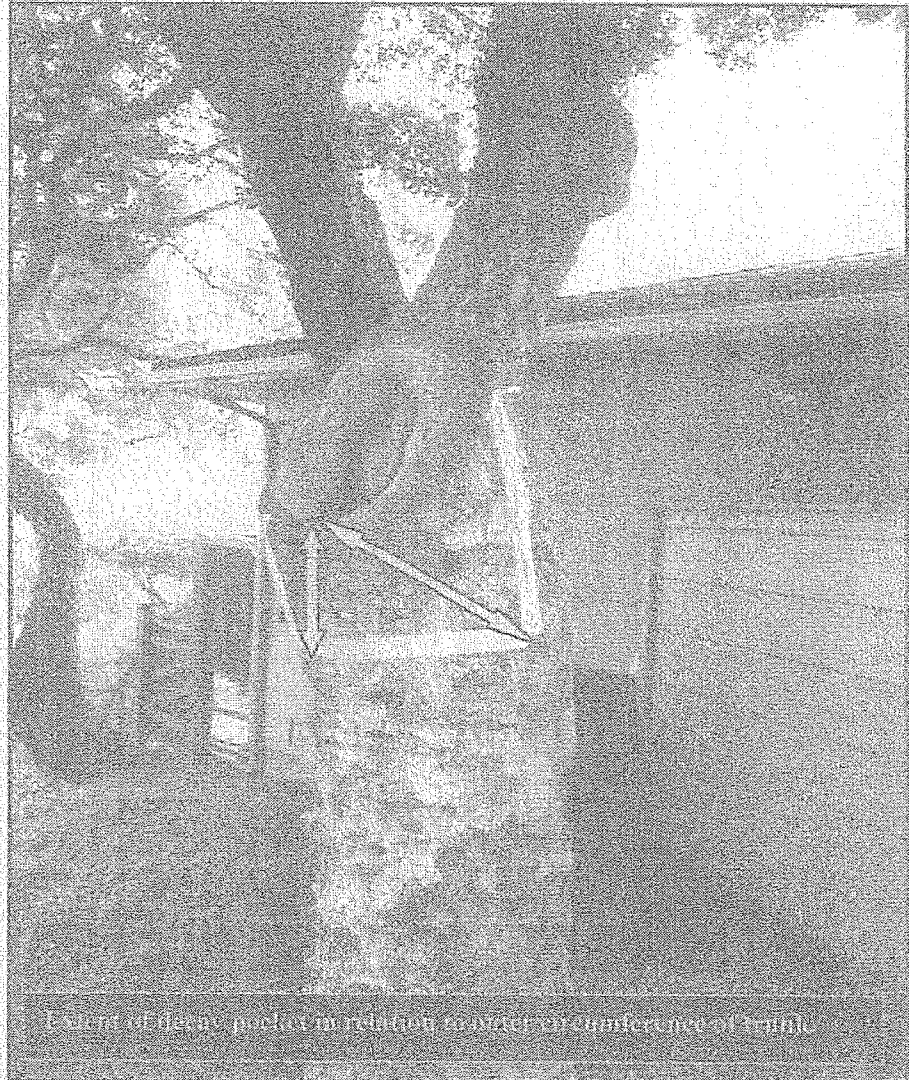
Tree #2

This tree is identified as a *Quercus agrifolia*, Coast Live Oak. The Circumference at Breast Height, (CBH) is 3.8 feet. This Oak tree is located on the North property boundary 12 inches from the curb of Lower Crescent Avenue opposite the neighboring property of 54 Lower Crescent Avenue. The tree is 5 feet left of the driveway at 49 Lower Crescent Avenue, and the canopy extends over the home. A large trunk cavity was noticed at 6 feet above grade. The cavity opening measured 11x6 inches. The interior of the cavity, (cavity pocket) measured 5 inches in depth from the lowest part of the cavity opening. The extent of the decay was masked with tape to indicate the extent of the decay in proportion to the overall circumference of the tree, see photograph at right.

This tree has an extensive decay pocket at a critical section with scaffold limb that supports the entire canopy. The dense wood tissue that provides support for a tree's canopy is compromised by at least 75 percent and there is only 25 percent of the support wood structure remaining. The most critical factor is that the heartwood which is the

densest wood that provides support for the canopy is compromised by the decay. The canopy is positioned over the home and will fall on the home when it fails. The recommendation is that the tree is removed as soon as possible to eliminate structure damage.

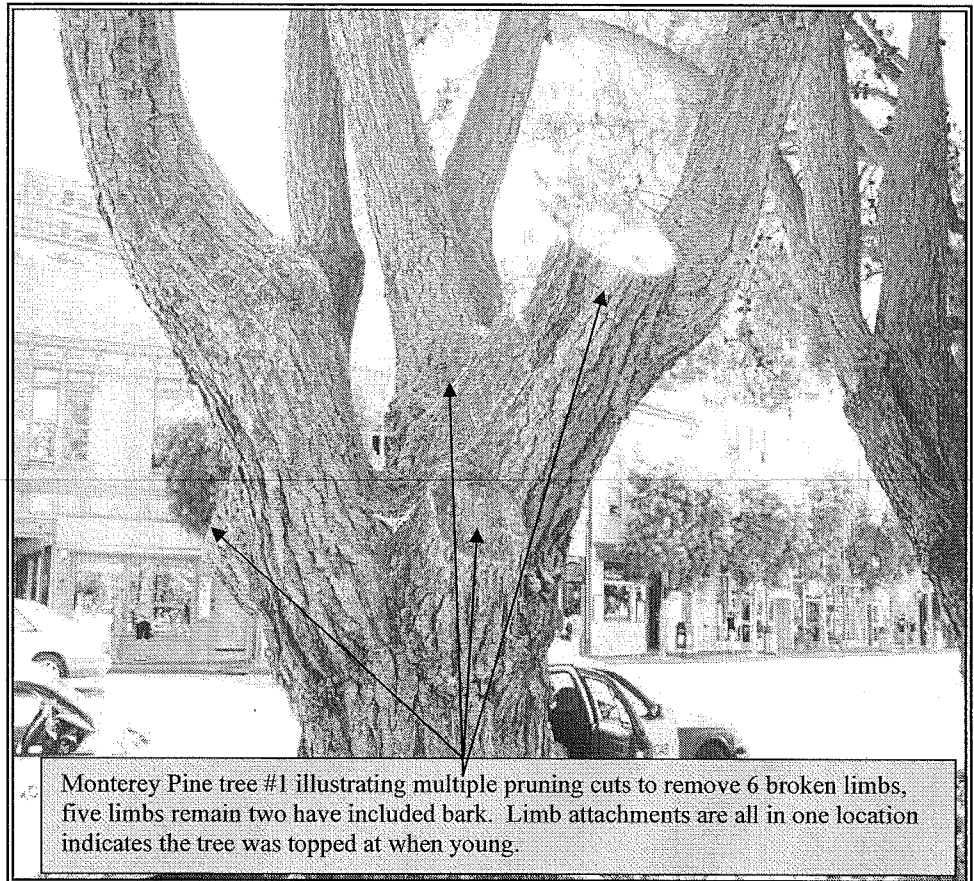
Circumference measurement at just below the lowest attachment point is 12.9 feet. Measuring at this location gives a more accurate measurement of the trunk size than if taken where limb attachments are because the attachments bulge there. The status of Monterey Pine trees is described as **undesirable** in the Sausalito Trees and Views Preservation Ordinance, 11.12.030, DEFINITIONS, Undesirable Tree. The tree has several larger diameter pruning cuts including one recent event when a large-diameter limb (16 inches in diameter) fell and damaged a street tree located on Anchor Street approximately 30 feet away from the trunk of the Monterey Pine. A count of remaining and removed limbs was made during the last site visit July 27, 2011. On this tree, there are five of eleven limbs remaining. A total of six large-diameter limbs were removed because of limb breakage. Two of the remaining limbs have very acute angles at their point of attachment to the trunk.

At the point of attachment, the two limbs have a condition referred to in arboricultural terms as bark inclusion, (bark that becomes embedded in a crotch (union) between branch and trunk or between codominant stems; causing a weak structure, ISA Glossary of Arboricultural Terms.)

This condition presents a very high-risk failure of one of the two limbs because of the extreme pressure of the two limbs against each other. The brick plaza where these trees are located is a very high density of pedestrian traffic. The bank entrance is located here, and the plaza is the location of a self-service bicycle rental location.

A close examination of the lower trunk revealed Pine Bark Beetle attacks very likely to be Red Turpentine Beetle, an important pest that introduces Pine Pitch Canker especially common in Monterey Pine trees. Bark Beetle is an indication

of environmental related stress. Monterey Pine trees are more vulnerable to beetle attacks when weakened by unfavorable environmental conditions.

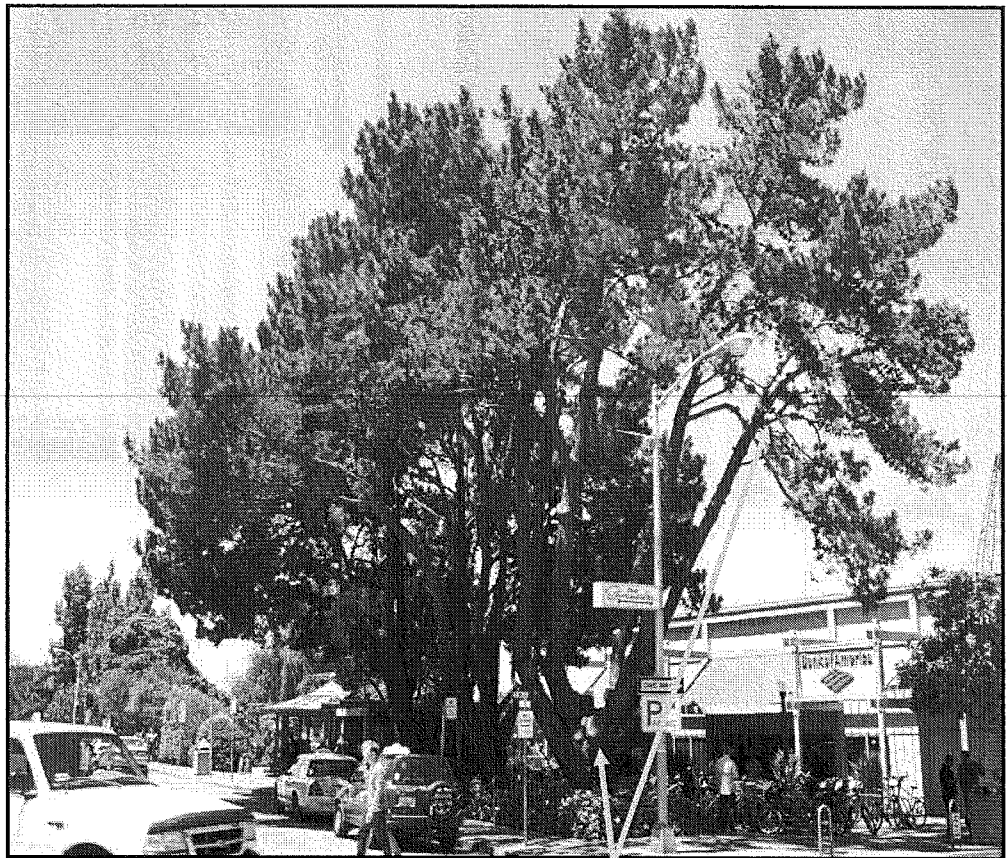
Monterey Pine #1 has large extended scaffold limb leaning over a brick Plaza. This tree has several large diameter pruning cuts due to limb failures caused by poor structure the result of topping when the tree was in its early growth stage.

These multiple leaders all compete for space and eventually fail because of their structure. In a location with infrequent traffic, risk would be reduced because potential for injury would be limited. The location of these Pine trees on Bridgeway in the down town business district has constant activity, the frequency of activity, the bicycle rental station, bank, bus shelter, public restrooms, and tourist traffic increase the risk of personal injury exponentially when limb failures occur. There are a poor canopy structure and history of limb failure, especially on Monterey Pine tree #1. There is very little that can be done to correct the trees' structure at this stage of the trees' growth. All three pines have either Pine pitch canker or Western Pine Rust fungal diseases most likely introduced by Pine Beetles. These compound conditions will very likely cause more limb failure that may cause personal injury if the heavy weight limbs strike a pedestrian. Monterey Pine tree #1 should be removed immediately. The Bridgeway corridor is a windy location and wind influence on heavy end-weighted limbs with poor attachments increases limb failure. The two limbs with bark inclusion are high failure potentials. These multiple factors are the basis of the recommendation for removal.

The three Monterey Pine trees are a group of trees that developed to maturity together. Removal of one will impact the remaining two trees. These two trees have the same structure and heavy end weight on each limb. Based on these factors and the fungal symptoms, removal of the two remaining trees is recommended.
