DEPARTMENT OF PUBLIC WORKS
 TREE MAINTENANCE ACTIVITIES PERFORMED AND PENDING
 SEPTEMBER 2011

RE: Monterey Pine (*Pinus radiata*) located on the corner of Miller Ave and Spencer Ave

**View Obstruction Arborist Report
81 Cazneau Avenue, Sausalito, CA**

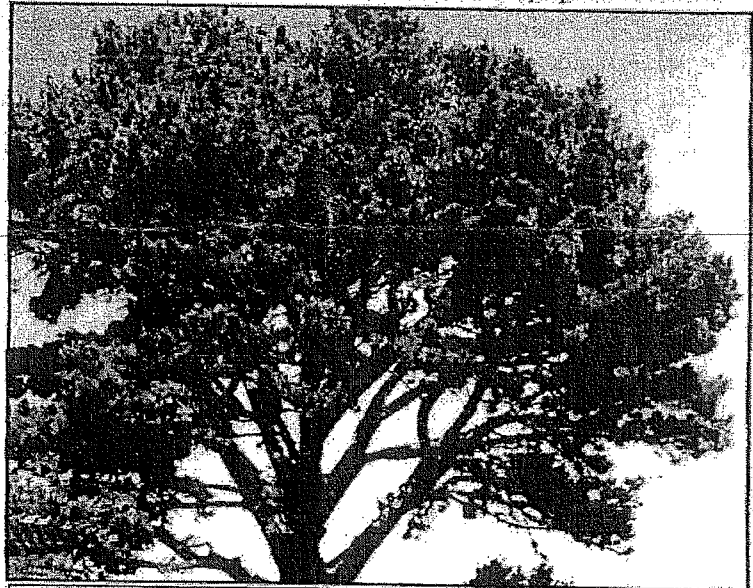
The Monterey Pine canopy inspection noted that there is tip dieback of terminal growth points throughout the upper canopy. In other limb tips, where smaller branches terminate, there appeared brown foliage, described as brown-needle coloration. It is very possible that the two conditions are related. First, the limb tips produce brown needles that result in bare limb tip branches, indicating a condition described as "dieback." This condition appears randomly throughout the canopy.

This dieback of branch tips and needle browning is a sign of Pine Pitch Canker, a fungal disease that most commonly occurs through wounding from pruning cuts or insect attacks.

Brown needles on Pine branch tips. 11.19.2010

This Monterey Pine tree is in a stressed condition that has compromised its defense mechanisms. This is exhibited by the symptoms identified and discussed in this report. The tree will continue to decline and will be determined by factors such as continued beetle attacks, advancement of the fungal disease and climate conditions. There are multiple high value risk targets present in the failure path from falling branches and debris from the tree. A heavy pinecone production will also add to the debris produced by the tree. These events will increase with frequency as the tree declines and risk associated within the fall path must be evaluated by the City if the tree is on public right of way. The recommendation, based on these discovered findings from the site inspection, is that the tree should be removed to eliminate the risk.

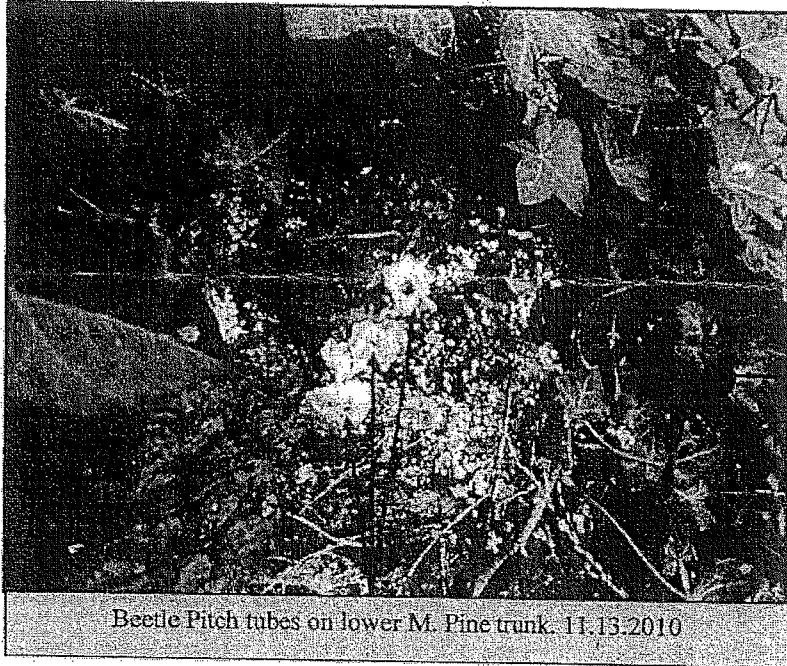
Pruning cuts performed during the growing season produce a sap pitch attracting pine beetles that are also active during the late spring, summer, and early fall months of the year. Since Pine Pitch Canker was noted during the time of visual inspection, the lower trunk area was examined for the presence of *Dendroctonus valens*, Red Turpentine Beetle. This beetle attacks the lower base of Pine trunks and exposed roots just below the soil surface. The Red Turpentine Beetle was detected in multiple locations on every side of the lower tree trunk. The beetle produces pitch tubes visible on the outer bark illustrated in the photograph from just one location on the lower trunk of this pine tree.

Beetle Pitch tubes on lower M. Pine trunk. 11.13.2010

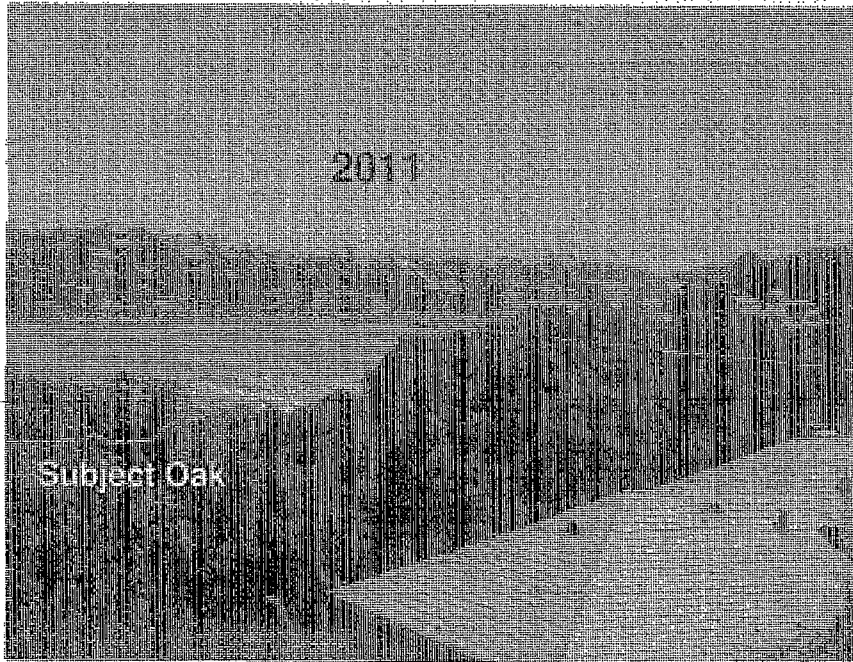
On the next page are two photographs showing the views from the Wells living room that were present in 1998 and in 2011. The approximate line of proposed pruning is shown on the 2011 photo in red.

Description and reasons for alteration. Ms. Wells proposes to prune one coast live oak downslope of her property to restore a documented, pre-existing view of Richardson Bay and Sausalito Yacht Harbor from her living room. Approximately 2-4 feet of the upper canopy would be pruned per American National Standards Institute (ANSI A300) pruning standards. See pruning profile in photo at right.
