STAFF REPORT

SAUSALITO TREES AND VIEWS COMMITTEE

Project Contreras Residence / 56/58 Rodeo Avenue
Tree Removal Permit
TRP 10-304

Meeting Date December 2, 2010

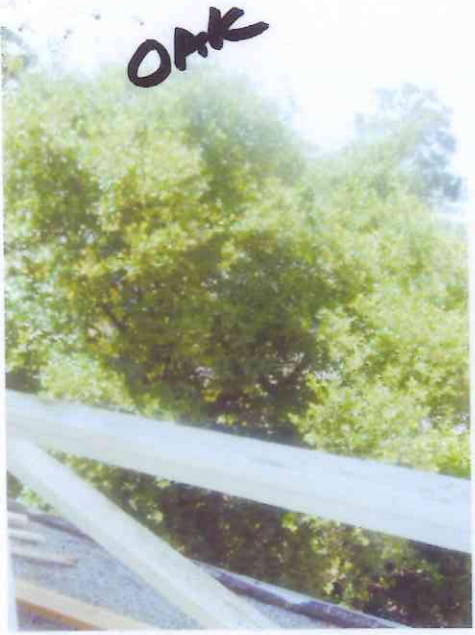
oak

- 30" DBH (diameter at breast height) Coast Live Oak *Quercus agrifolia*
- This tree is located on the back left side of property (N/W side)
- The overall health of this tree is fair
- This tree was heavily reduced in the past and has grown a thick crown which now blocks the view from this home
- In order to regain the view this tree will have to be Re-reduce to last reduction (Pollard)

In order to regain the view this tree will have to be topped by about 60%. The Coast Live Oak *Quercus agrifolia* is a hardy evergreen tree and will survive to heavy topping. This tree was already topped heavy before, around 8-12 years ago. This tree should survive the heavy reduction if done during the fall or spring time. The tree will re-sprout heavy and a new canopy should be established or developed in a two to three year period to a certain height to maintain view. The alternative solution would be to remove this tree.

- 1) Reduce two feet below decks top rail one Coast Live Oak *Quercus agrifolia*

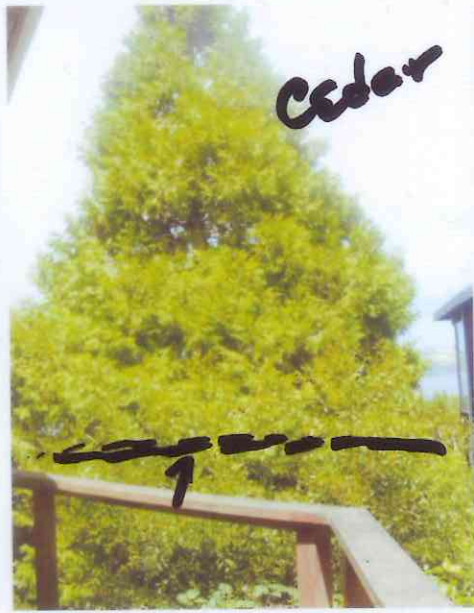
cedar

- 24" DBH (diameter at breast height) Red Cedar *Juniperus virginiana*
- This tree is located on the back right side of the property (N/E side)
- The overall health of this tree is good
- This tree is also blocking the view from this home
- In order to regain the view this tree will have to be reduce by about 50%

In order to regain the view this tree will have to be topped by about 50%. The Red Cedar *Juniperus virginiana* is an evergreen tree that may not respond well to heavy topping. This tree should survive the heavy reduction if done during the fall or spring time. This tree may not re-sprout and the lateral limbs will fight for dominance to act as new dominant leaders. One alternative solution is to open up a window in the canopy of this tree by removing the limbs in the way of the view. The upper canopy will have to be thinned to balance the weight of the crown & reduce the wind sail. The second alternative solution would be to remove the entire tree.

- 4) Reduce back yard Red Cedar *Juniperus virginiana* to decks top rail
