# STAFF REPORT

## SAUSALITO TREES AND VIEWS COMMITTEE

**Project** Macannan Tree / 83 Princess Street  
Tree Alteration Permit  
TRP 11-144

## ARBORIST REPORT

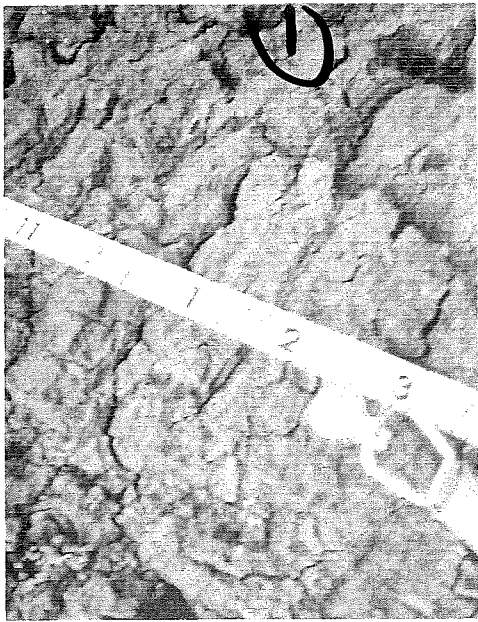
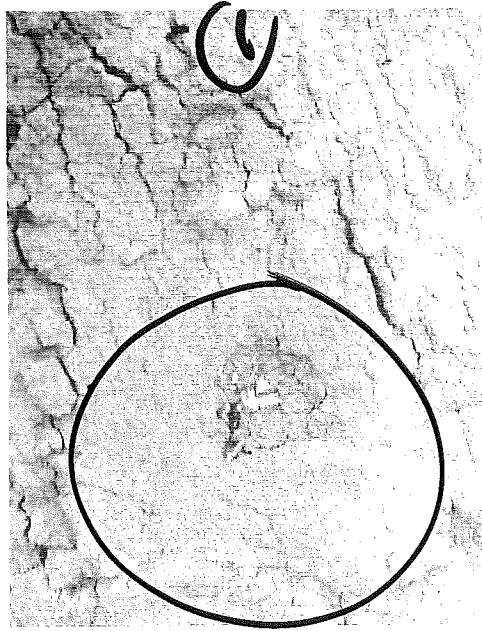
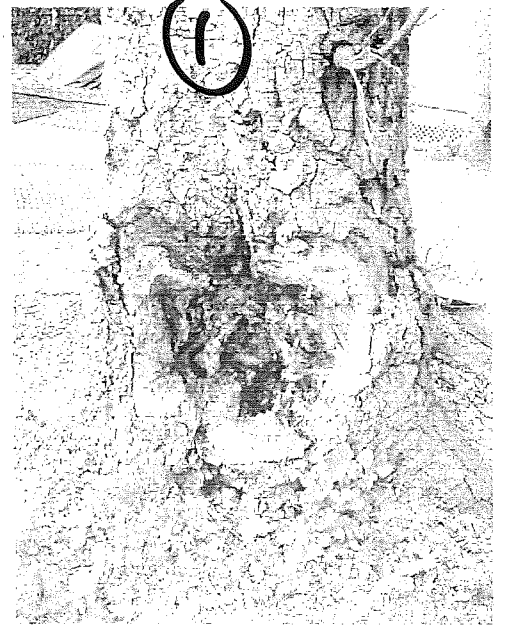
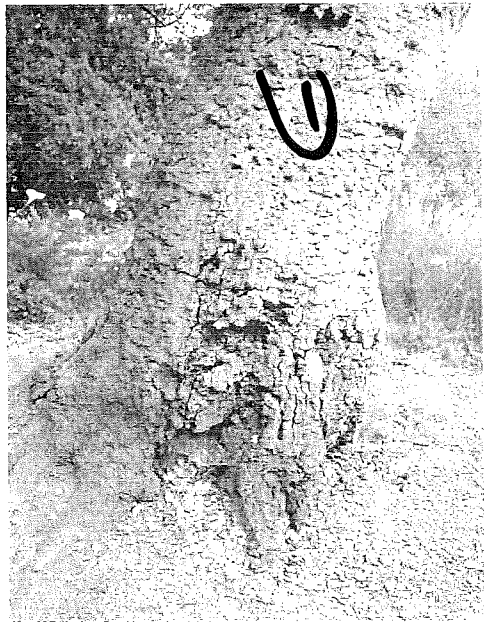
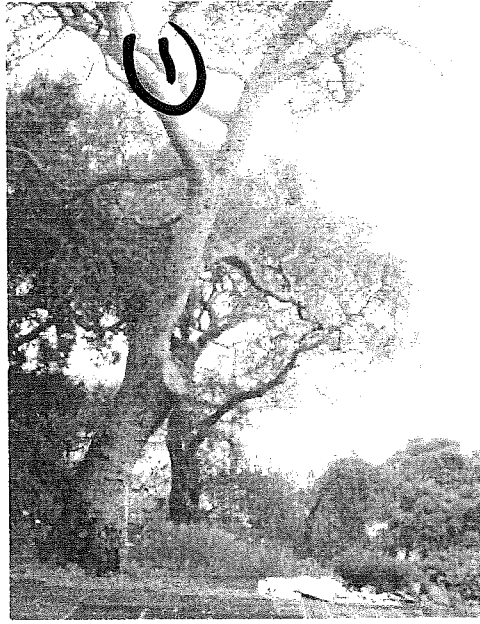
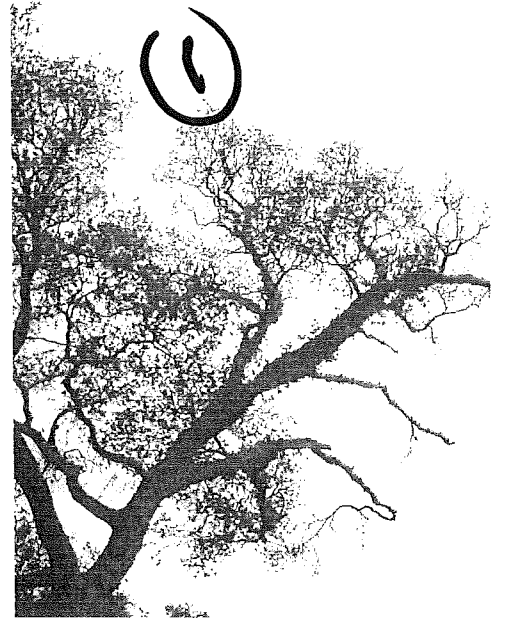
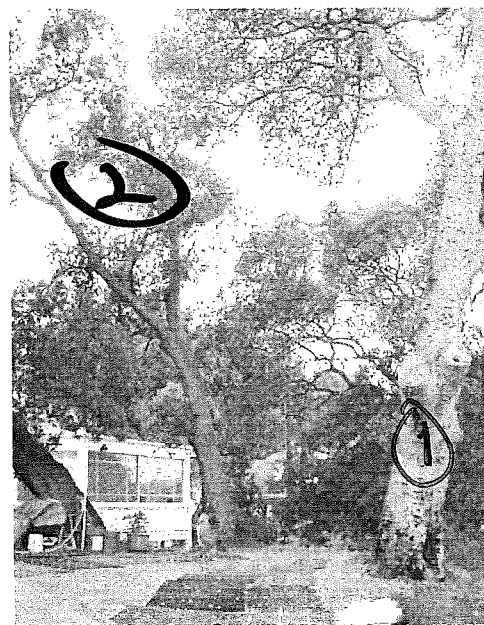
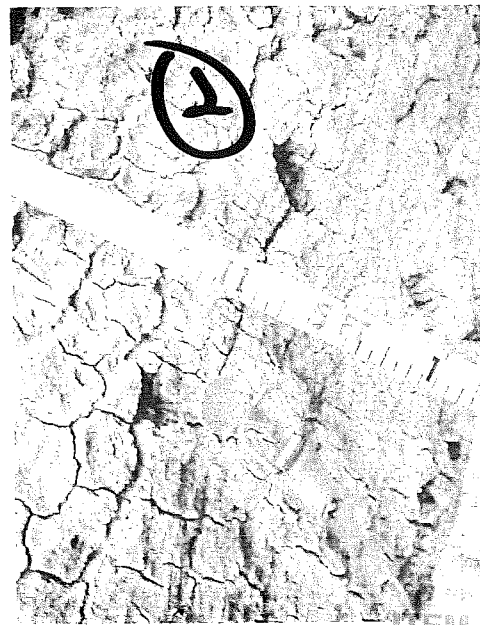
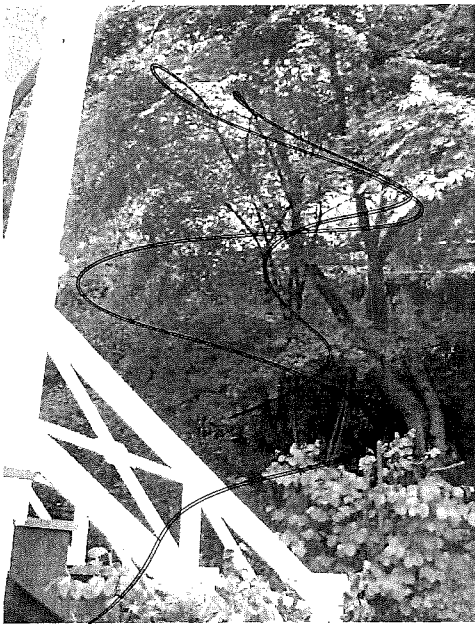
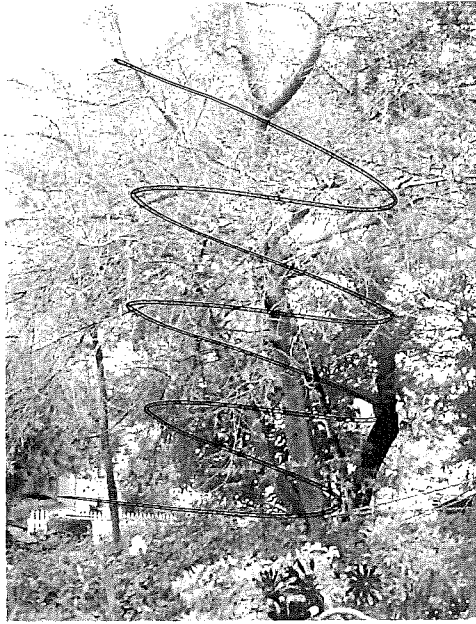
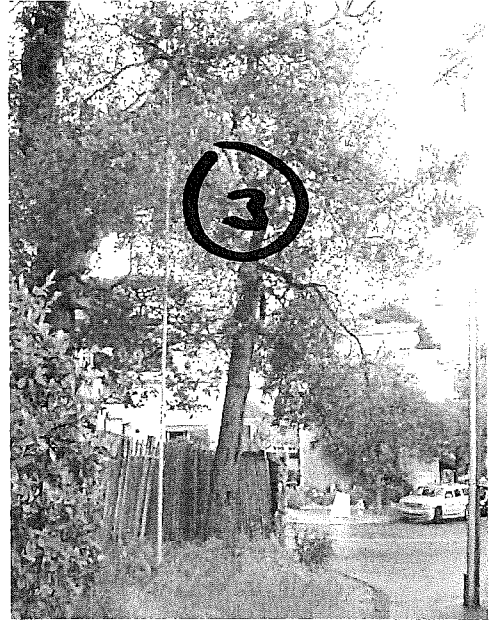
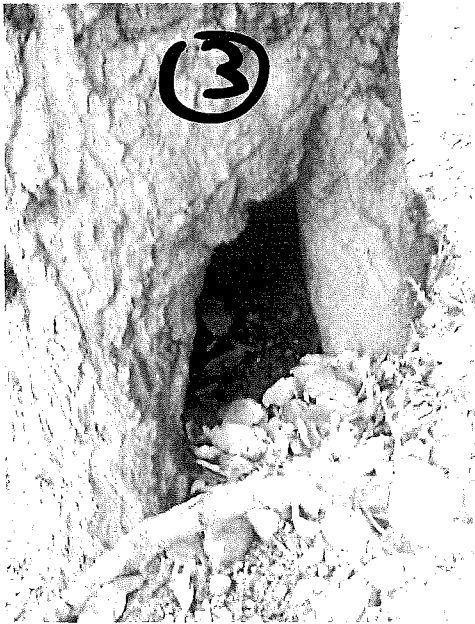
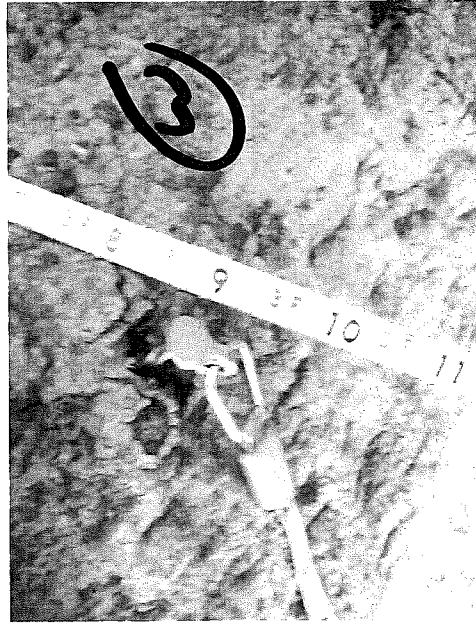
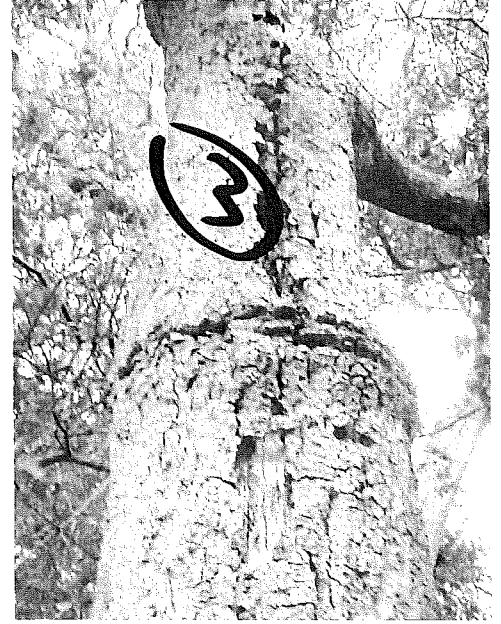
83 Princess St.

- Tree is located at the top of the driveway on right hand side.
- Tree has a CBH of 7'2" and a height of 40'.
- Tree has major decay at base.
- Tree has SOD (Sudden Oak Death) *Phytophthora ramorum*.
- Tree has Armillaria Root Rot *Armillaria mellea*.
- Tree targets driveway and people.
- This tree is considered an extreme hazard.
- Little to no effect on soil stability or water run off.
- Tree is valued at \$4,439.00

- Tree is located at the top of the driveway on right hand side.
- Tree has a CBH of 4'11" and a height of 35'.
- Tree has decay at base.
- Tree targets home and people.
- Tree has lean towards home.
- Tree has dieback on crown tips indicating decline.
- Little to no effect on soil stability or water run off.

- Tree is located at the bottom of the driveway on right hand side.
- Tree has a CBH of 3'9" and a height of 25'.
- Tree has decay at base.
- Tree targets cars and people.
- Tree has major decay from base to crown.
- Tree is in major decline.
- Tree is being held up by a metal brace.
- Little to no effect on soil stability or water run off.
- Tree is valued at \$954.00

Trees are in severe decline and have targets.

Recommend immediate removal of these hazardous trees due to targets of home, cars and people.
