DEPARTMENT OF PUBLIC WORKS
 TREE MAINTENANCE ACTIVITIES PERFORMED AND PENDING
 SEPTEMBER 2011

RE: Monterey Pine (*Pinus radiata*) located on the corner of Miller Ave and Spencer Ave

**View Obstruction Arborist Report
81 Cazneau Avenue, Sausalito, CA**

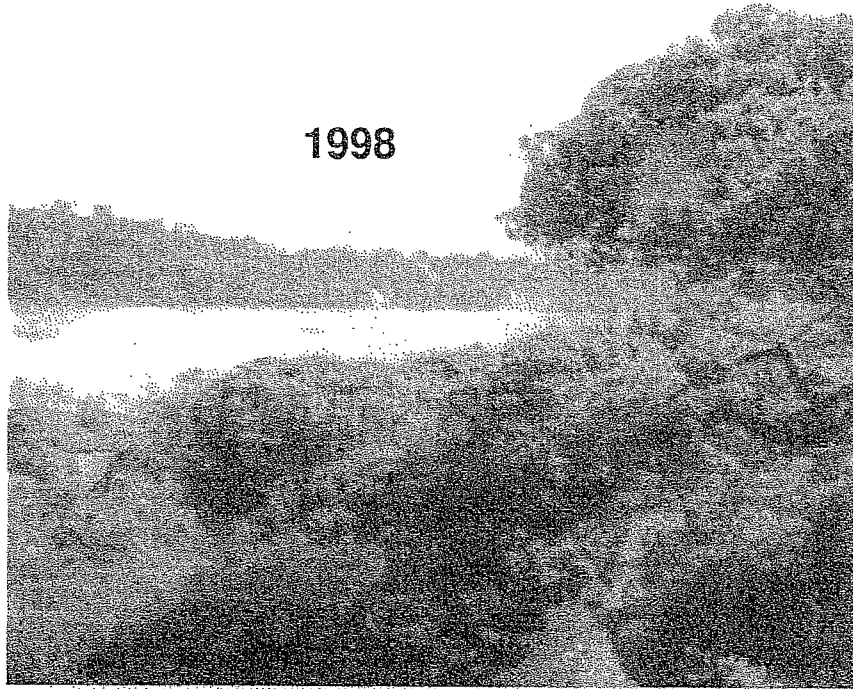
On the next page are two photographs showing the views from the Wells living room that were present in 1998 and in 2011. The approximate line of proposed pruning is shown on the 2011 photo in red.

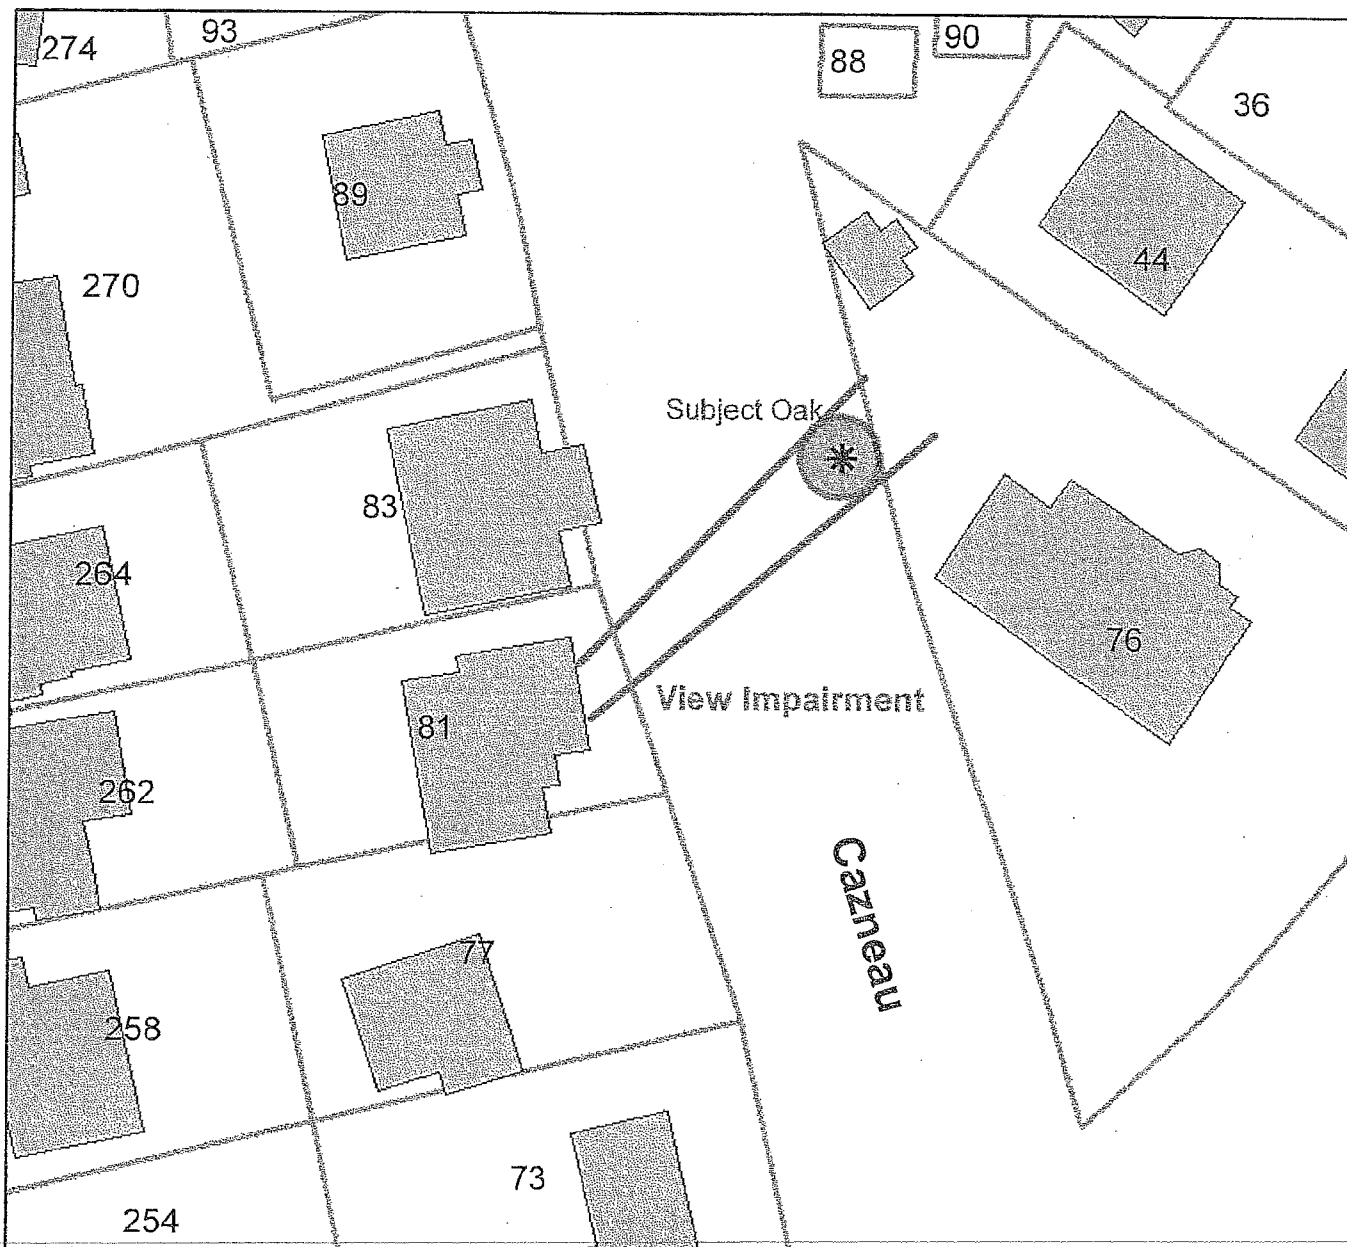
Site Map for Pruning Application
 81 Cazneau Avenue
 Sausalito, CA

Tree	Species	CBH (in)	DBH (in)	Height (ft)	Value
Subject Oak	Quercus agrifolia	37.7	12.0	16	\$3,000
