Ed Gurka, Consulting Arborist

August 1, 2011

ASSIGNMENT:

A request to provide an Arborist Report for Stefan Hastrup, Turnbull Griffen & Haeslopp and Daphane Edwards, MLA, for the Collier Reynolds Residence located at 2-2¹/₂ Bulkley Avenue construction project. Plants scheduled for removal, and replacement are located on public right of way and private property locations. The proposed removals will include replacement of landscape plants with plants suitable to the designated location. This report will provide information on trees within the front yard area and make recommendations for future construction plans.

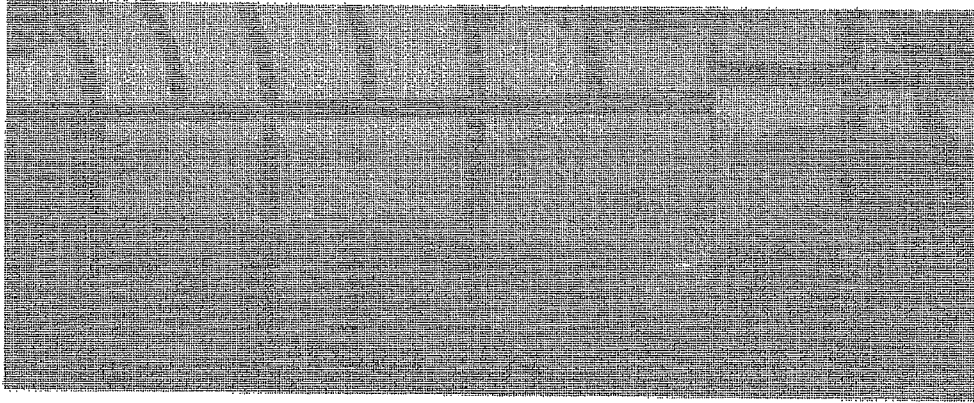
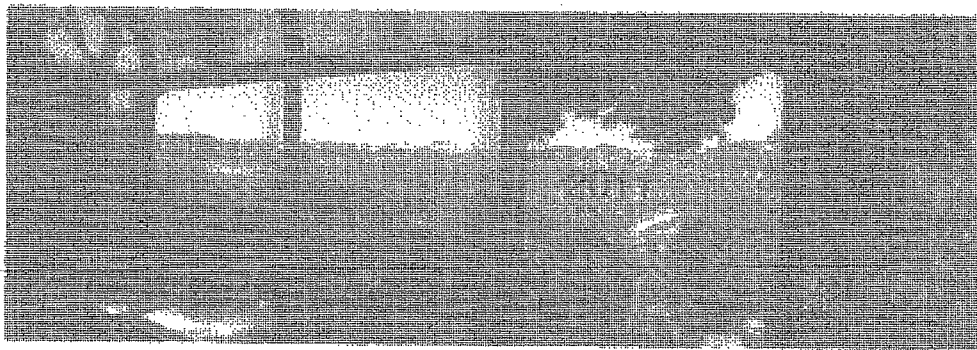
Below are two photographs showing the view from the Skunda sun room that were present in 1996 and in 2011. Also included are ground photographs of the four subject trees for which pruning is requested.

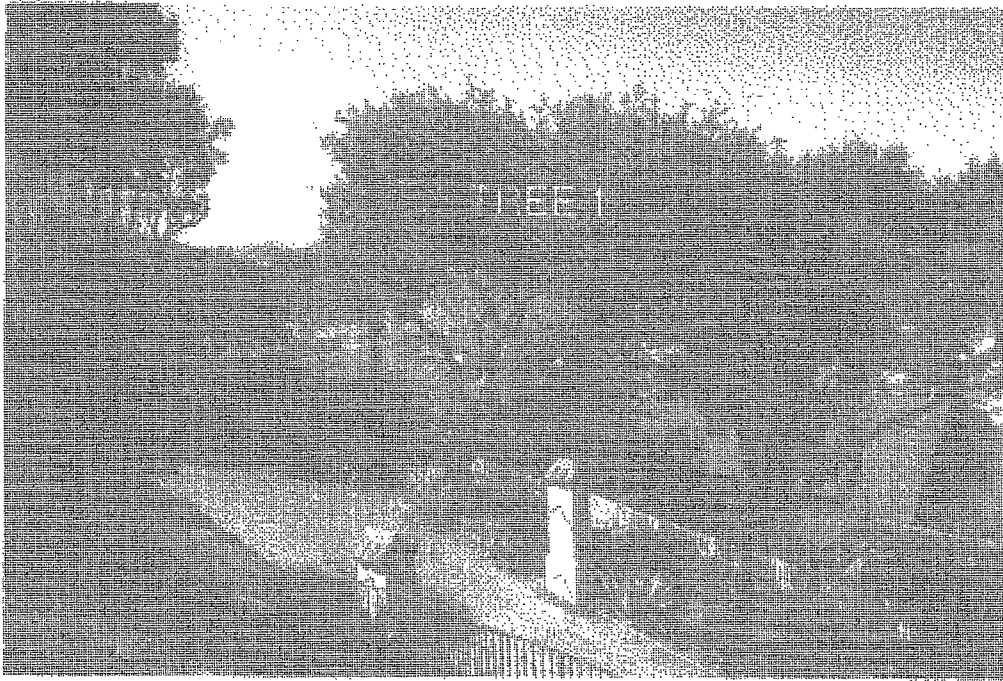
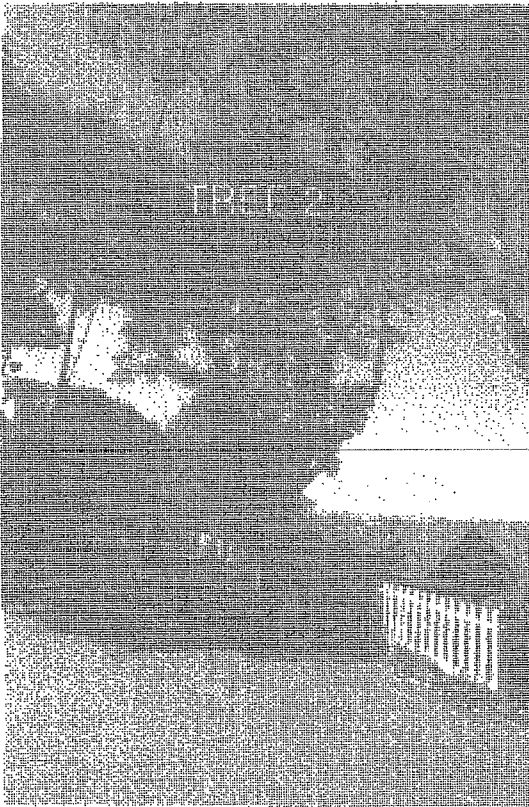
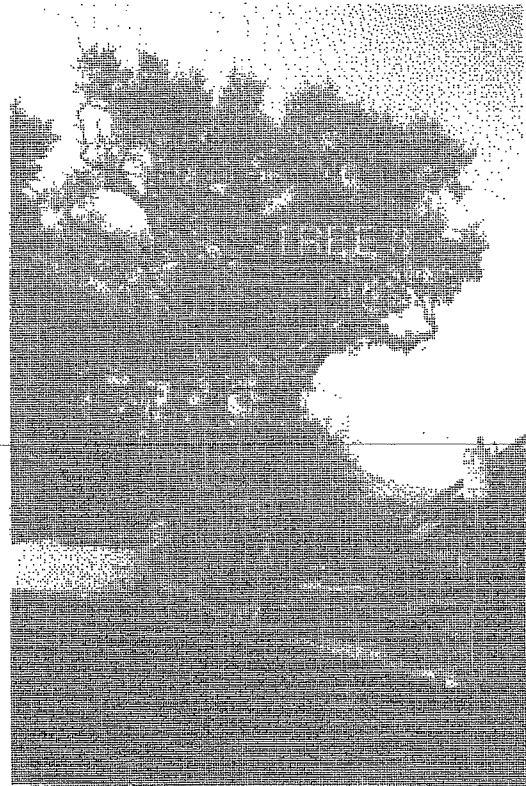
Suggestions for improving the health of the tree, such as improving root or soil conditions beneath the tree. I have no recommendations for improving the health of the subject trees. All three trees show no symptoms of sudden oak death (*Phytophthora ramorum*) and are growing under stable soil conditions. Tree #3 has incipient trunk decay that warrants regular safety inspections.

Description and reasons for alteration. Mr. Skunda proposes to maintain three coast live oaks downslope of his property to restore pre-existing views of Strawberry Point, Richardson Bay, and the Tiburon Peninsula from his sun and living rooms. Approximately 2-4 feet of the upper canopies will be pruned per American National Standards Institute (ANSI A300) pruning standards.

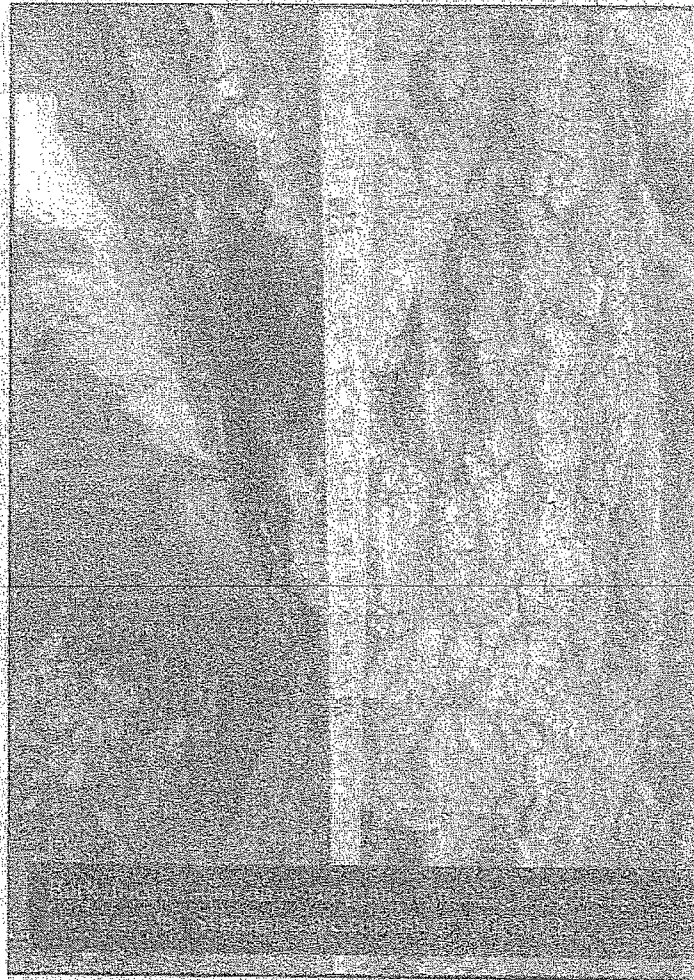
Tree #2

This tree is identified as a *Quercus agrifolia*, Coast Live Oak. The Circumference at Breast Height (CBH) is 3.8 feet. This Oak tree is located on the North property boundary 12 inches from the curb of Lower Crescent Avenue opposite the neighboring property of 54 Lower Crescent Avenue. The tree is 5 feet left of the driveway at 49 Lower Crescent Avenue, and the canopy extends over the home. A large trunk cavity was noticed at 6 feet above grade. The cavity opening measured 11x6 inches. The interior of the cavity, (cavity pocket) measured 5 inches in depth from the lowest part of the cavity opening. The extent of the decay was masked with tape to indicate the extent of the decay in proportion to the overall circumference of the tree, see photograph at right.

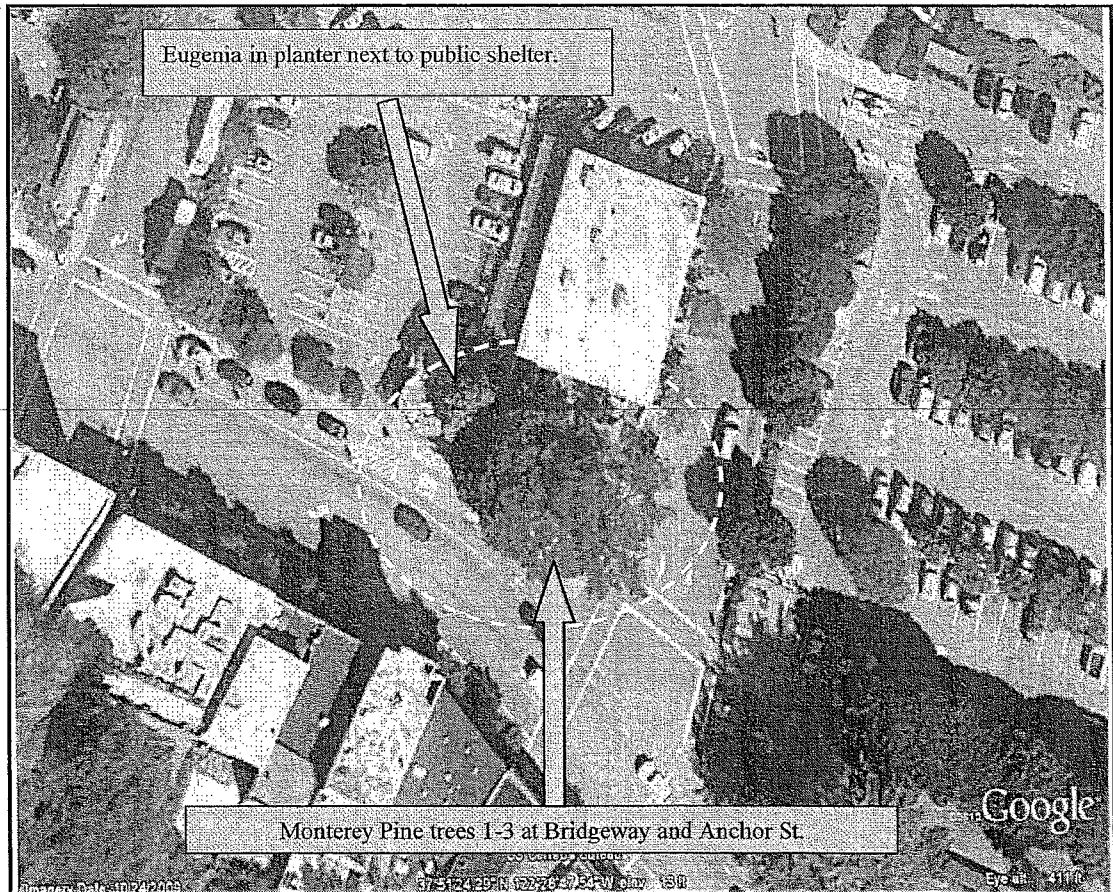
The trees are identified as three mature *Pinus radiata*, Monterey Pine and a *Syzygium paniculatum*, Eugenia paniculata, Australian Brush Cherry. The three Monterey Pine trees are located in a planter area bordered by a brick plaza and Bridgeway sidewalk. The Eugenia tree is located just to the left in a small planter that is next to and below the ramp leading from the bus shelter portion of the structure to the public restrooms. See aerial photograph page 1. The circle indicates the three pine trees in the planter and the Eugenia tree by the bus stop and restrooms.
