DEPARTMENT OF PUBLIC WORKS
 TREE MAINTENANCE ACTIVITIES PERFORMED AND PENDING
 OCTOBER-NOVEMBER 2011

Arborist Report, Monterey Pine Tree, Spencer & Miller Avenue, Sausalito, CA.
Prepared by Ed Gurka Independent Services, San Rafael, California

**View Obstruction Arborist Report
81 Cazneau Avenue, Sausalito, CA**

Arborist Report 2 Bulkley Avenue, Sausalito, CA
Prepared by Ed Gurka, Independent Services, San Rafael, California

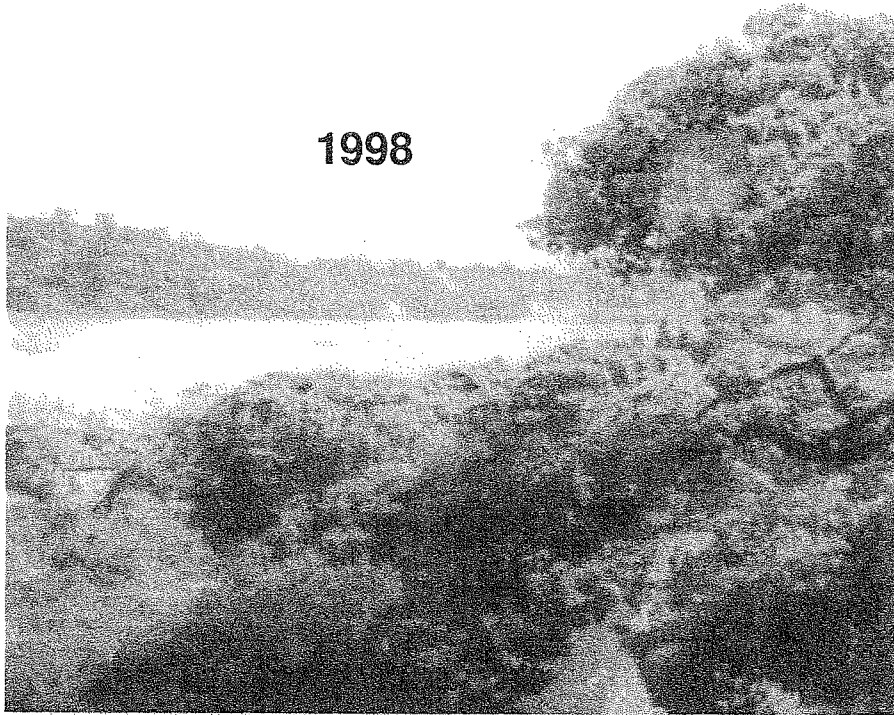
On the next page are two photographs showing the views from the Wells living room that were present in 1998 and in 2011. The approximate line of proposed pruning is shown on the 2011 photo in red.

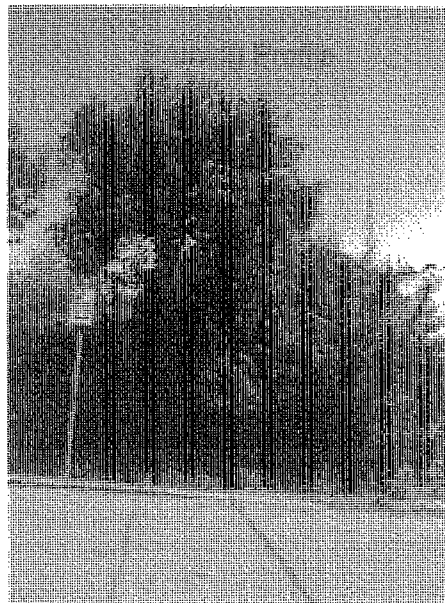
Description and reasons for alteration. Ms. Wells proposes to prune one coast live oak downslope of her property to restore a documented, pre-existing view of Richardson Bay and Sausalito Yacht Harbor from her living room. Approximately 2-4 feet of the upper canopy would be pruned per American National Standards Institute (ANSI A300) pruning standards. See pruning profile in photo at right.

Structural or health effects on the tree which would result from the proposed alteration. The subject tree is expected to maintain its structural integrity and systemic health after pruning is completed.
