Ed Gurka, Consulting Arborist  
 Member, American Society of Consulting Arborists

I received a request to prepare an Arborist Report that will describe trees located within a proposed public works construction project on the public right of way in front of 750 Bridgeway, Sausalito, California. A report is necessary because the trees are located in the construction area and will affect the planning and outcome of the project. This report will provide information on the trees' condition, their compatibility for the location, and make a recommendation based on the information and knowledge of the species.

**RE:** Black Acacia (*Acacia melanoxylon*) located at the intersection between Sausalito Blvd and Spencer Ave, on the left side of the stairway on Cooper Lane

Re: Tree report proposing pine tree removals

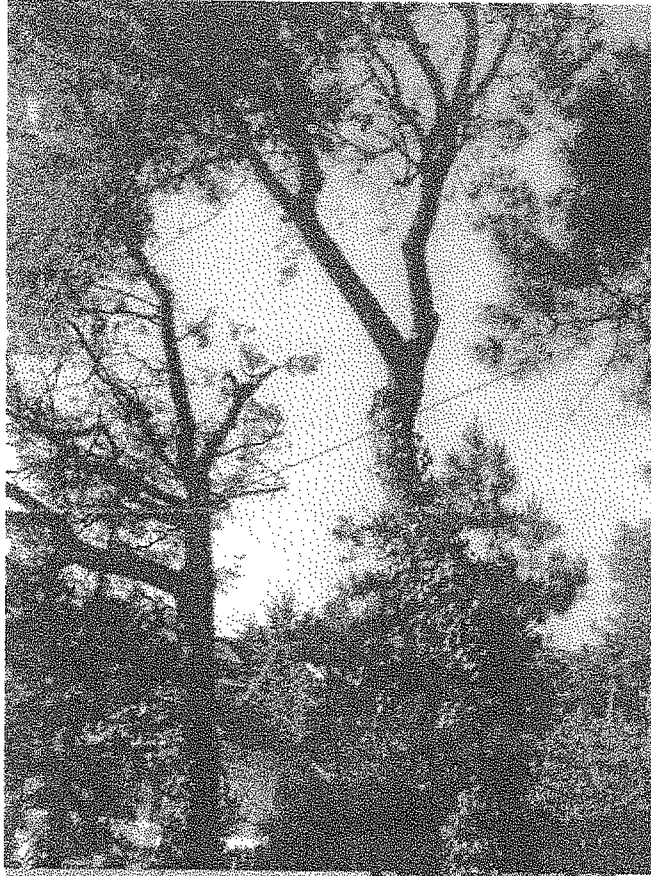
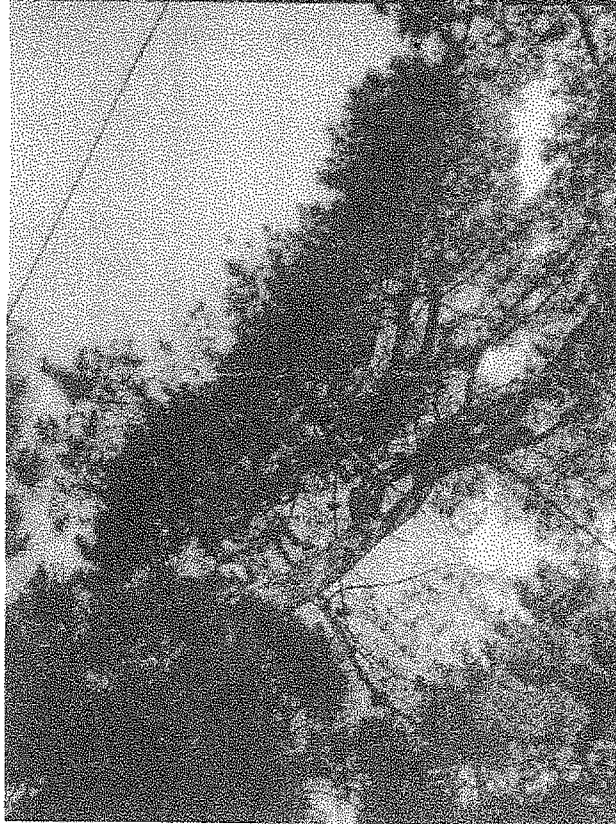
This letter is in response to your query about the current condition and general outlook of the four pine trees located along the PG&E high voltage power lines that run along the street side of your property. Three of the trees are Monterey pines, *pinus radiata*, starting with the down hill most tree and moving uphill the dbh measurements are 28", 25" and 17" dbh, diameter at breast height and one pine is a Canary Island pine, *pinus canariensis*, with a dbh of 17.5". The trees range from 40-60 feet in height. They have been repeatedly reduced in height with heading cuts, and drop crotch pruning, with many branches eventually dying back as a result of PG&E's line clearance and vegetation management program

Pine pitch canker is found evident by dead or dying back twig tops. There is evidence of bark beetle activity inside of the trees indicated by the presence of beetle frass or a mix of beetle excrement and sawdust. These beetles will eventually girdle and kill the tree. It's only a matter of time. The present structure of the trees are producing long heavy ended lever arms growing out towards parked cars on the street and children playing in the yard around the trees. These trees are too old and far gone for restructuring, they also pose a risk to the power lines, it would be better to remove them and plant something more suitable for overhead high voltage lines, something much shorter in stature at maturity and unlikely to interfere with the utilities.
