DEPARTMENT OF PUBLIC WORKS TREE MAINTENANCE ACTIVITIES PERFORMED AND PENDING JULY 2012

Ed Gurka, Consulting Arborist Services Member, American Society of Consulting Arborists Certified Arborist, International Society of Arboriculture, Western Chapter, # 0418

October 16, 2011

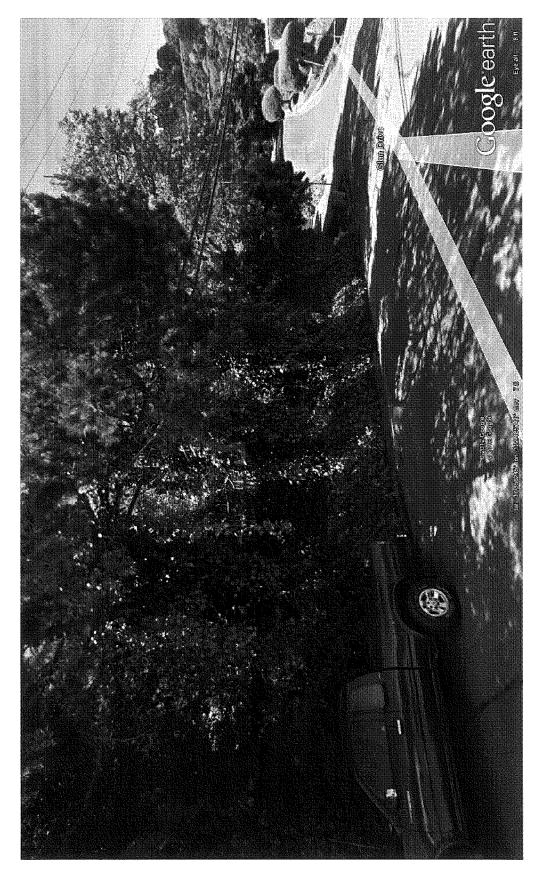
49 Glen Drive Google Street View

COMMENTS	leaning stem to tree's other stems to increase stability. Two proposals rec'd for install of cabling and pruning. Low is \$1980 Significant lifting of curb section, branches straining telecommunications cables (see picture). Arborist report pending.	Emergency removal. Trunk of tree had a 4" split. Removed by city crew. Stump needs to be ground with cement repair to follow. No arborist report. Seasonal pruning. Tree posted 7/17/12. Arborist report.
REMOVED	Pending	Completed 6-1-12
ALTERED (TRIM)		Pending
DIAMETER		
TYPE OF TREE	3) Pine (variety pending)	1) Myoporum
ADDRESS	ROW at 49 Glen Drive (Rose Ct)	ROW at 1001 Bridgeway ROW at 115 Harrison Ave
