Friar Associates, Incorporated . Engineers . Consultants Soils . Foundations . Geology . Geotechnology

June 24, 2019 Project 1942

Report Geotechnical Investigation New Residential Development 654 Sausalito Boulevard Sausalito, California

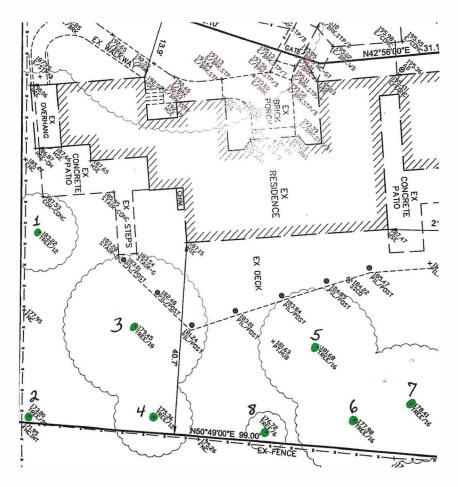
#### TREE LOCATION at 654 Sausalito Blvd., Sausalito, CA

Tree No. #	Species	DBH	Height	Dripline	Condition
#1	Q.agrifolia	12 in	12ft	5 ft	Р
#2	Q.agrifolia	24 in	30 ft	15 ft	Р
#3	Q.agrifolia	18 in	25 ft	17 ft	Р
<mark>#</mark> 4	Q.agrifolia	12 in	20 ft	10 ft	Р
<b>#</b> 5	Q.agrifolia	16 in	25 ft	10 ft	Р
<b>#</b> 6	Q.agrifolia	16 in	25 ft	5 ft	Р
#7	Q.agrifolia	16 in	20 ft	5 ft	Р
#8	L.nobles	6 in	15 ft	4 ft	Р

Trees #1-7 (Q.agrifolia)

Tree #8 (L.nobollis)
