DEPARTMENT OF PUBLIC WORKS
 TREE MAINTENANCE ACTIVITIES PERFORMED AND PENDING
 JULY 2011

BARTLETT TREE EXPERTS

RE: Black Acacia (*Acacia melanoxylon*) located at the intersection of Currey Ave, Platt Ave and Monte Mar Dr in Sausalito.

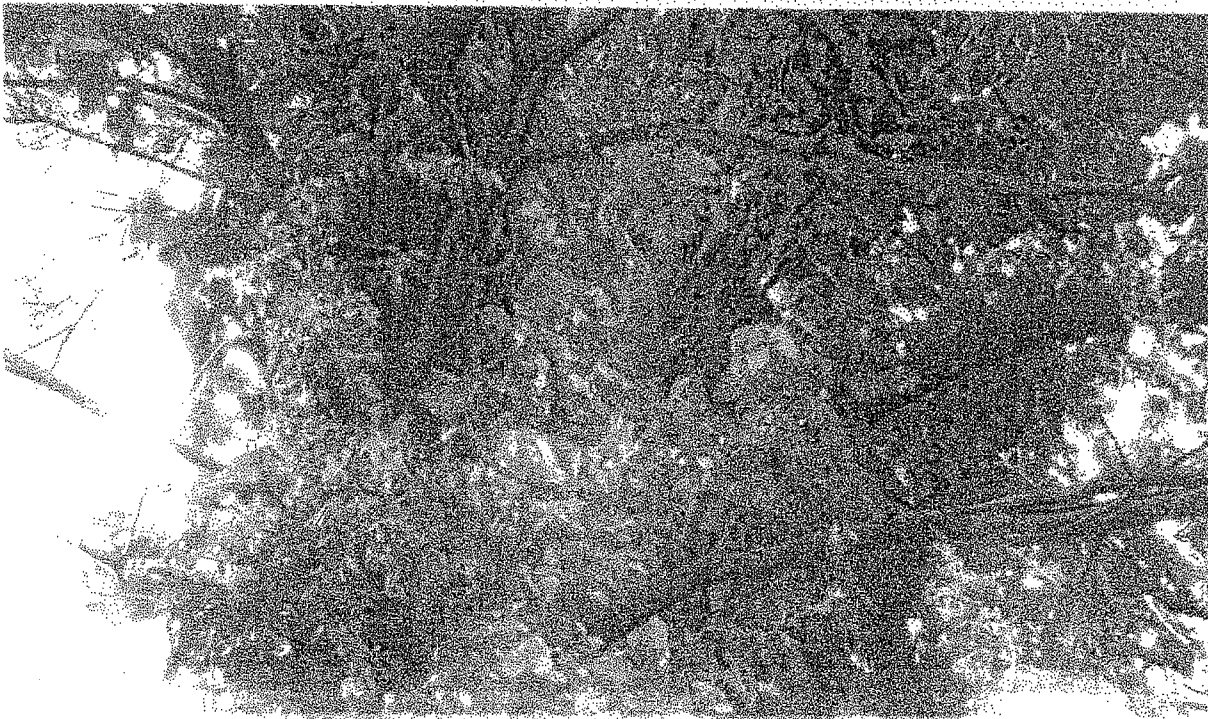
There is a large amount of Ivy growing up the trunks of the leaders from ground-level to the crown of the tree as shown in photo 2. This is a problem for three reasons: one, this increases the weight or load of the tree. Two, it increases the trees wind resistance; in other words the wind cannot actually blow through the tree without encountering more resistance. This increases the possibility of a failure. And finally, three, as the Ivy grows in caliper and the tree trunks grow in caliper, the Ivy starts constricting around the trunk and this becomes a problem when it can girdle the flow of nutrients up and down in the Cambia Layer.

This situation causes numerous problems, such as tip die back and even total death of one of the leaders. When examining the leaders I noted that the plane in which several of the limbs emanate from and have tight crotches of greater than 60° which is ideal in the tree world. This species happens to be weak structurally in regards to where the limbs attach, which is a cause of limb failure. Photo #3 depicts a limb failure in the lower canopy.

The value would then be degraded by a condition and location factor to come up with the appraised value of the tree. As you can see in the appraisal of the tree, it is not worth much money, and the tree has already had failures.

Conclusion: I recommend that the tree be removed as soon as possible to prevent damage to the home below and the possibility of injury to persons or vehicles on the street. If the city does not act to remove the tree, then they will have to pay the cost of an accident or indemnify themselves.
