DEPARTMENT OF PUBLIC WORKS
 TREE MAINTENANCE ACTIVITIES PERFORMED AND PENDING
 SEPTEMBER 2011

Tree Maintenance Activities September 22, 2011

Arborist Report, Monterey Pine Tree, Spencer & Miller Avenue, Sausalito, CA.
Prepared by Ed Gurka Independent Services, San Rafael, California

Arborist Report 2 Bulkley Avenue, Sausalito, CA
 Prepared by Ed Gurka, Independent Services, San Rafael, California

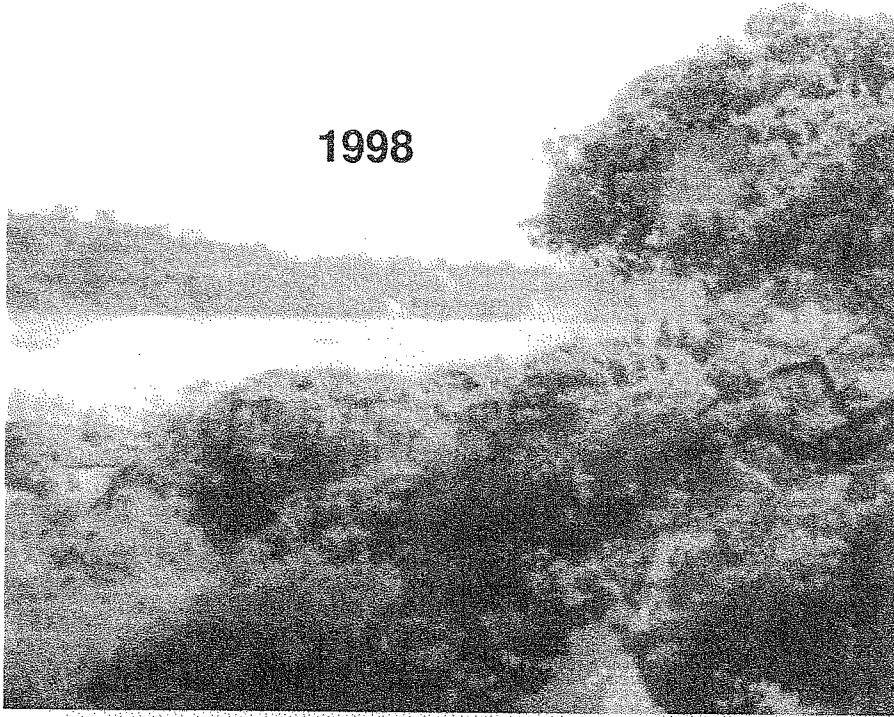
On the next page are two photographs showing the views from the Wells living room that were present in 1998 and in 2011. The approximate line of proposed pruning is shown on the 2011 photo in red.

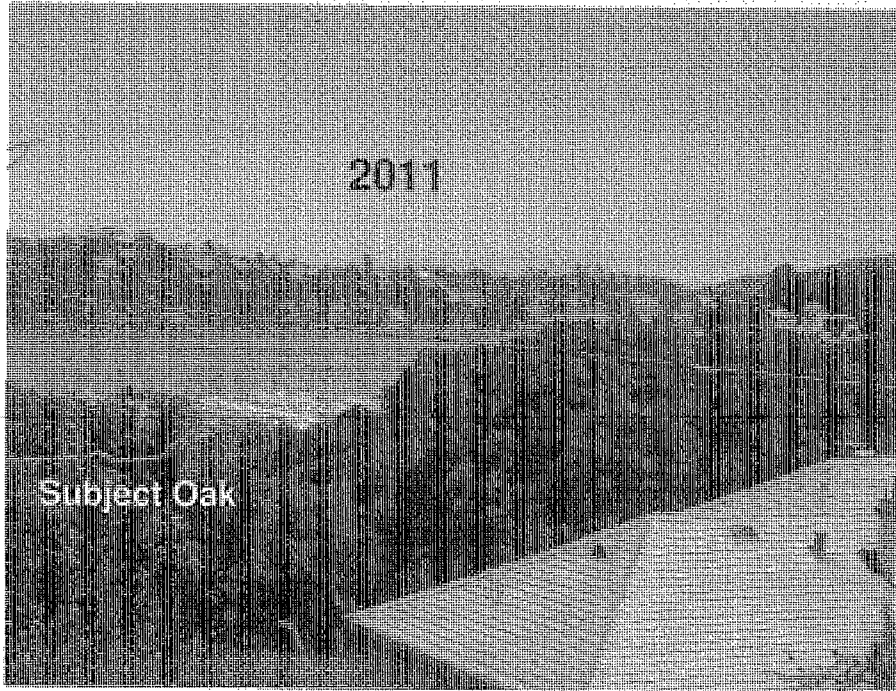
2011

Description and reasons for alteration. Ms. Wells proposes to prune one coast live oak downslope of her property to restore a documented, pre-existing view of Richardson Bay and Sausalito Yacht Harbor from her living room. Approximately 2-4 feet of the upper canopy would be pruned per American National Standards Institute (ANSI A300) pruning standards. See pruning profile in photo at right.

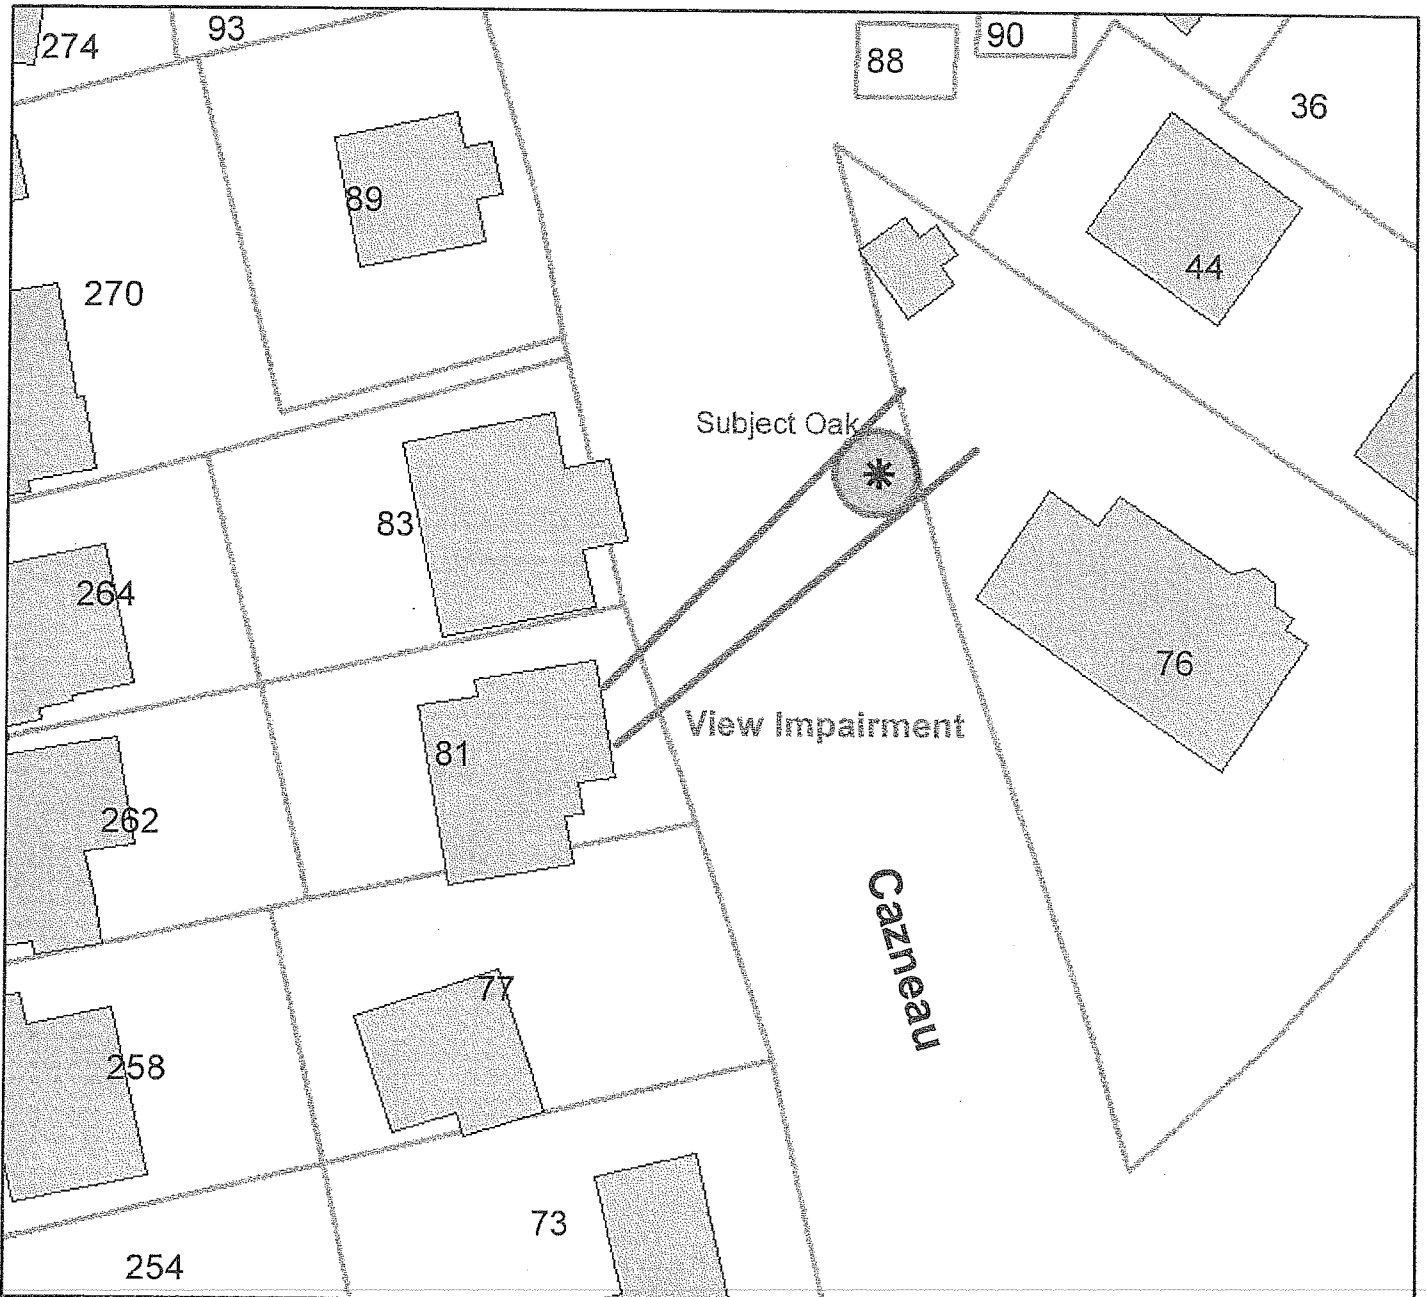
Site Map for Pruning Application
 81 Cazneau Avenue
 Sausalito, CA

Tree	Species	CBH (in)	DBH (in)	Height (ft)	Value
Subject Oak	Quercus agrifolia	37.7	12.0	16	\$3,000

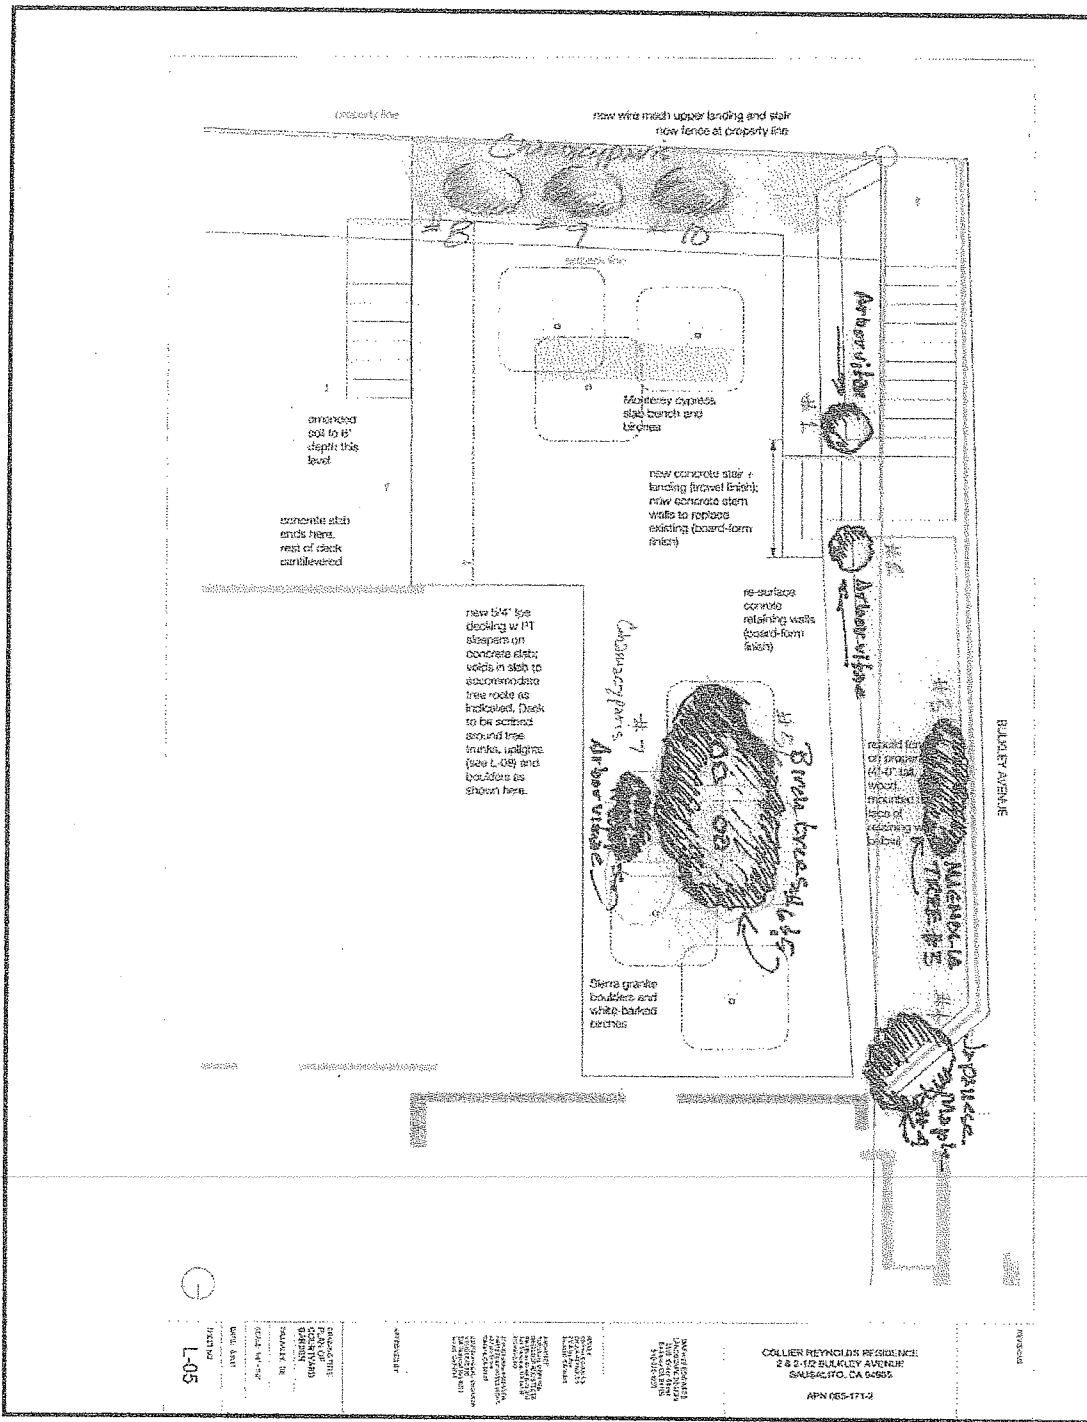
Site map with tree locations trees numbered 1, 2, 3, 4, 5, 6, 7, 8, 9, and 10 are to be removed and replaced with other trees, small shrubs, and perennials.
