ARBORIST REPORT

I have inspected 4 *Pittosporum undulatum* located at 254 Glen Drive and have made the following report.

View Obstruction Arborist Report
141 Santa Rosa Avenue
Sausalito, CA

Site Map for Pruning Application
 141 Santa Rosa Avenue
 Sausalito, CA

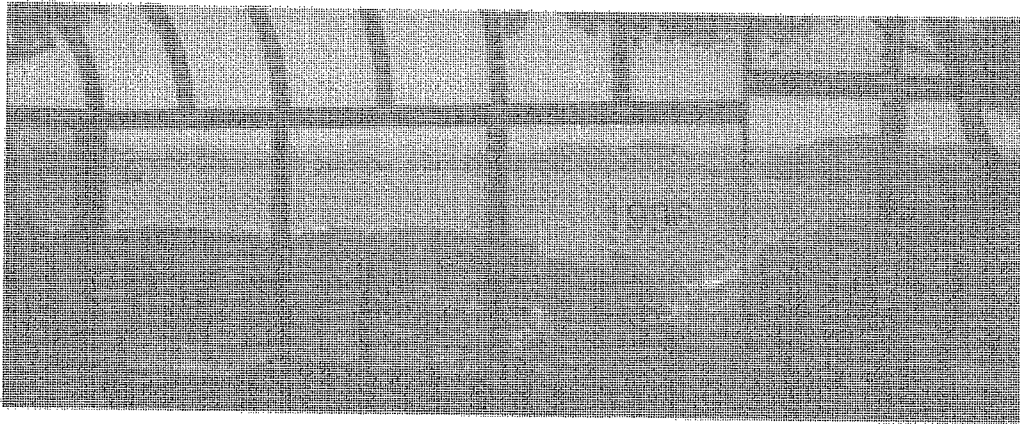
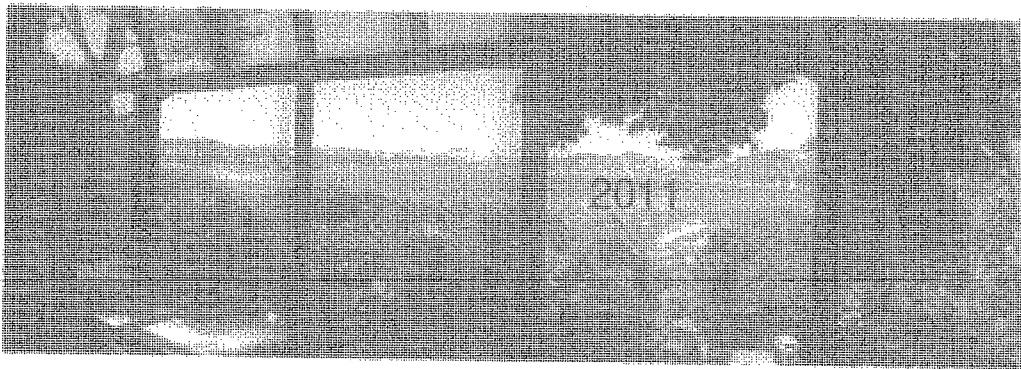
Below are two photographs showing the view from the Skunda sun room that were present in 1996 and in 2011. Also included are ground photographs of the four subject trees for which pruning is requested.

Description and reasons for alteration. Mr. Skunda proposes to maintain three coast live oaks downslope of his property to restore pre-existing views of Strawberry Point, Richardson Bay, and the Tiburon Peninsula from his sun and living rooms. Approximately 2-4 feet of the upper canopies will be pruned per American National Standards Institute (ANSI A300) pruning standards.

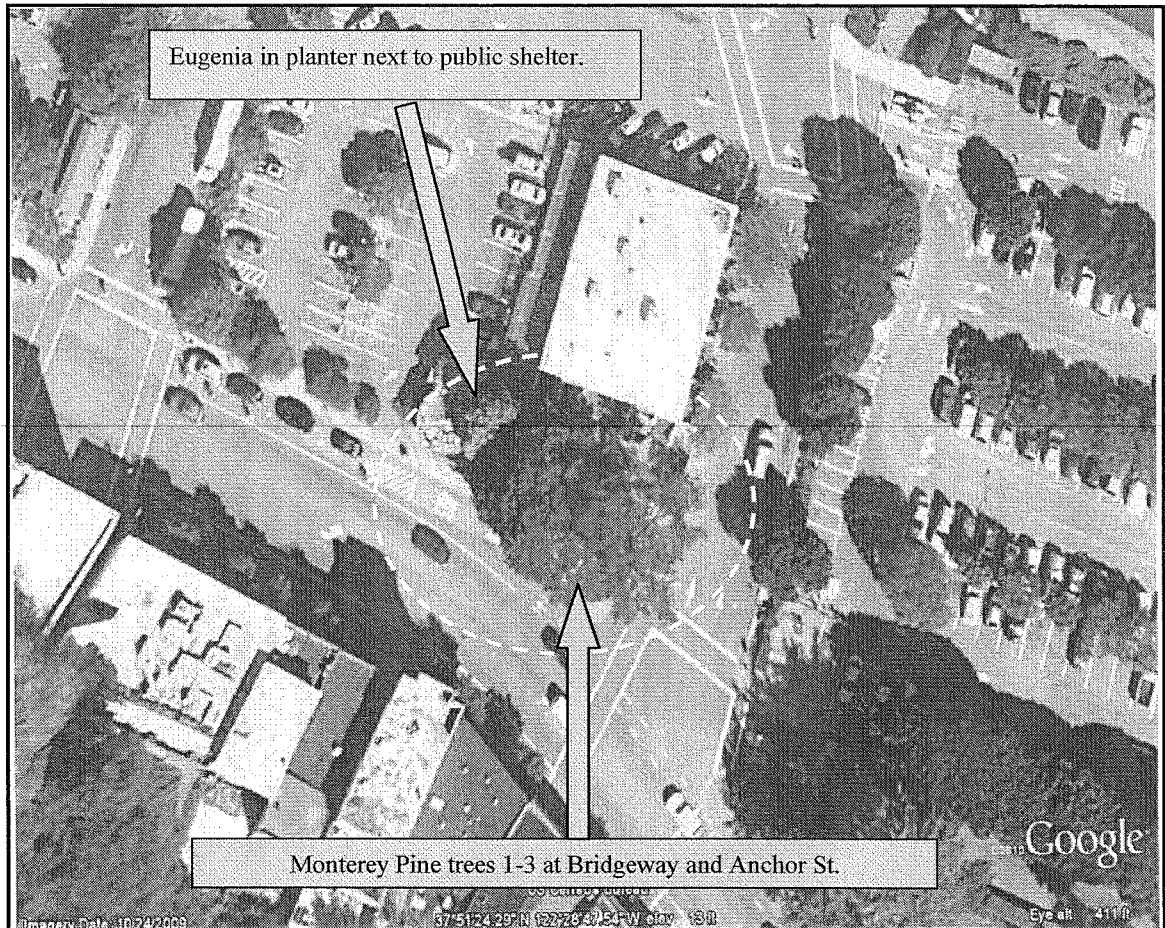
information on these trees. The third visit was made July 13th, after a large limb failure on one of the trees.

The trees are identified as three mature *Pinus radiata*, Monterey Pine and a *Syzygium paniculatum*, Eugenia paniculata, Australian Brush Cherry. The three Monterey Pine trees are located in a planter area bordered by a brick plaza and Bridgeway sidewalk. The Eugenia tree is located just to the left in a small planter that is next to and below the ramp leading from the bus shelter portion of the structure to the public restrooms. See aerial photograph page 1. The circle indicates the three pine trees in the planter and the Eugenia tree by the bus stop and restrooms.
