Facility Condition Assessment

Executive Summary Report

For
MLK Campus
City of Sausalito

Date of Report April 28 2015

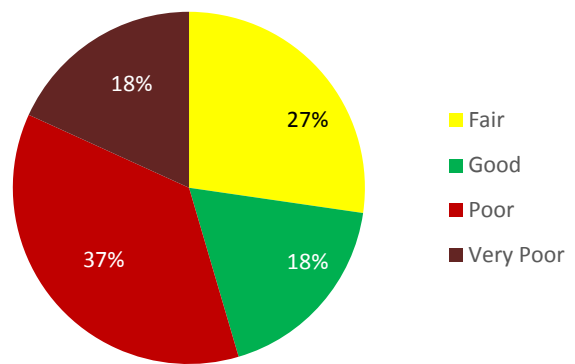
Current Campus FCNI Ratings

The Current campus FCNI chart indicates that currently 18% of the buildings are in good condition, 27% in fair condition, 37% in poor condition and 18% in very poor condition.

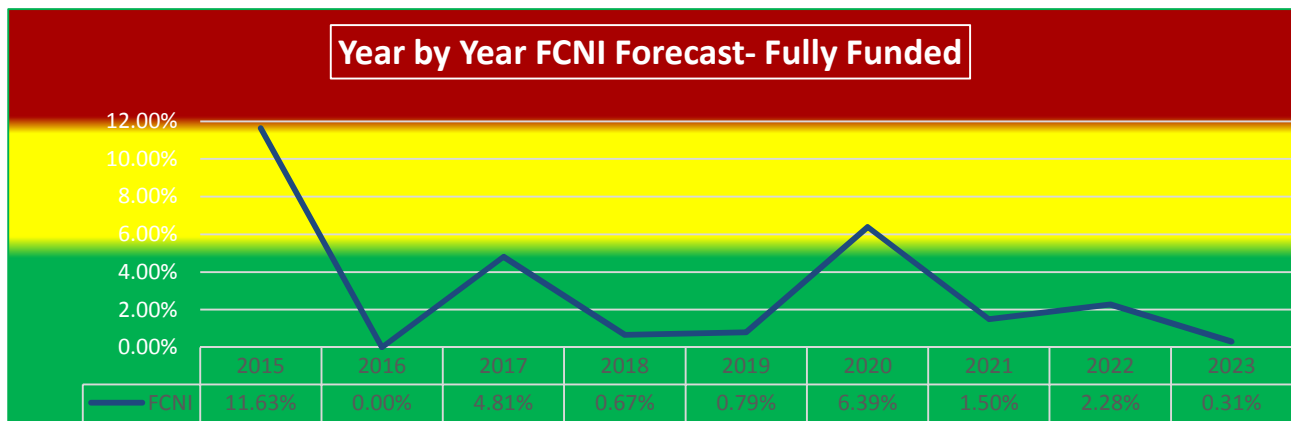
The Year by Year FCNI Forecast chart below illustrates the condition of the combined MLK campus should the identified needs be fully funded each year.

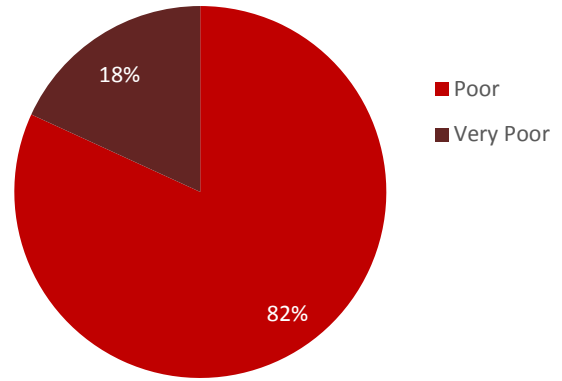
Year 10 FCNI with No Spend Over the Study Period

The Year 10 FCNI with No Spend over the Study Period Chart indicates the cumulative effects of the FCNI ratio over the study period assuming the required funds and expenditures are NOT provided to address the identified works and deferred maintenance each year. The chart indicates that 82% of the buildings will fall into Poor condition and the remaining 18% will be in Very Poor condition.

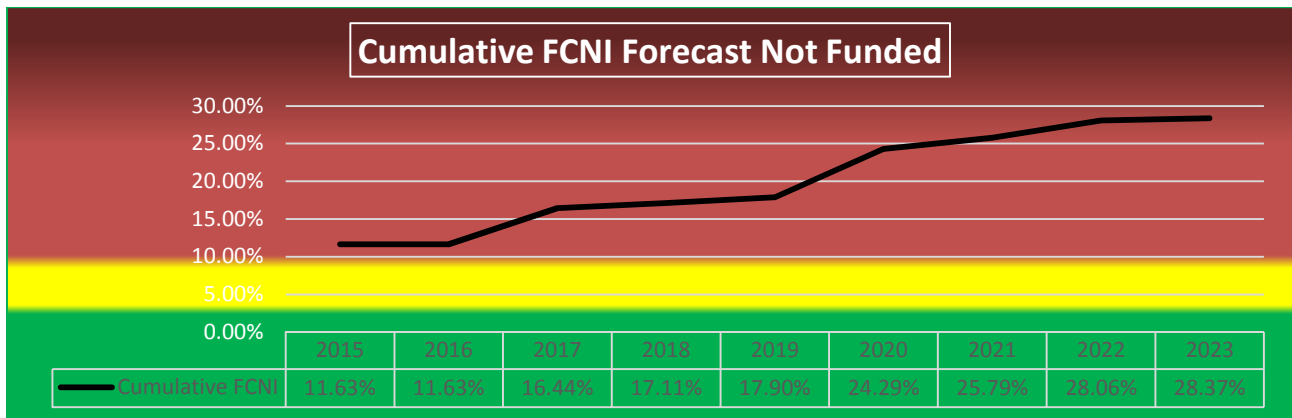
The Cumulative FCNI Forecast chart below illustrates the condition of the combined MLK campus should the identified needs NOT be fully funded each year.

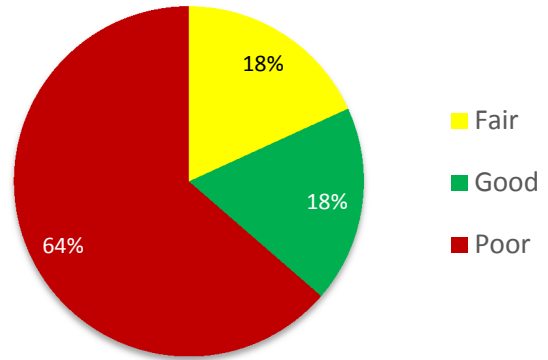
Year 10 FCNI After DM Needs are Complete Over the Study Period

The Year 10 FCNI after Deferred Maintenance (DM) needs are complete over the Study Period Chart indicates the cumulative effects of the FCNI ratio over the study period assuming the Deferred Maintenance Needs are addressed early in the study period. The chart indicates that 64% of the buildings will fall into Poor condition and 18% will be in fair condition with 18% in good condition.

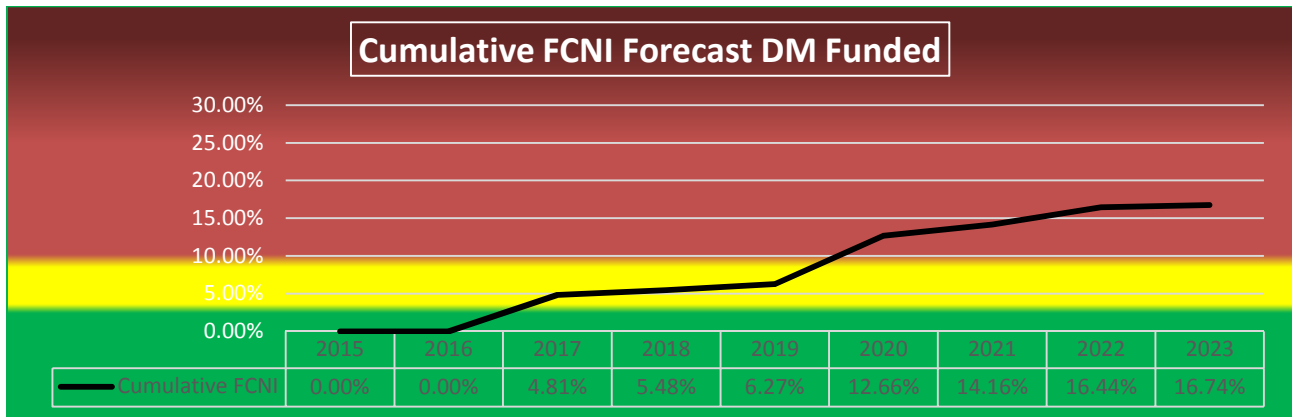
The Cumulative FCNI Forecast chart below illustrates the condition of the combined MLK campus should the identified needs for Deferred Maintenance be initially funded and the remaining years NOT be fully funded each year.

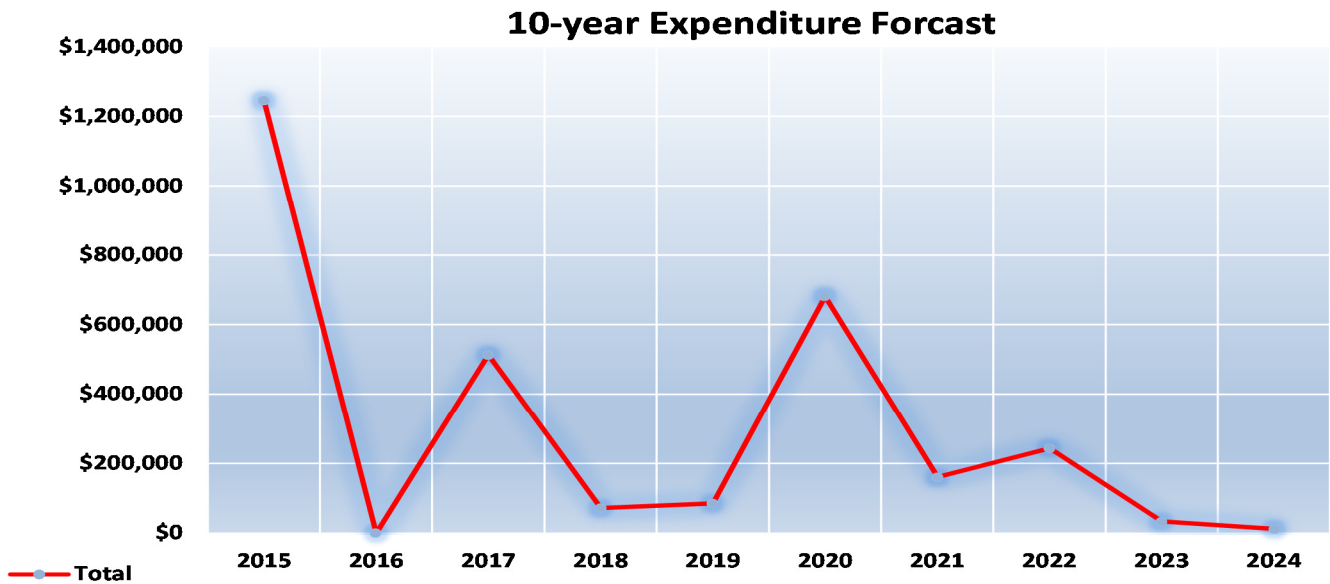
The chart below provides a summary of yearly anticipated expenditures over the ten year study period for the MLK campus. Further details of these expenditures are included within each respective report section. The results illustrate a total anticipated expenditure over the study period of circa **\$3,038,045**

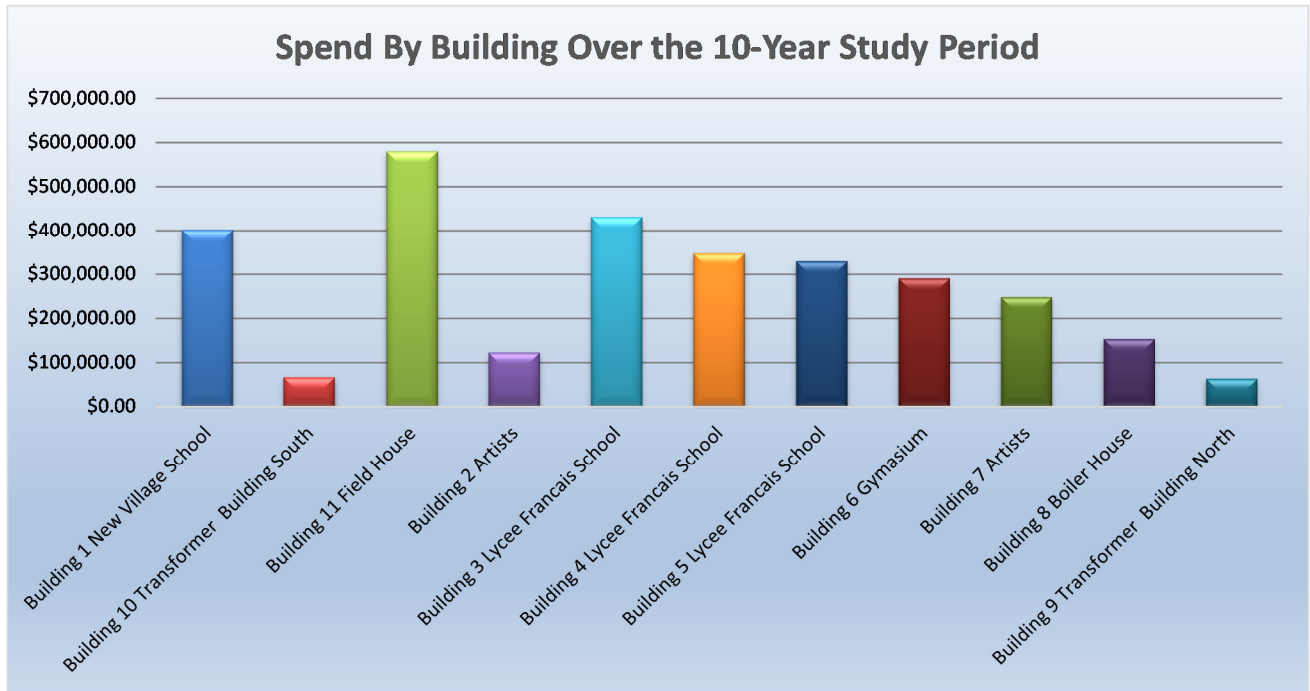
The chart below shows a 10-year a breakdown of the expenditure by building. As can be seen the Field House and its associated playing fields and hard surface playing courts has the largest anticipated spend of \$580,690.71 over the study period. One of the main key issues at this facility and related fields and courts is the failure of the hard surface playing courts of the basketball and tennis courts.

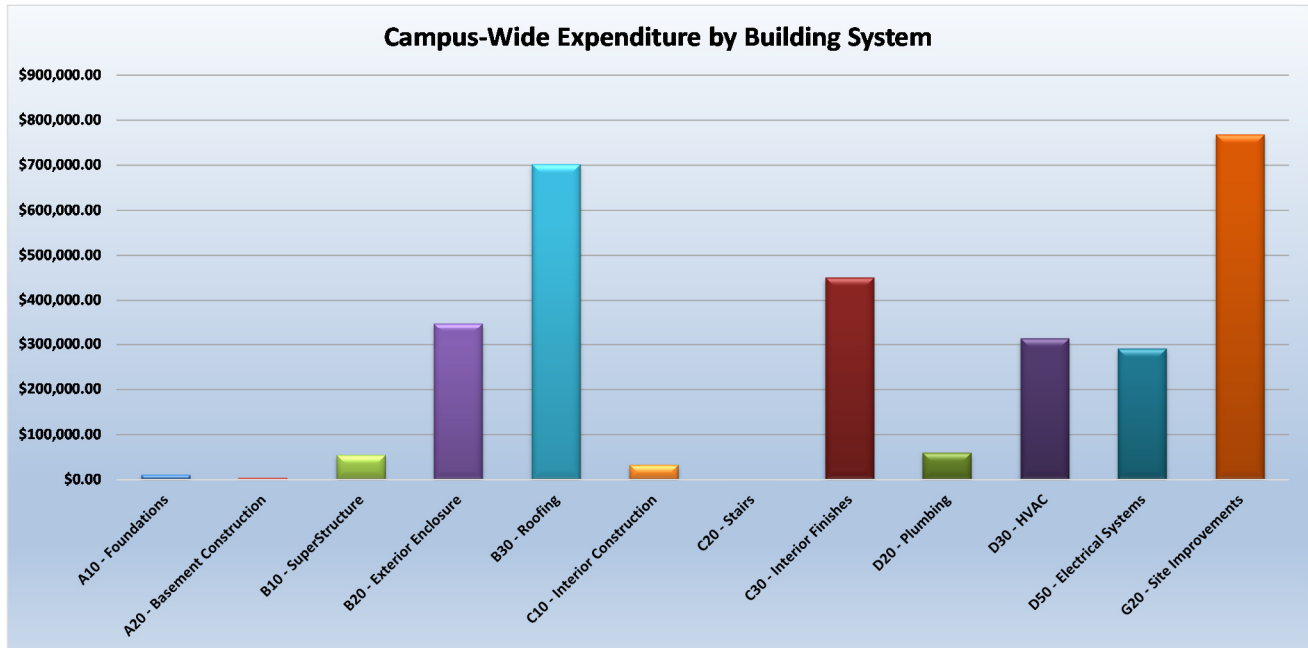
The below chart shows the distribution of expenditure by building system with roofing and site improvements being the highest building system spend area over the study period.

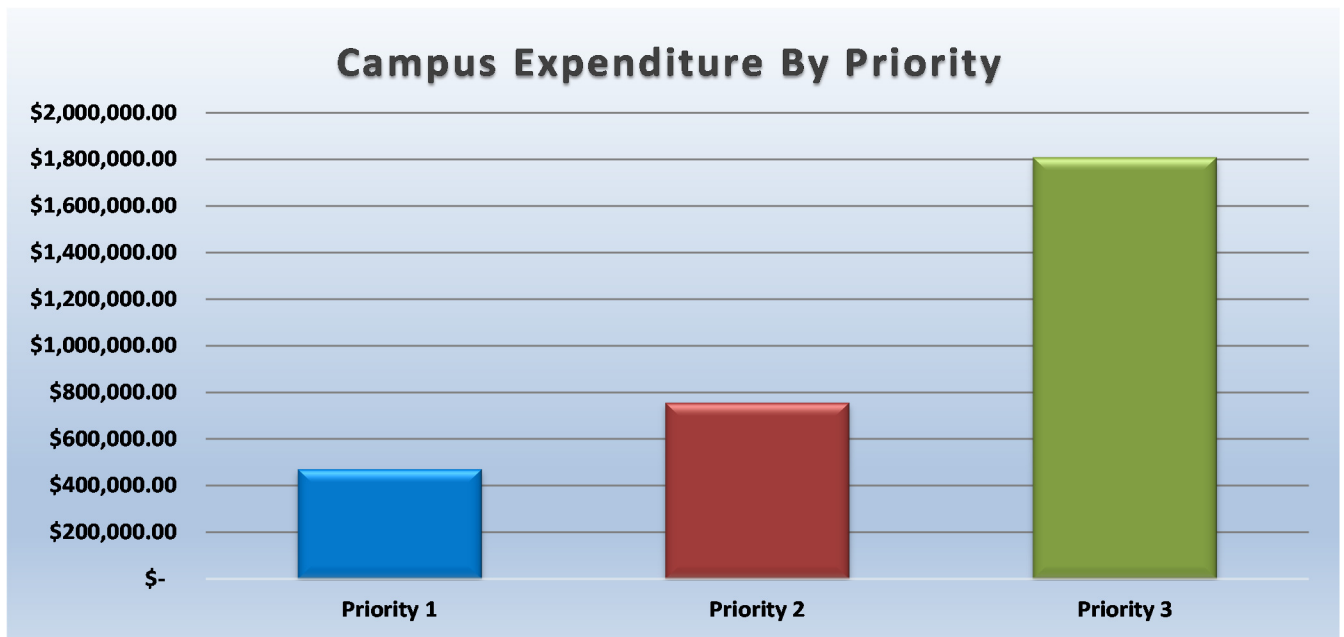
There is \$471,204.25 rated as priority 1 currently critical. There is \$756,250.91 rated as priority 2 potential critical. There is \$1,810,589.70 rated as priority 3 necessary / not critical.

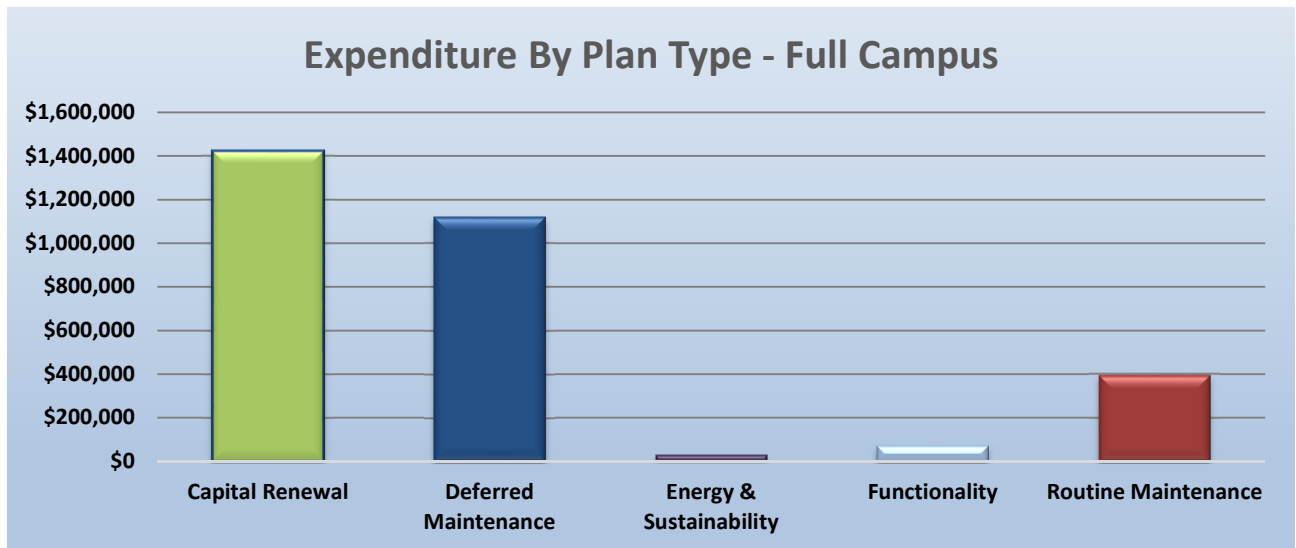
As can be observed from the chart below capital renewal is the highest expenditure during the study period, which coincides with the renewal of roof coverings and HVAC as the main spends over the study period.
